# LANDSLIDE INVENTORY AND LAND-USE MAPPING, DEM PREPARATION, PRECIPITATION THRESHOLD VALUE AND ESTABLISHMENT OF EARLY WARNING DEVICES

March 2012

### **Rainfall Triggered Landslide Hazard Zonation in Cox's Bazar & Teknaf Municipalities as well as Introducing Community-based Early Warning System for Landslide Hazard Management**

#### **Revised Report on Landslide Inventory and Land-use Mapping, DEM Preparation, Precipitation Threshold Value & Establishment of Early Warning Devices**

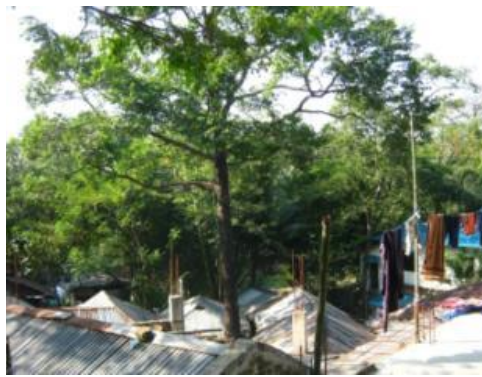
Houses vulnerable to Landslide-Mohajer para

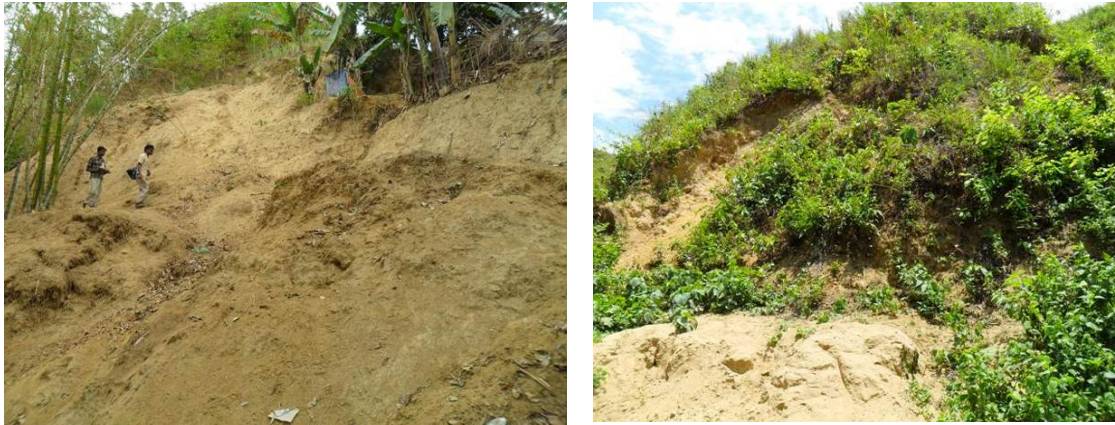
Landslide Sites at Puran Pallan Para

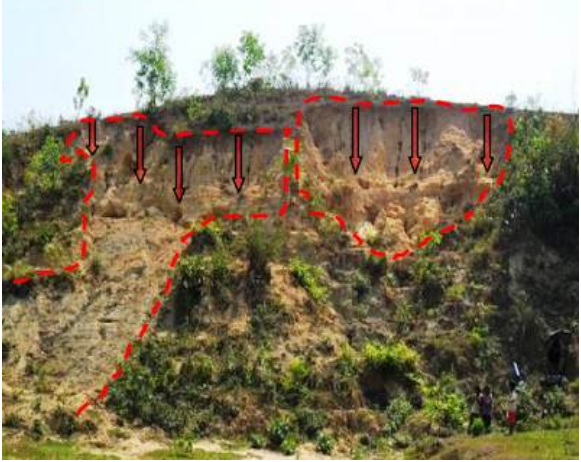
| <p><b>Landslide ID:</b> 09<br/><b>Location:</b> South Ganar Ghona, Cox's Bazar district</p> | <p><b>Coordinates:</b><br/>N-21°25'00.5", E-92°01'04.6"</p> |

| <p><b>Date of Occurrence:</b> 15 June 2010, 3 July 2008 and 11 June 2007.<br/>(The Landslide Occurred around 6:00am due to heavy rain.</p> | <p><b>Landslide History:</b> Initiated movement in June 2007, Subsequently activated in July 2008 and June 2010.</p> |

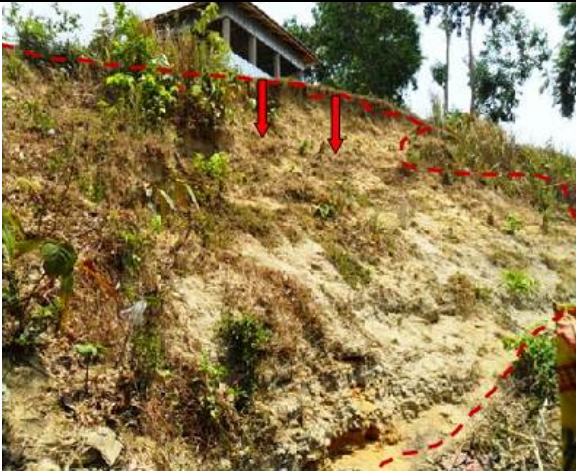
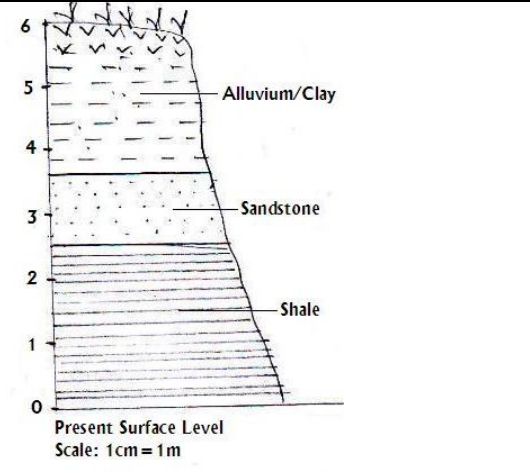
| <b>Landslide ID:</b> 47<br><b>Location:</b> Adorsha Gram, Cox's Bazar district | | <b>Coordinates:</b><br>N-21°24'47.6",<br>E-91°59'30.9" | |

| <b>Date of Occurrence:</b> 15 June 2010.<br><b>Rainfall:</b> | | <b>Landslide History:</b> Landslide occurred here in June, 2010. | |

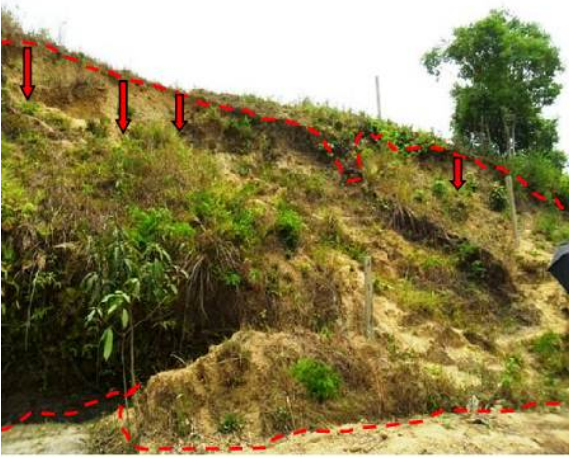
| <p><b>Landslide ID:</b> 70<br/><b>Location:</b> West Lar Para, Kolatoli Bypass., Cox's Bazar district</p> | <p><b>Coordinates:</b><br/>N-21°25'35.8"<br/>E-91°59'47.0"</p> |

| <p><b>Date of Occurrence:</b> 15 June, 2010 and 15 June, 2003.</p> | <p><b>Landslide History:</b> Initiated movement in June 2003, Subsequently activated in June 2010 (Repetitive).</p> |

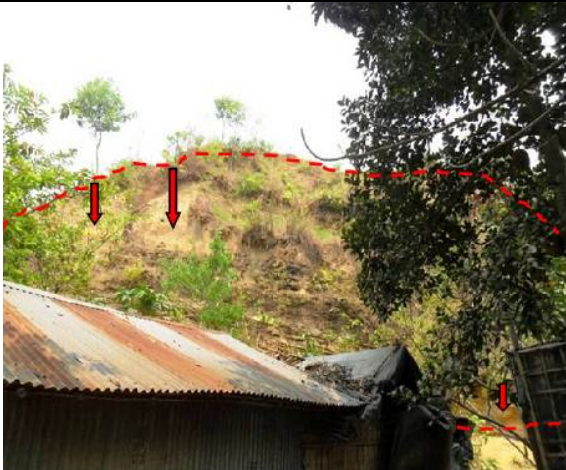
| <p><b>Landslide ID:</b> 87<br/> <b>Location:</b> South Dikkul, Lar Para, Kolatoli Bypass., Cox’s Bazar district.</p> | <p><b>Coordinates:</b><br/> N-21°25'20.4",<br/> E- 92°00'27.2"</p> |

| <p><b>Date of Occurrence:</b> June 19, 2004 and July 8, 2006.</p> | <p><b>Landslide History:</b> Initiated movement in June 2004, Subsequently activated in July 2006.</p> |

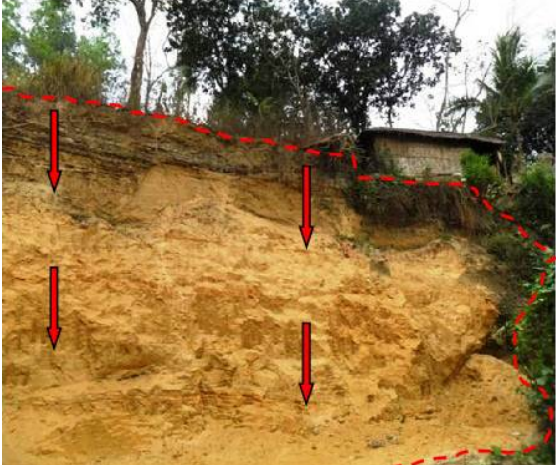
| <b>Landslide ID:</b> 97<br><b>Location:</b> South Haji Para, Cox's Bazar district | <b>Coordinates:</b><br>N-21°25'26.6"<br>E-92°00'40.0" |

| <b>Date of Occurrence:</b> 15 June 2010 and 10 June 2006. | <b>Landslide History:</b> Initiated movement in June 2006, Subsequently activated in June 2010. |

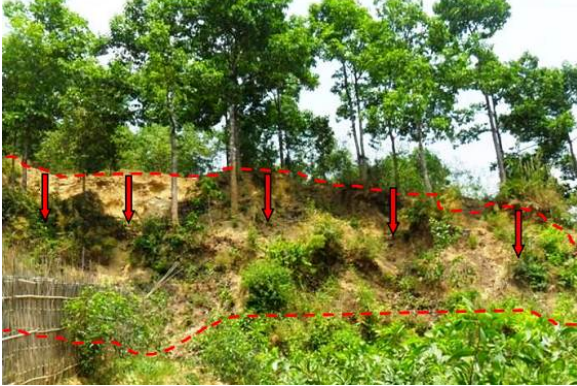
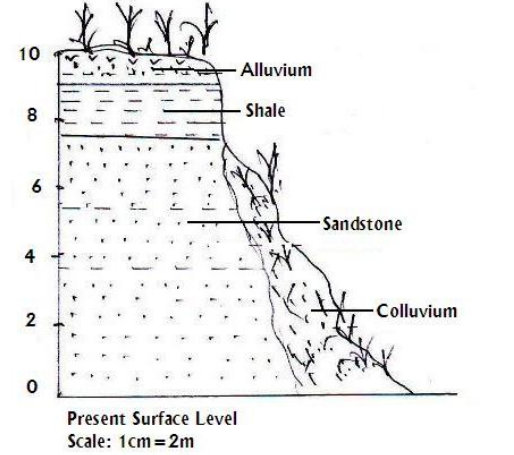
| <p><b>Landslide ID:</b> 100<br/><b>Location:</b> South Haji Para, Cox's Bazar district</p> | <p><b>Coordinates:</b><br/>N-21°25'11.5"<br/>E-92°00'43.3"</p> |

| <p><b>Date of Occurrence:</b> 14 June 2010<br/><b>Rainfall:</b></p> | <p><b>Landslide History:</b> Subsequently activated in June 2010.</p> |

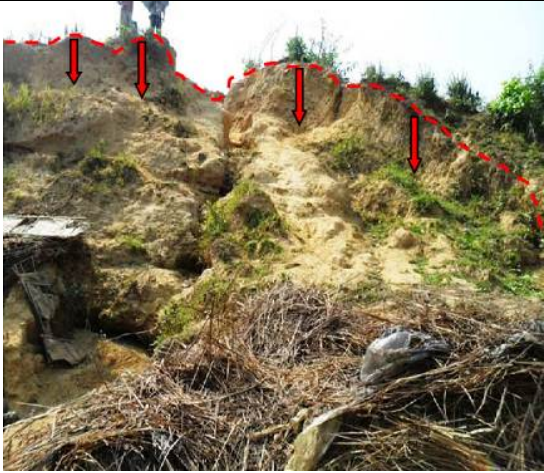
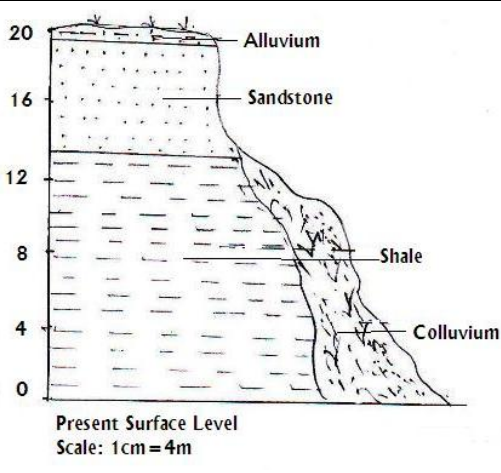
| <p><b>Landslide ID:</b> 103<br/><b>Location:</b> Badshar Ghuna, Cox's Bazar district</p> | <p><b>Coordinates:</b><br/>N-21°26'0.4"<br/>E-91°58'50.2"</p> |

| <p><b>Date of Occurrence:</b> 15 June 2010<br/><b>Rainfall:</b></p> | <p><b>Landslide History:</b> Subsequently activated in June 2010.</p> |

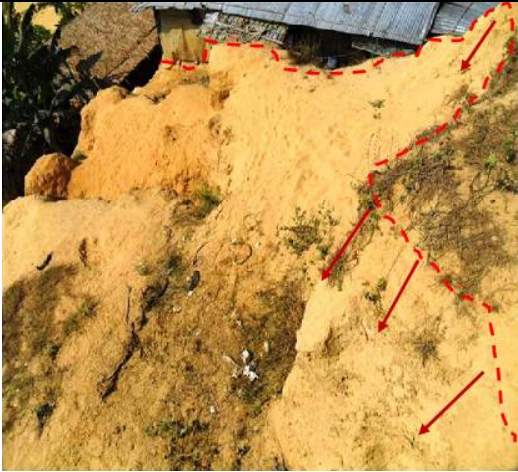
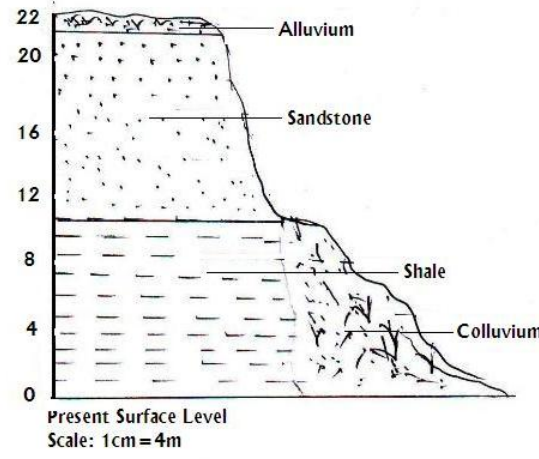
| <p><b>Landslide ID:</b> 104<br/><b>Location:</b> Badshar Ghuna, Cox's Bazar district</p> | <p><b>Coordinates:</b><br/>N-21°25'58.6"<br/>E-91°58'52.2"</p> |

| <p><b>Date of Occurrence:</b> 15 June 2010<br/><b>Rainfall:</b></p> | <p><b>Landslide History:</b> Subsequently activated in June 2010.</p> |

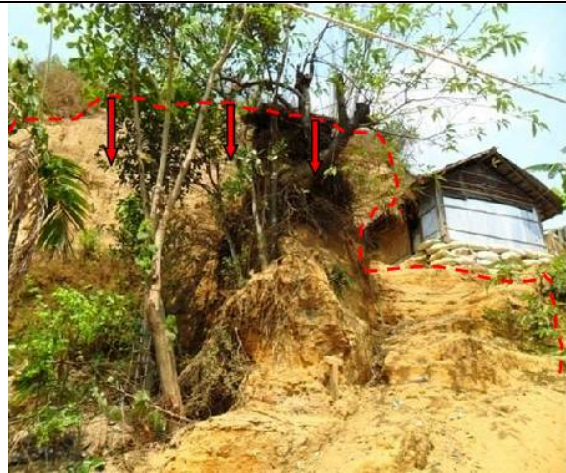
| <p><b>Landslide ID:</b> 107<br/><b>Location:</b> Badshar Ghuna, Cox's Bazar district</p> | <p><b>Coordinates:</b><br/>N-21°26'4.4"<br/>E-91°58'50.7"</p> |

| <p><b>Date of Occurrence:</b> 15 June 2010 and June 11, 2007.</p> | <p><b>Landslide History:</b> Initiated movement in June 2007, Subsequently activated in June 2010.</p> |

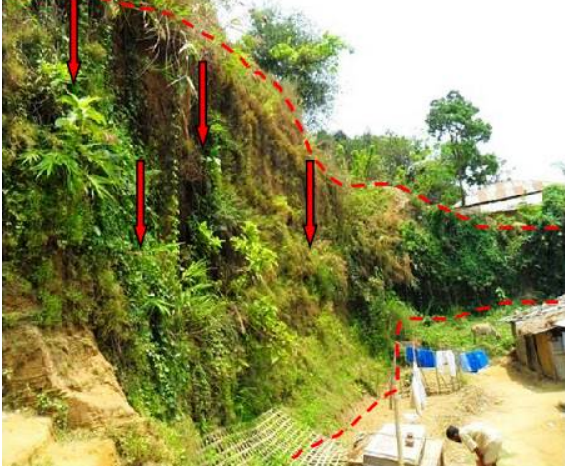
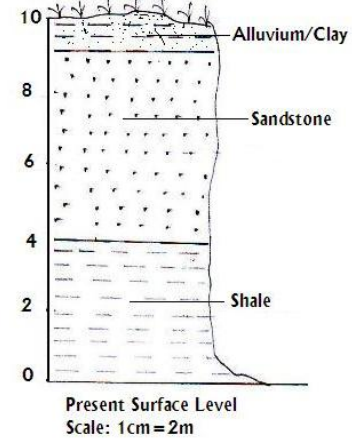
| <p><b>Landslide ID:</b> 108<br/><b>Location:</b> East Light House para, Cox's Bazar district</p> | <p><b>Coordinates:</b><br/>N-21°25'42.2"<br/>E-91°58'52.4"</p> |

| <p><b>Date of Occurrence:</b> 15 June 2010<br/><b>Rainfall:</b></p> | <p><b>Landslide History:</b> Subsequently activated in June 2010.</p> |

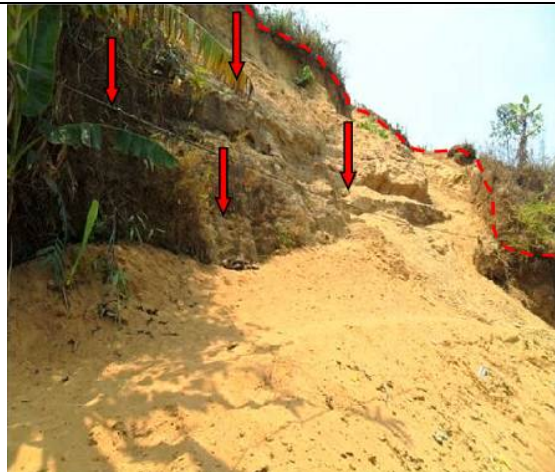
| <b>Landslide ID:</b> 109<br><b>Location:</b> East Light House para, Cox's Bazar district | <b>Coordinates:</b><br>N-21°25'40.2"<br>E-91°58'49.3" |

| <b>Date of Occurrence:</b> 15 June 2010 and July 3, 2008. | <b>Landslide History:</b> Initiated movement in July 2008, Subsequently activated in June 2010. |

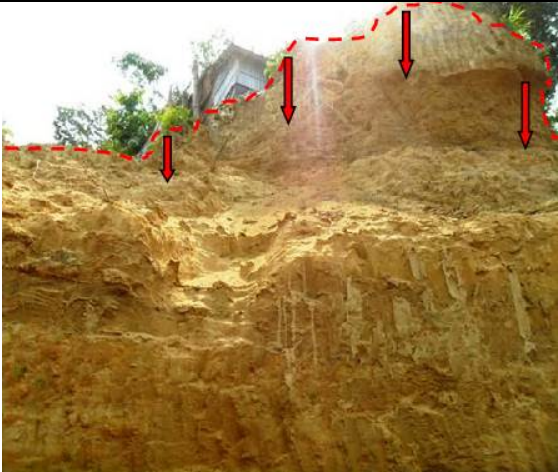
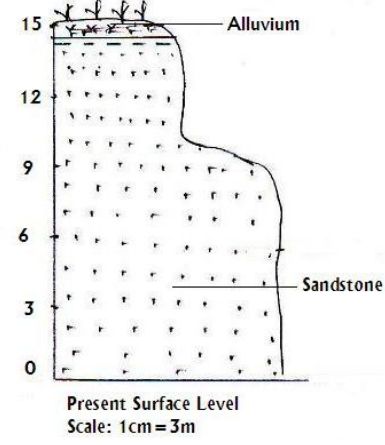
| <b>Landslide ID:</b> 112<br><b>Location:</b> Pahartoli, Cox's Bazar district | | <b>Coordinates:</b><br>N-21°26'8.2"<br>E-91°58'57.1" | |

| <b>Date of Occurrence:</b> 15 June 2010<br><b>Rainfall:</b> | | <b>Landslide History:</b> Subsequently activated in June 2010. | |

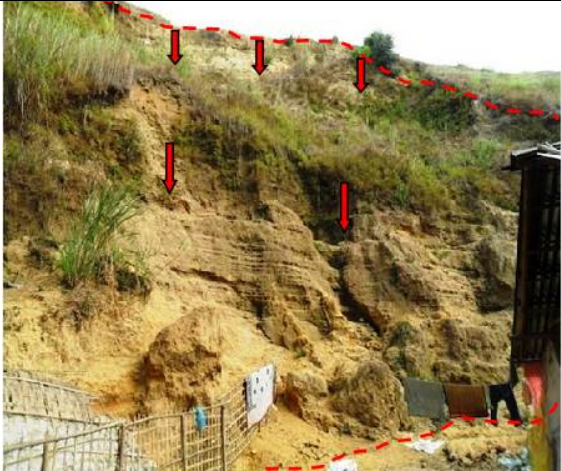
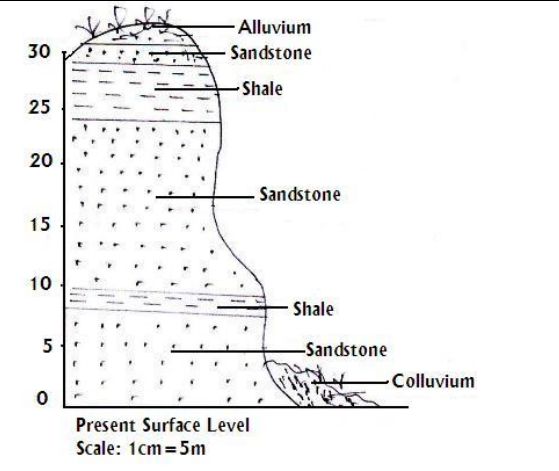
| <p><b>Landslide ID:</b> 124<br/><b>Location:</b> Sahittika Palli, Cox's Bazar district</p> | <p><b>Coordinates:</b><br/>N-21°26'11.4"<br/>E-91°59'37.0"</p> |

| <p><b>Date of Occurrence:</b> 15 June 2010<br/><b>Rainfall:</b></p> | <p><b>Landslide History:</b> Subsequently activated in June 2010.</p> |

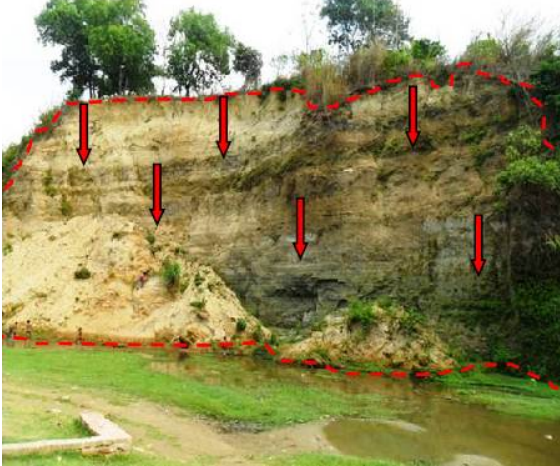
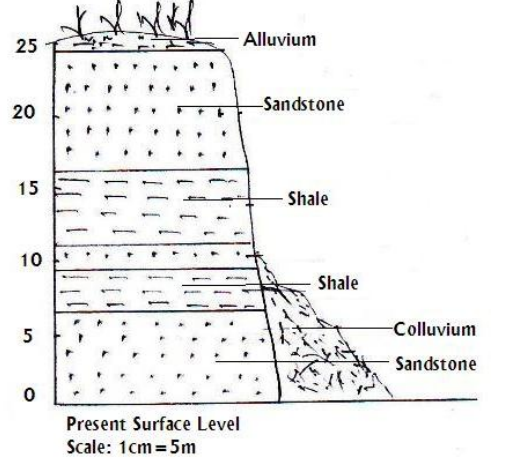
| <p><b>Landslide ID:</b> 129<br/><b>Location:</b> Barachara, South kولاتoli, Cox's Bazar district</p> | <p><b>Coordinates:</b><br/>N-21°23'46.7"<br/>E-92°00'02.0"</p> |

| <p><b>Date of Occurrence:</b> 15 June 2010<br/><b>Rainfall:</b></p> | <p><b>Landslide History:</b> Subsequently activated in June 2010.</p> |

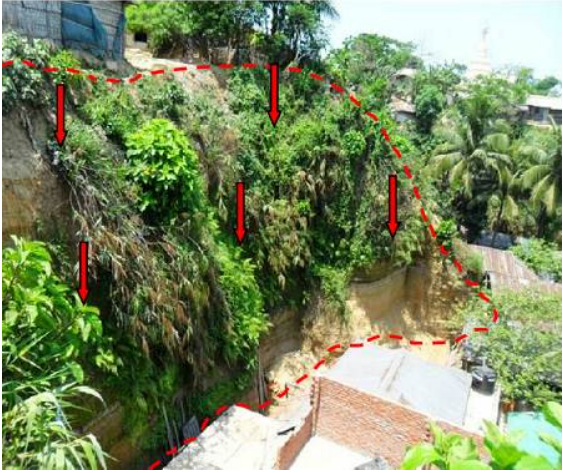
| <b>Landslide ID:</b> 143<br><b>Location:</b> Baidder Ghuna, Cox's Bazar district | <b>Coordinates:</b><br>N-21°26'16.9"<br>E-91°58'54.6" |

| <b>Date of Occurrence:</b> 15 June 2010 and July 3, 2008. | <b>Landslide History:</b> Initiated movement in July 2008, Subsequently activated in June 2010. |

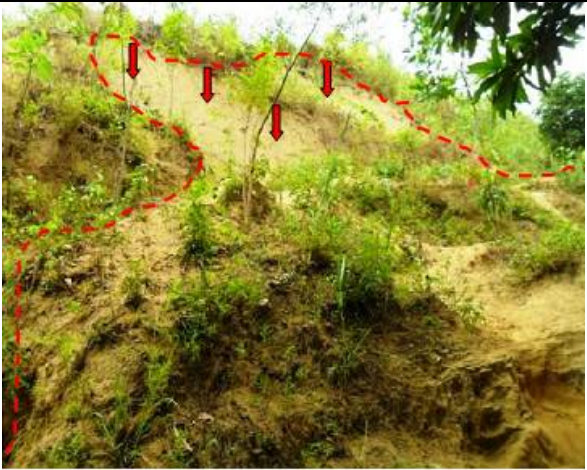
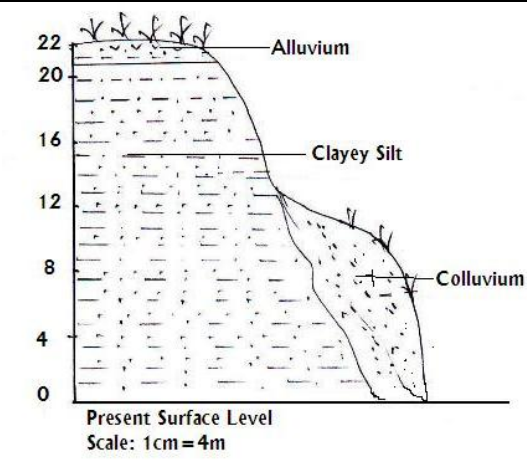
| <b>Landslide ID:</b> 04<br><b>Location:</b> Puran Pallan Para, Teknaf Municipal Area | <b>Coordinates:</b><br>N-20°52'21.3"<br>E-92°17'30.9" |

| <b>Date of Occurrence:</b> June 15, 2010<br><b>Rainfall:</b> | <b>Landslide History:</b> Subsequently activated in June 2010. |

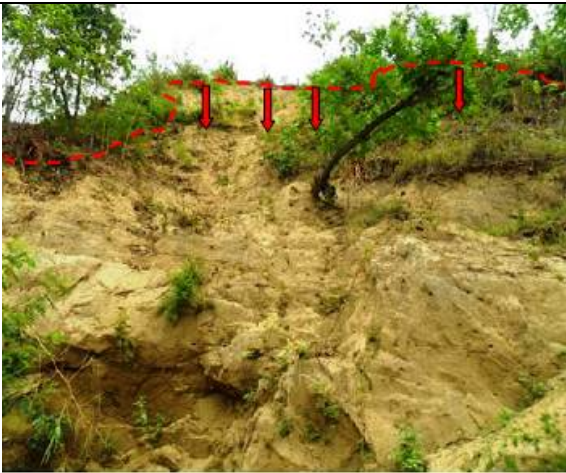
| <b>Location:</b> Puran Pallan Para, Teknaf Municipal Area | N-20°52'31.1"<br>E-92°17'29.5" |

| <b>Date of Occurrence:</b> June 15, 2010 | <b>Landslide History:</b> Subsequently activated in June 2010. |

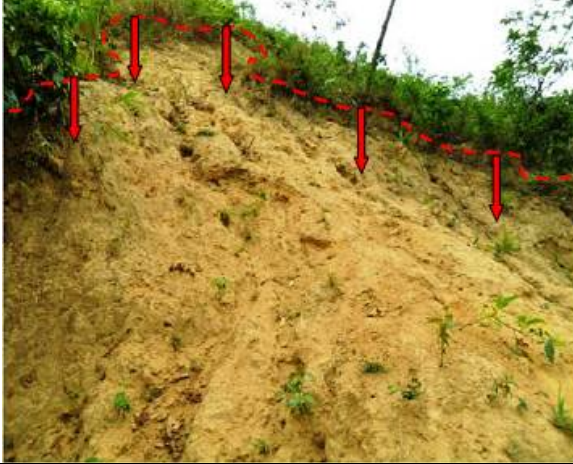
| <p><b>Landslide ID:</b> 08<br/><b>Location:</b> Puran Pallan Para, Teknaf Municipal Area</p> | <p><b>Coordinates:</b><br/>N-20°52'22.2"<br/>E-92°17'28.6"</p> |

| <p><b>Date of Occurrence:</b> July 6, 2008.</p> | <p><b>Landslide History:</b> Subsequently activated in July 2008.</p> |

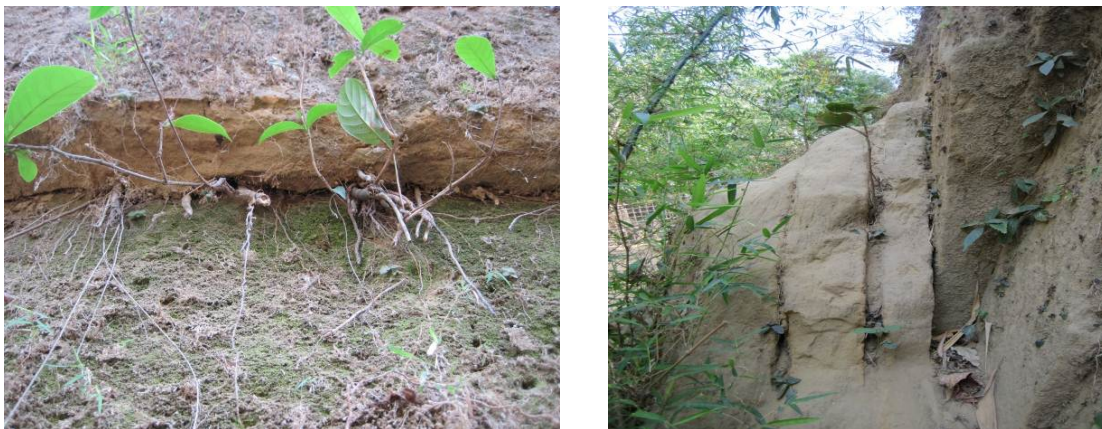
It is seen from the past landslide Inventory that there are 4-5 categories of rock types observed on the failed slopes but predominant rock types to be shale and sandstones. All other rock types are variations of the same with thinner inter-bedding and presently highly to completely weathered. It is seen that all such main Rock types also are subjected to weathering to a different degree or covered with a Residual soil layer where the relic structure was intact .In certain cases it have had a colluviums layer that has been accumulated on the slope, which overlay the weathered bed rock layer or the residual soil layer. Since the mapping has been carried out several months in some cases year or more, it is difficult to establish the proper boundaries or to postulate the situation within the failure mass. However it is evident that the major impact in destabilizing the slope is due to inter-bedding of clay and sand layers in predominant rock types of Shale and Sandstone weathering penetrated along the thinner layers to a greater depth. Apparently these inter-bedded layers are result of weathering along the bedding plane which usually occurs in a near horizontal angle. Combination of weathering along bedding planes and two fracture zones observed in the area are influencing the detachment of rock mass from the main bed rock and tend to destabilize under gravity. It is easy to have water saturation along such layers and interplay of several joints with bedding plane always create wedge failures or down slope movement of blocks. However since majority of the layer is in highly weathered condition or covered with residual soil or weathered colluviums now we see it as a mass dislocation containing a mixture of rock and soil so it is imperative to see such movements as Debris flows. The vegetation (*see Plate:03*) also play a major role in destabilization of such mass as root systems developed in whether thin layers can help expansion of joint systems as well as bedding planes which help water penetration deep in to rock mass which always increases the potential of failure.

**Plate 3: Root systems developed in joints and in think inter-bedded layers**
