# Developing Dynamic Web-GIS based Early Warning System for the Communities at Landslide Risks in Chittagong Metropolitan Area, Bangladesh

## Landslide Inventory Report August, 2014

# **Landslide Inventory Report of Chittagong Metropolitan Area, Bangladesh**

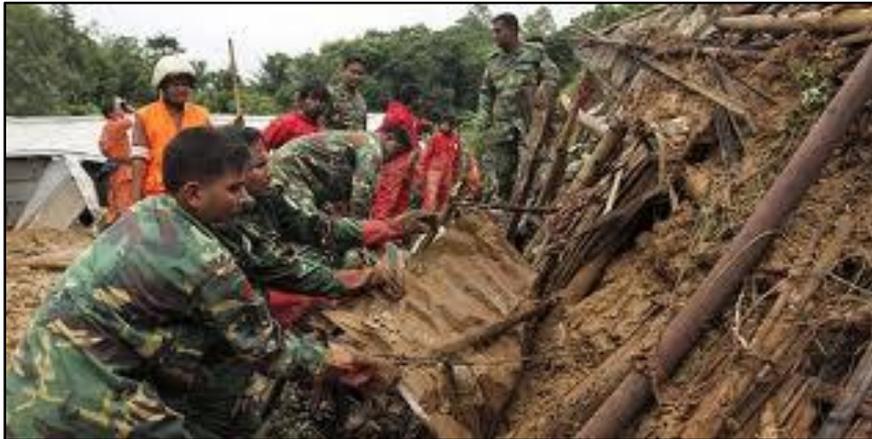
Figure 1.12: Existing condition in the most landslides prone of Chittagong City: a) Instable slope near Batali Hill b) View from Tankirpahar in Matijhorna area where in foothill informal settlement with high landslide risk c) Residential Buildings built by cutting hills d) Hill cutting near Batali Hill area. Source: *Field survey, August 2014*

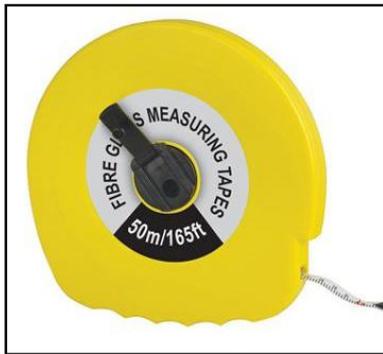
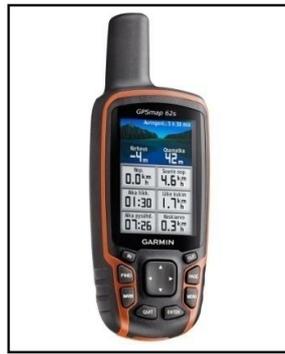
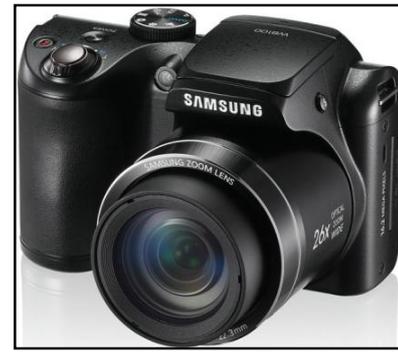
Figure 1.21: Survey Instruments (a) Measuring tape, (b) GPS device, (c) Camera

The displacement of mass has been measured using long fiberglass measuring tape. (Figure 1.21)

(b) **GPS Instrument:** Garmin map 62s has been used to collect the GPS values in selected points. (Figure 1.21)

(c) **Camera:** The photographs of study locations have been captured using Samsung WB100 digital camera. (Figure 1.21)

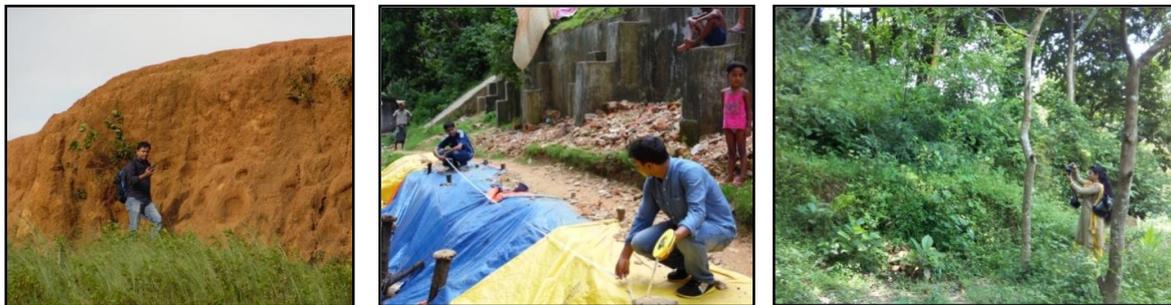
Figure 1.22: Field Survey (a) Taking GPS values, (b) Measuring displacement of mass, (c) Taking Photographs

Location name was collected by interviewing people. Coordinate values of landslide locations was collected by using GPS (Figure 1.22-a). In case of some restricted/unreachable places information was collected through interpreting the Google earth image. The displacement of mass has also been measured (Figure 1.22-b). Besides, landslide mechanism, causes of movement, landslide history and consequences have been collected from the local people and the affected people to some places as the collected documents could not provide us with those information. The daily rainfall data have been collected from Bangladesh Meteorological Department up to the year 2010. However, as the exact date of some landslide events could not found from archive or the local people, the rainfall data could not be provided for those landslide events in the detailed inventory report. The future risks have been determined after over viewing the previous consequences of landslide and the opinion of the local people. Throughout the field survey photographs of the landslide areas considering different issues were collected by the project team (Figure 1.22-c).

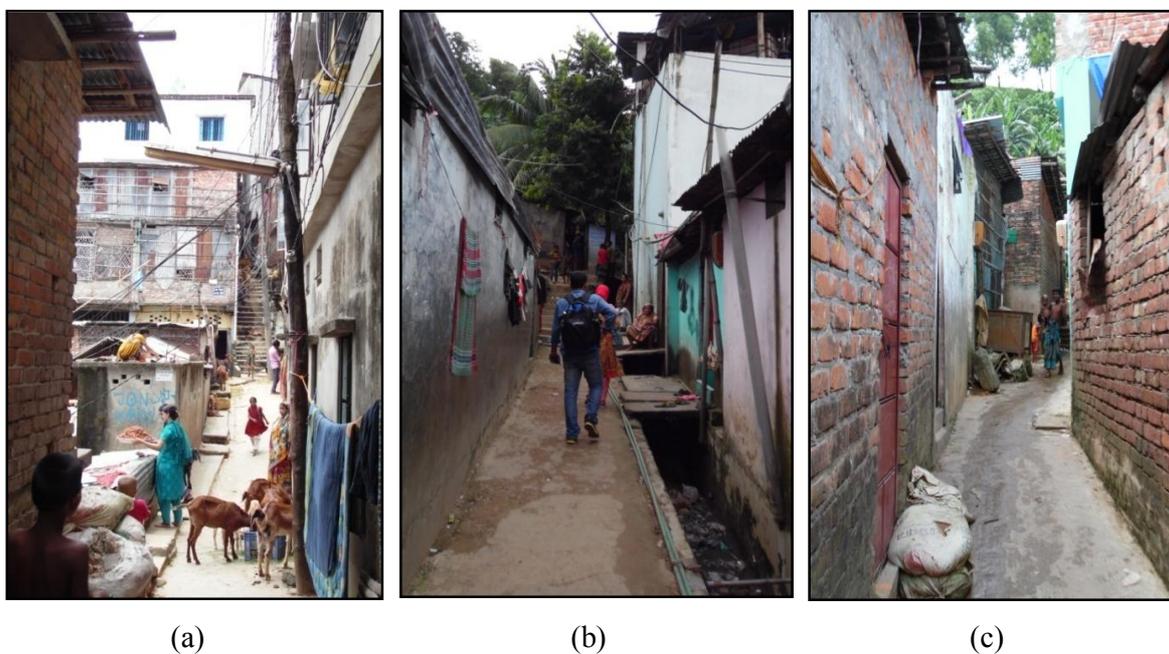
Motijharna lane, Tankir Pahar lane and Chanmari bi lane interconnect the areas in Tankir Pahar, Motijharna Pahar, Batali Hill, Chanmari Lane (**Figure 3.1**). The roads in Tankir Pahar and Motijharna are nearly 5-7 feet in width. The roads are made of clay, sand and brick chips i.e; semi-paved and broken in most of the places. In Tankir pahar there are stairs instead of roads in some places because of sloppy condition (Figure 2.4-a).

Figure 2.4: Internal roads (a) & (b) Tankir Pahar community, (c) Motijharna pahar community. Source: *Field Survey, August 2014*

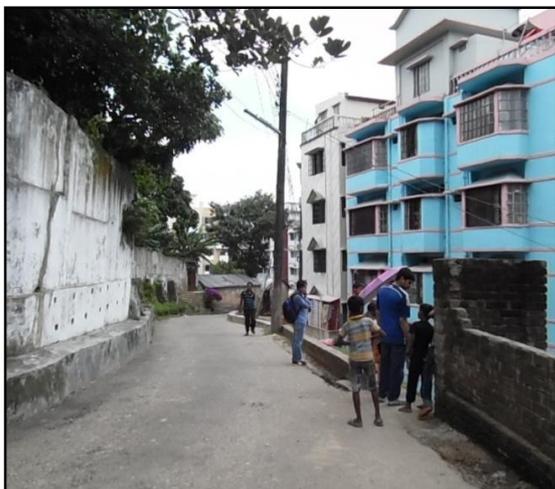
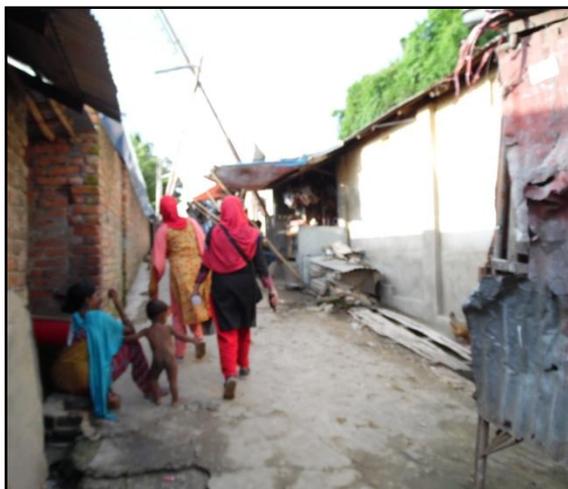
On the other hand, the roads in Chanmari Lane and Batali Hill community are paved (material: asphalt) and semi-paved respectively. The road width in both the areas is 8-10 feet.

Figure 2.5: Roads in (a) Chanmari Bi Lane community, (b) Batali Hill community

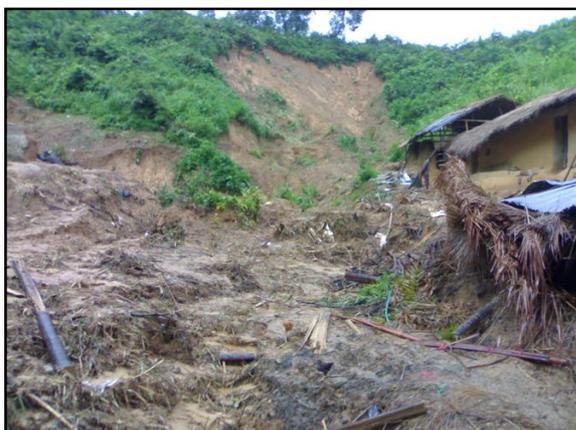
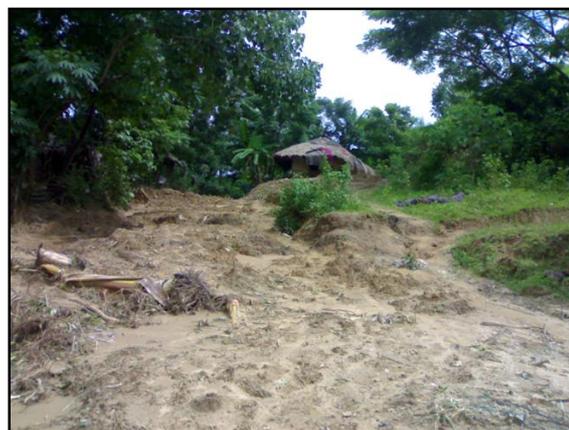
The areas defined in cluster 2 are mainly in Chittagong Cantonment Area. After the devastating landslide occurred in the year 2007 (Figure 2.6), the areas were taken under the Cantonment Area and no human settlement was further developed here.

Figure 2.6: Scenario after devastating landslide in the year of 2007, (a) Lebugaban (b) Sekandar para

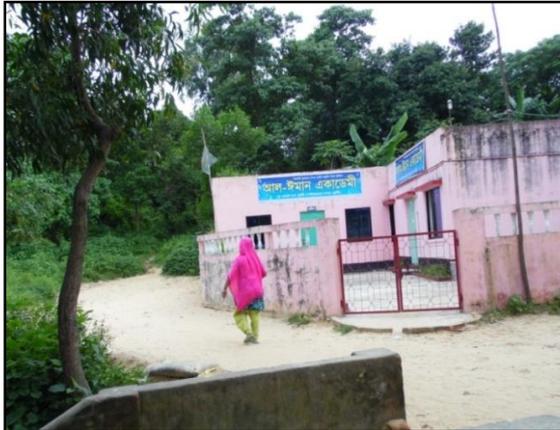
The Kushumbagh area (cluster 3) consists of Lalkhan Bazar, Goribullah Shah Mazar and Ispahani Hill. The roads are unpaved and in very poor condition. During rainy season they become muddy and in dry season they remain dusty. The average width is 7-9 feet. (Figure 2.7 and 2.8)

Figure 2.7: Road condition in dry season at Kusumbagh, Lalkhan Bazar.

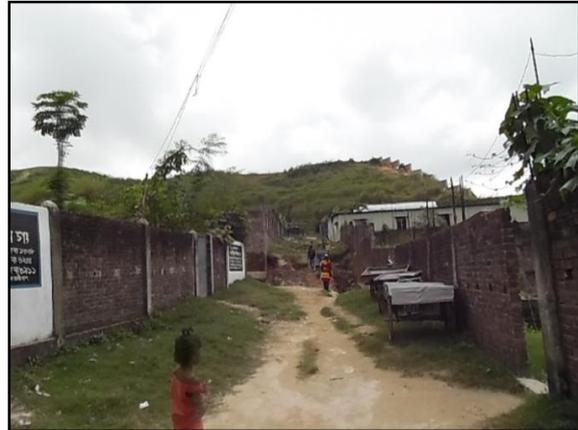
Figure 2.8: Road condition in dry season at Ispahani Pahar.

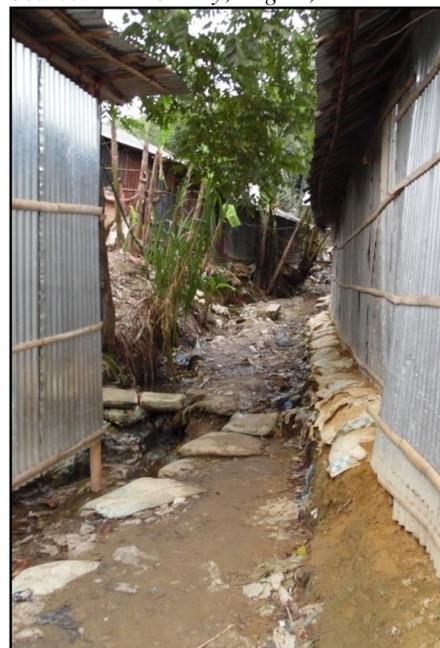
In Golpahar settlement (cluster 5), there are mud roads of 3-4 feet in width. People dump garbage on those narrow roads (Figure 2.9). As there is a very few housing in Akbar Shah Mazar Hill, Red Hill and Nasirakona Hill area, the road network cannot be defined as like as the areas described earlier. People in this community moves along the muddy walkways (Figure 2.10). The settlement in hills at Foy’s lake area also has mud roads as like as Akbar Shah Mazar Area.

Figure 2.9: Road at Golpahar community

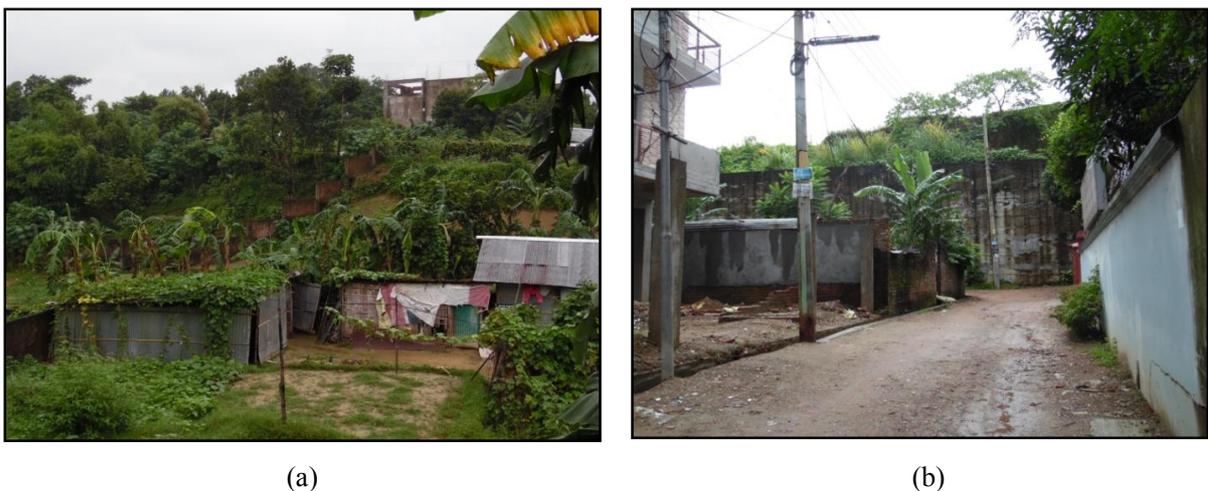
The settlement pattern in different hills of Khulshi area (cluster-7) is not alike. The roads in Kishnochura Housing Area are as same as Akbar Shah Mazar Area and Foy’s Lake Area. Besides, Zakir Hossain Road in South Khulshi is semi-paved and 10-12 feet in width (Figure 2.11). The Holy Crescent Hill is a restricted area.

Figure 2.11: Roads in different community, (a) Krishnochura housing, (b) Zakir Hossain Road, South Khulshi.

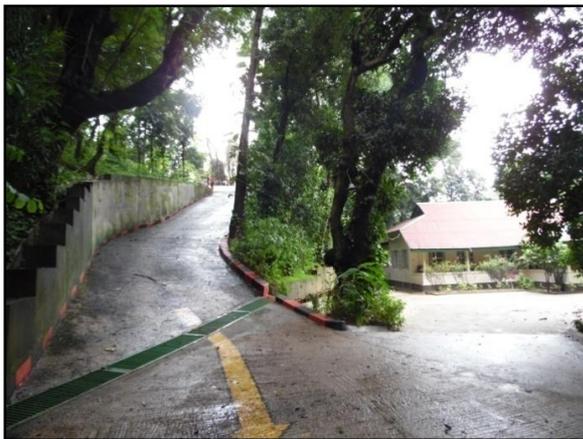
There are two hills in Chotteswari Area namely Finley Hill and Dolphin Hill. There are Bungalows for the corresponding officers on both of the hills. The roads in Finley Hills are well planned and made of concrete (Figure 2.12). There is some housing at the bottom of Dolphin Hill but roads are mainly walkways (Figure 2.13).

Figure 2.12: Road in Finley Hill.

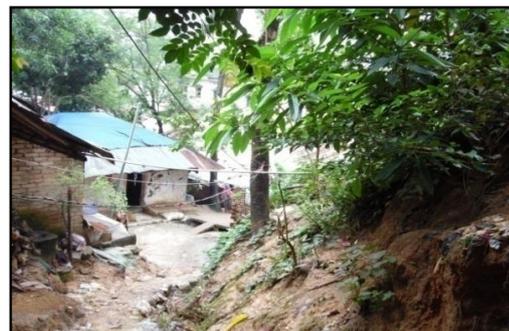
The Goachi Bagan Hill and The King of Chittagong hill are located in Pachlaish Area (cluster 9). The roads are muddy in Goachi Bagan (Figure 2.14) and the roads in other hill are made of concrete.

Figure 2.14: Road in Goachi Bagan

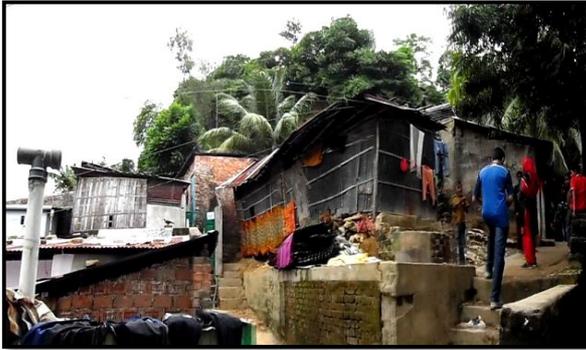
Figure 2.16: Foundation condition of houses (Akbar Shah Mazar Hill, Akbar Shah Area)

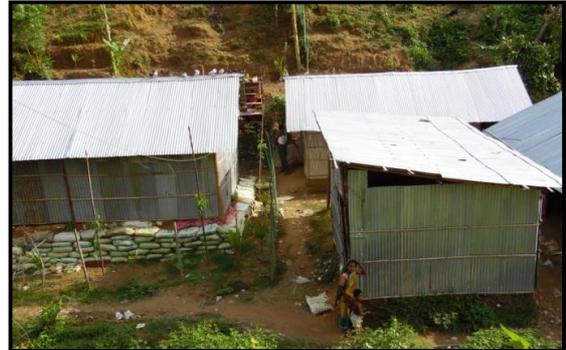
Figure 2.17: Render condition of houses (Motijhorna Hill, Motijhorna area)

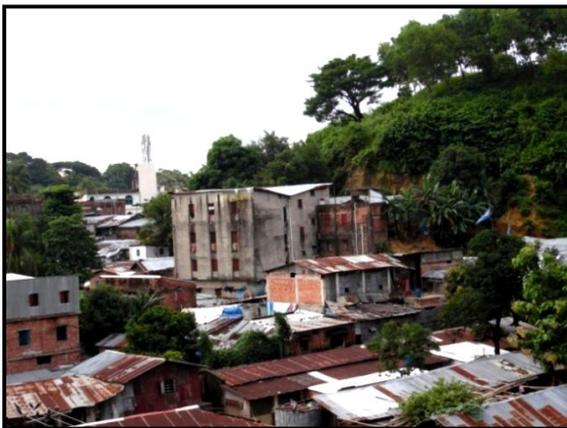
Figure 2.18: Condition of doors and windows (Goachi Bagan Hill, Pachlish area).

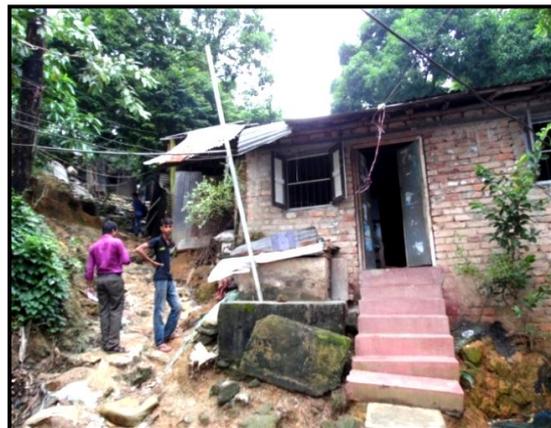
Multistoried buildings are developed without any foundation on the base of the structures. Moreover rendering of the houses is very poor. Most of the buildings lacks proper or minimum plastering (Figure 2.17). Many houses do not have sufficient number of windows and condition of door and windows are very poor (Figure 2.18). Most of the houses lack proper ventilation.

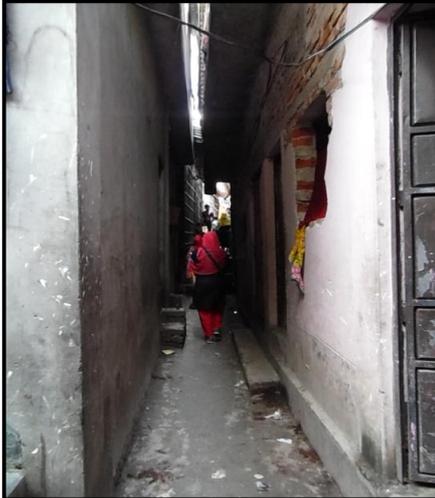
These houses are developed on these hills in different periods. It has been observed that row houses of 3 to 4 rooms form one block. These housing blocks have been established at different time periods. As a result housing blocks are settled in an unplanned manner. 1-2 feet space is kept between two housing blocks (Figure 2.19). Narrow roads of 3 to 4 feet are seen inside the housing settlements. As there is no veranda or corridor in the housing block, these internal roads are used for social gathering, walking and maintaining communication by people living inside the housing settlements (Figure 2.20). Use of steps is a common characteristic of housing of these areas as houses are settled on the slope of the hills. Houses are developed in an unplanned manner, which reflects the characteristics of slum (Field Survey, 2014).

Figure 2.19: Narrow space between two houses (Tankir hill, Motijhorna area) Source: *Field Survey (August, 2014)*

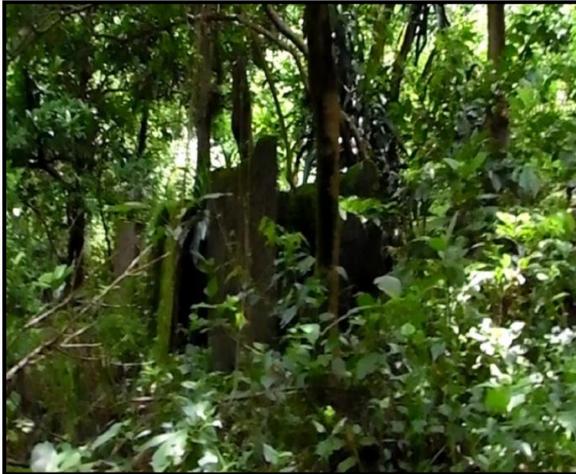
No housing settlements have been found around the hills of Cluster 2 and Cluster 4 of Chittagong Cantonment Area and Chittagong University area (Field Survey, 2014). Once there was settlement around Lebubagan hill of Cantonment area. A massive landslide took place in Lebubagan hill on 2007, which destroyed many houses. After the disaster occurred people left that place (Figure 2.25 and Figure 2.26).

Figure 2.25: Present condition of Leubagan hill, Cantonment

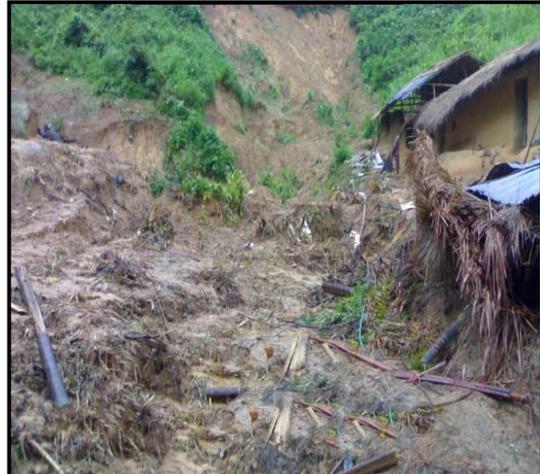
Figure 2.26 :Leubagan hill in 2007, Cantonment

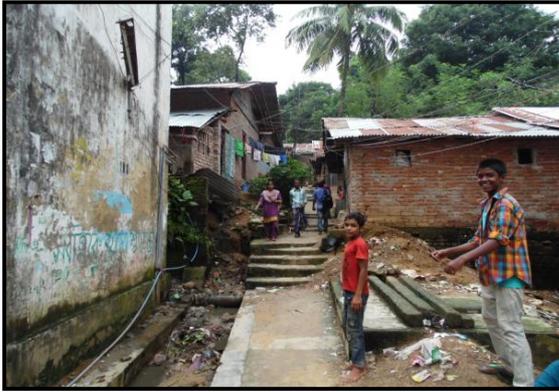
Figure 2.29: Houses are constructed through hill cutting in Goachi Bagan Hill, pachlish

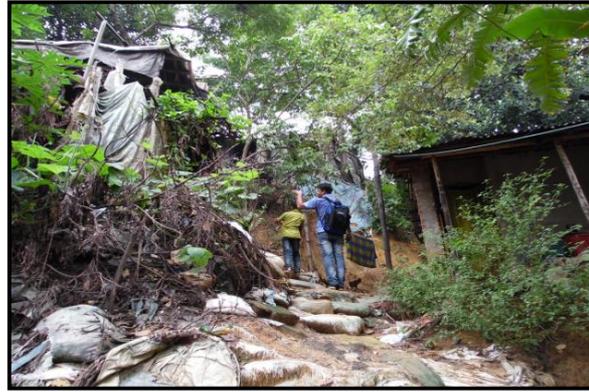
A slum has been developed through cutting Medical hill in Goachi Bagan. Houses are made of brick, tin and bamboo. Houses are of small sized comprised of one room for one family. Housing Characteristics of Goachi Bagan hill is similar to the general characteristics described earlier (Figure 2.28), (Figure 2.29).

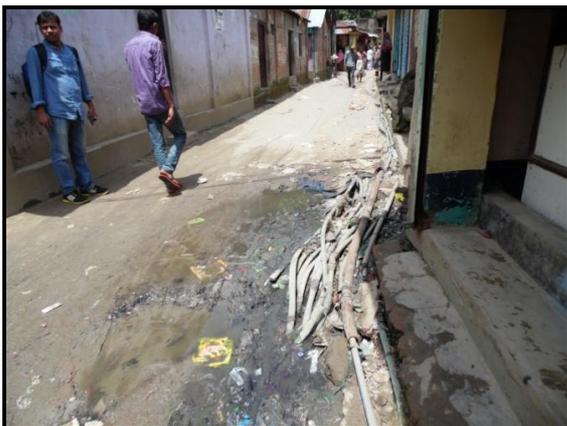
Figure 2.31: Co existence of drainage and water pipelines, Motijhorna hill, Motijhorna. Source: *Field survey, August, 2014*

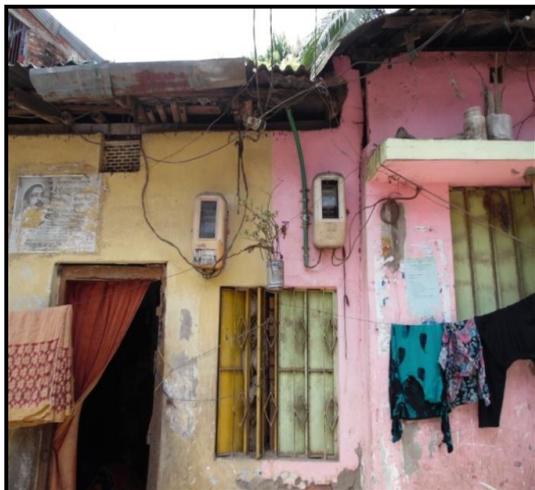
Figure 2.32: Electric meter is kept unprotected outside of the house, Chanmari bi lane, Motijhorna. Source: *Field survey, August, 2014*

There is provision of electricity in the localities surrounding the landslide vulnerable hills. Improper arrangements of electric wires have been observed in the localities surrounding the hills of Cluster 1, Cluster 3, Cluster 5 and Cluster 6 (Figure 2.32 and 2.33) There are many houses in these localities which have illegal electric connection (Field survey, August, 2014 ).

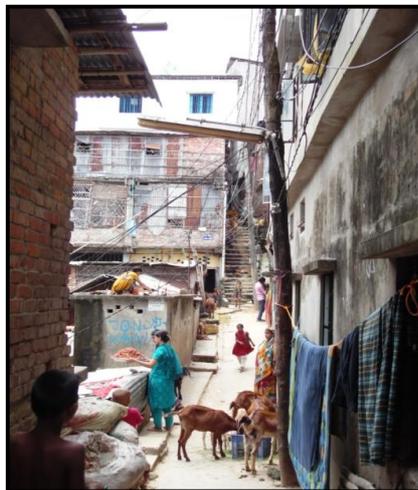
Figure 2.33: Disorganized electric lines in landslide vulnerable communities Source: *Field survey, August, 2014*

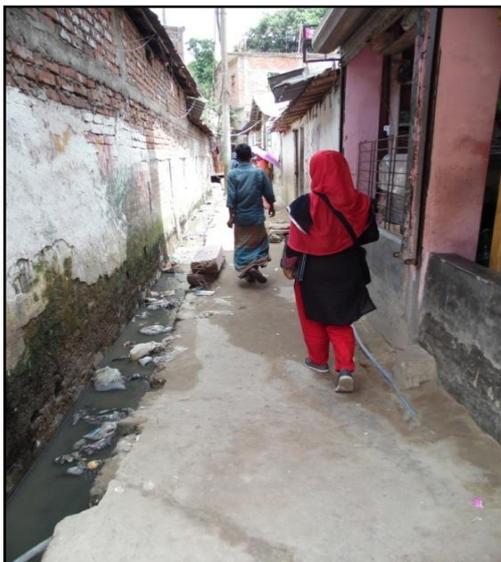
Figure 2.34: Open drain beside road  
Tankir hill, Motijhorna

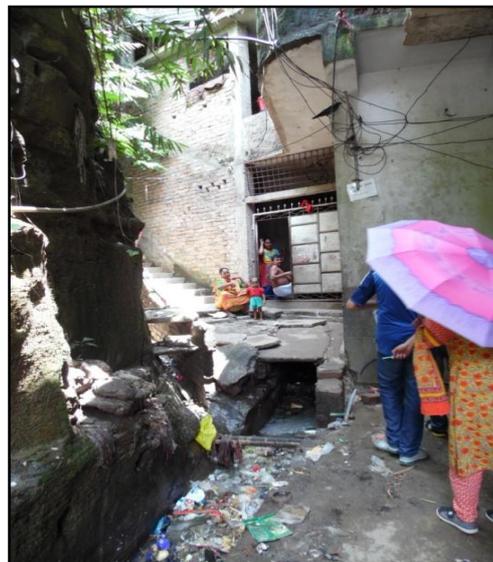
Figure 2.35: Open drain inside community  
Motijhornahill, Motijhorna

**Drainage condition in localities around the hills:** It has been observed from the field investigation that the drainage condition of the landslide vulnerable communities is very poor. Localities around the hills of cluster 1 have drainage facility but condition of drainage system is very poor. There is no management of the drainage network. Drainage network is broken in many places. People dump waste on drains which creates blockage and disturbs the function of drainage (Figure 2.34). Most of the drains are open to sky. Bad odor comes out from drains. Improper drainage system is a contributor to the unhygienic and unhealthy environment of these areas (Figure 2.35).

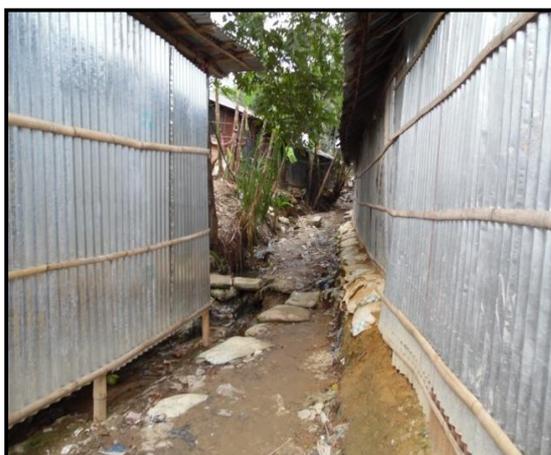
Figure 2.36: People dump waste on Naturally developed; Foy's lake zoo hill, Foy's lake area  
Source: *Field survey, August, 2014*

There is no drainage system developed in the landslide vulnerable communities around the hills of cluster 3, cluster 5 and cluster 6. In these areas water is drained off through natural way (Figure 2.37). But due to human settlements, the natural drainage system always gets disturbed (Figure 2.36). Lack of drainage system has been deteriorating living condition of these communities.

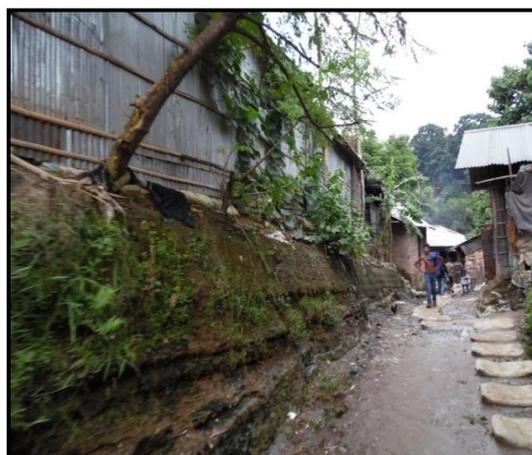
Figure 2.37: Naturally developed drainage is disturbed by human activities; GolPahar, Akbar Shah area. Source: *Field survey, August, 2014*

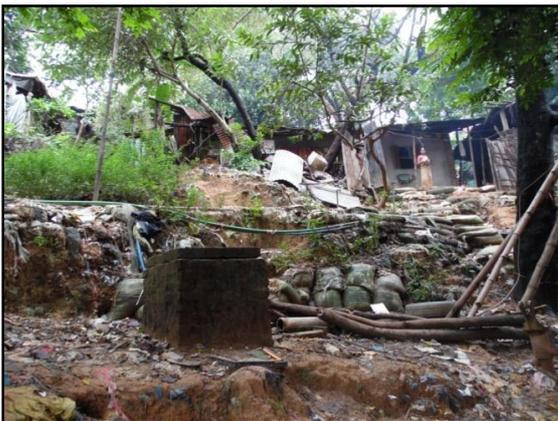
Figure 2.38: Houses are constructed through cutting hill; Medical hill of Goachi Bagan, Pachlish

Rain water is naturally drained off through the slope of the hills. In Chittagong metropolitan area houses are constructed through cutting hill (Figure 2.38). In some areas hills are used for agricultural activities (Figure 2.3). These activities have destroyed the slope characteristics of hills, which results in deterioration of natural drainage condition of hills. Rain water cannot drains off properly and gets logged in different parts of hills. This causes landslide.

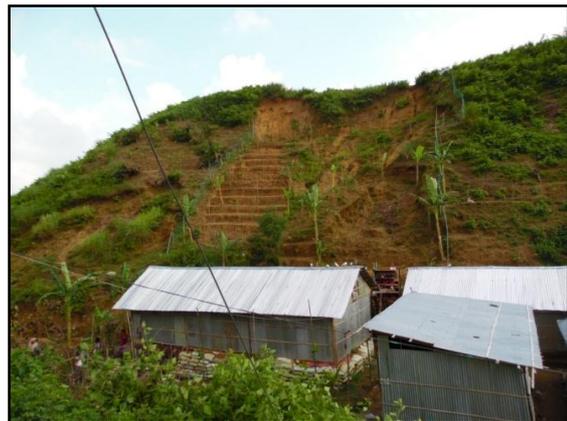
Figure 2.39: People cut hill for agricultural purpose; Akbar Shah Mazar Hill; Akbar shah area

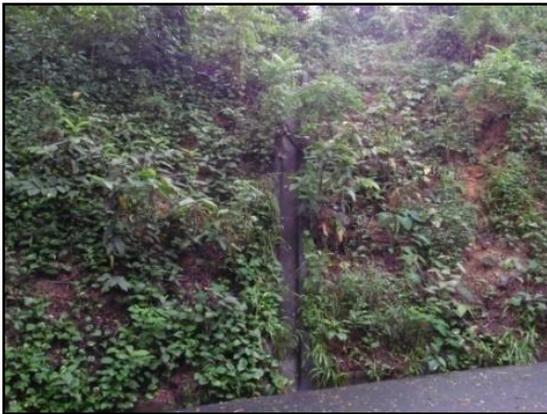
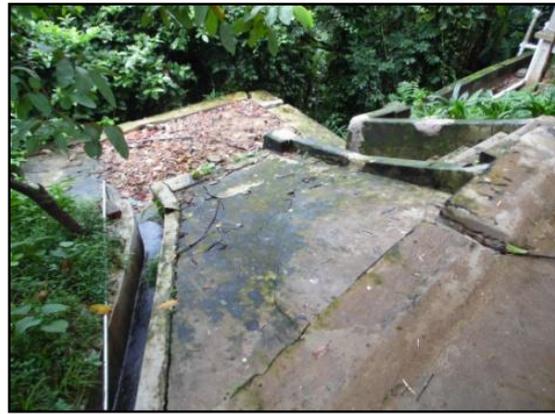
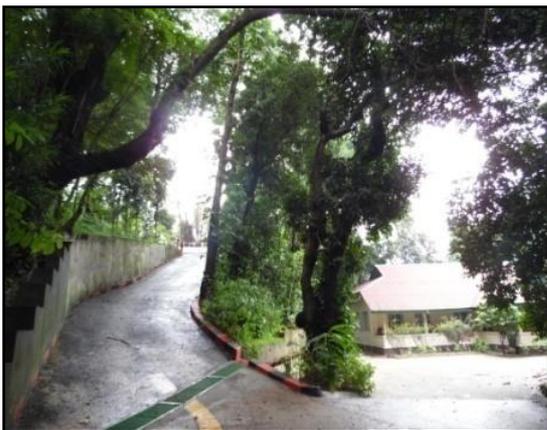
Finley hill is under the authorization of Finley Tea Company. There are 8 bungalows for the officer's of this company. These bungalows and roads are constructed through hill cutting. But there exists a good drainage network (Figure a, b and d). This well developed drainage system helps to drain off water properly. Roads are constructed maintaining the slope of hills (Figure c). No landslide event has been occurred in Finley hill till now. Finley Hill shows a good example of manmade Hill drainage management.

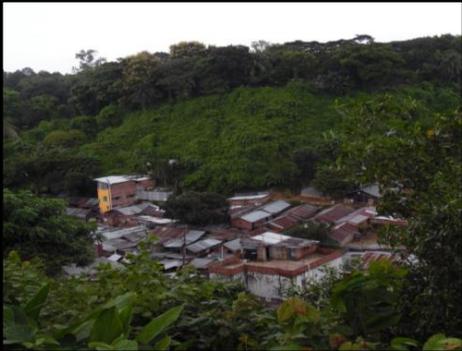
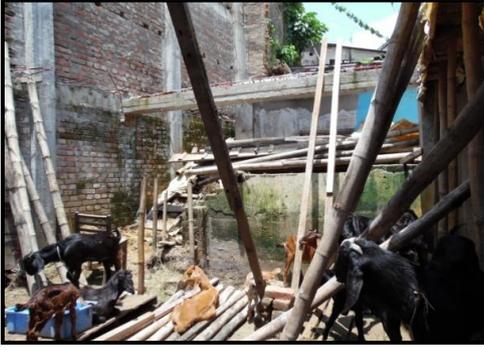
<b>Basic Information</b>	
<p><b>Landslide ID :</b>01  <b>Landslide Location:</b> Motijhorna  <b>Coordinates:</b> 22° 20 ' 51.43'' N, 91° 48 ' 49.68'' E</p>	<p><b>Datum :</b>WGS 1984  <b>Elevation (m):</b> 55.95  <b>Area of Displaced Mass (sqm):</b> 89.91  <b>Rainfall:</b> Unknown</p>

<p>Source: <i>Field survey, August 2014</i></p>
<b>Landslide Mechanism</b>	
<p><b>Type of Movement:</b> Fall  <b>State:</b> Stabilized  <b>Distribution:</b> Confined</p>	<p><b>Style:</b> Single  <b>Water Content:</b> Moist  <b>Material:</b> Soil/Earth</p>
<p><b>Land Cover/Use Type :</b>                  Bare soil and built over have been found as the land cover in this site.</p>	
<p><b>Causes of Movement:</b>                  Improper construction work has been observed in this site. Along with this, Intense and prolonged rainfall contributed to the collapse of slope which finally turned into landslide.</p>

<b>Land Slide History and Future Risk of Landslide</b>	
<p>Landslide in this site occurred on August, 2013. Intense and prolonged rainfall had been occurring for 8-10 days prior to landslide. A chunk of earth collapsed on a tin shed house. The house was completely destroyed. Two people died on spot. At present people has constructed a Boundary wall of about 10 feet to protect the place from further landslide.</p> <p>Utility facilities did not get damaged in this incident. Economic and Environmental loss was not quantifiable.</p>

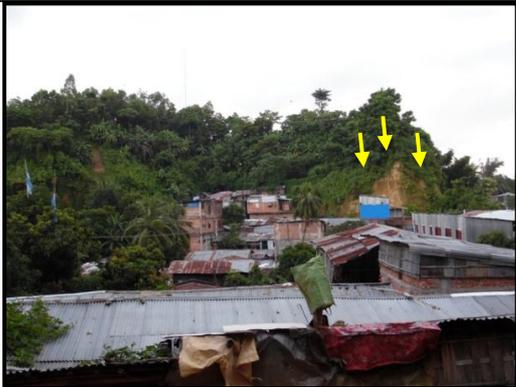
<p style="text-align: center;"><i>Source: Field survey, August 2014</i></p>
<b>Landslide Mechanism</b>	
<p><b>Type of Movement:</b> Fall</p> <p><b>State:</b> Stabilized</p> <p><b>Distribution:</b> Confined</p>	<p><b>Style:</b> Single</p> <p><b>Water Content:</b> Moist</p> <p><b>Material:</b> Soil/Earth</p>
<p><b>Land Cover/Use Type (%):</b> Herbaceous vegetation is the Primary land cover of Motijhirna hill. Forest/ woodland type is also visible in this hill.</p>	
<p><b>Causes of Movement:</b> Hill cutting is the major issue that caused landslide in this area and intense rainfall acted as a triggering factor for landslide.</p>

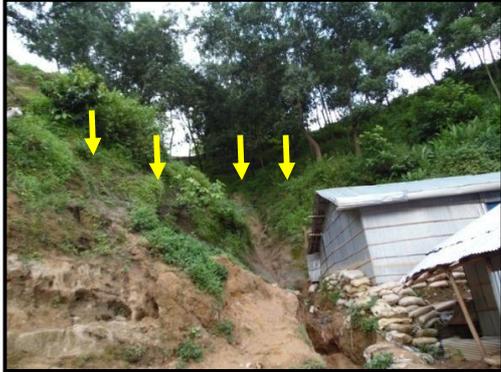
<p>Source: <i>Field survey, August 2014</i></p>
<b>Landslide Mechanism</b>	
<p><b>Type of Movement:</b> topple</p> <p><b>State:</b> Active</p> <p><b>Distribution:</b> Confined</p>	<p><b>Style:</b> Single</p> <p><b>Water Content:</b> Moist</p> <p><b>Material:</b> Soil/Earth</p>
<p><b>Land Cover/Use Type :</b> Herbaceous vegetation is the Primary land cover of Motijhirna hill. Forest/ woodland type is also visible in this hill.</p>	
<p><b>Causes of Movement:</b> Hill cutting is the major issue that caused landslide in this area and intense rainfall acted as a triggering factor for landslide.</p>

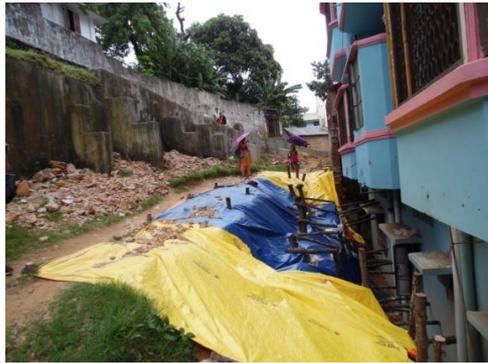
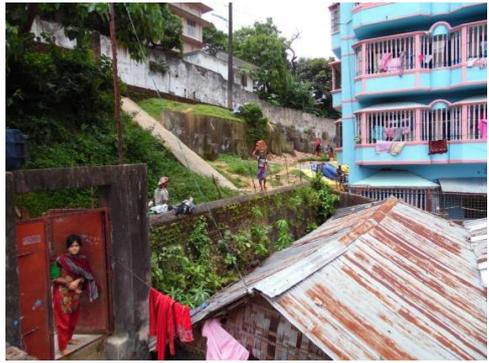
<p>Source: <i>Field survey, August 2014</i></p>
<b>Landslide Mechanism</b>	
<p><b>Type of Movement:</b> Topple</p> <p><b>State:</b> Stabilized</p> <p><b>Distribution:</b> Confined</p>	<p><b>Style:</b> Single</p> <p><b>Water Content:</b> Moist</p> <p><b>Material:</b> Soil/Earth</p>
<p><b>Land Cover/Use Type :</b></p> <p>Bare soil and built over have been found as the land cover in this site.</p>	
<p><b>Causes of Movement:</b></p> <p>Improper construction work has been observed in this site. Along with this, intense and prolonged rainfall contributed to the collapse of slope which finally turned into landslide.</p>

<b>Land Slide History and Future Risk of Landslide</b>	
<p>Landslide in this site occurred on 22 June, 2014 (Field survey, August 2014). Intense and prolonged rainfall had been occurring for 5-7 days prior to landslide. Boundary wall of a five storied building was partially collapsed. None was found to be injured or dead. Utility facilities did not get damaged in this incident. Economic and Environmental loss was not quantifiable. Boundary wall was constructed through cutting hill which made escarpment vertical. Soil characteristic of this site is of sandy type. Boundary wall was not reinforced. During rainfall water got logged into the side of the wall which triggered landslide. Land use around the site is residential. There is high-rise buildings and roadway in this site. Houses at the down slope and road upon the hill are at risk of getting damaged by landslide (Field survey, August 2014).</p>

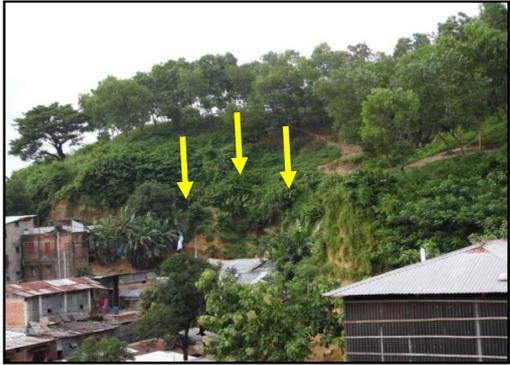
<p>Source: <i>Field survey, August 2014</i></p>	<p>Source: <i>Field survey, August 2014</i></p>
<b>Landslide Mechanism</b>	
<p><b>Type of Movement:</b> Slide</p> <p><b>State:</b> Active, Reactivated, Suspended</p> <p><b>Distribution:</b> Advancing</p>	<p><b>Style:</b> Single</p> <p><b>Water Content:</b> Moist</p> <p><b>Material:</b> Soil/Earth</p>
<p><b>Land Cover/Use Type (%):</b></p> <p>Herbaceous vegetation is the Primary land cover of Tanker Pahar. Forest/ woodland type is also visible in this hill.</p>	
<p><b>Causes of Movement:</b></p> <p>Hill cutting is the major issue that caused landslide in this area and intense rainfall acted as a triggering factor for landslide.</p>

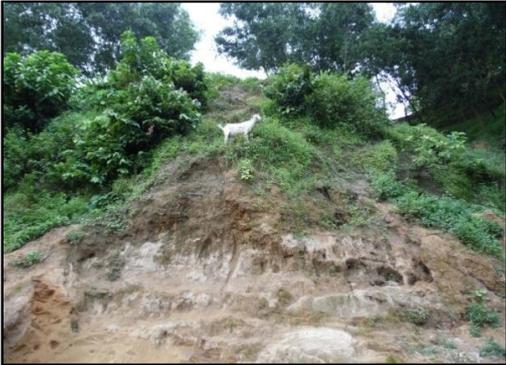
<b>Land Slide History and Future Risk of Landslide</b>	
<p>Landslide in this site occurred in 1982, 1989,1991,1994,1996 and 2013. 10 houses got damaged and almost 22 people died due to landslide at different periods. Utility facilities were highly damaged in this incident. Economic activities were hampered so does the social life of people. Environment has been found to be severely damaged. Still there are many houses located at the down slope of the hill. Soil of this site has been found to be sandy. The escapement slope is found to be near vertical. The failed mass is a part of upper portion. Vertical Slope characteristics can be considered as a contributing factor to future landslide for this hill. Settlements located at the down slope of this hill are at a huge risk of massive landslide. The risk is high (Field survey, August 2014).</p>

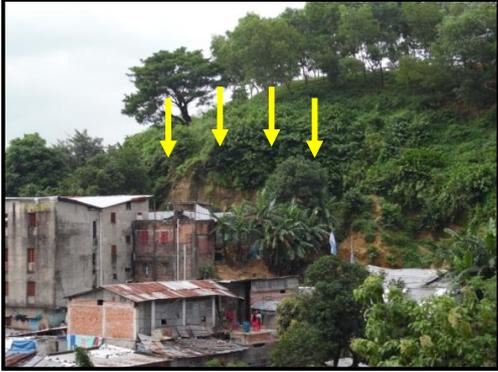
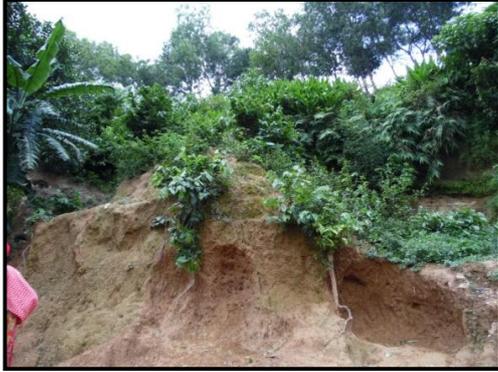
<b>Basic Information</b>	
<p><b>Landslide ID :</b> 06  <b>Landslide Location:</b> Tankir Pahar , Motijhorna  <b>Coordinates:</b> 22° 20 '55.71''N, 91° 48' 50.11''E</p>	<p><b>Datum :</b> WGS 1984  <b>Elevation (m):</b> 47.04  <b>Area of Displaced Mass (sqm):</b> 211.06  <b>Rainfall:</b> Unknown</p>

<p>Source: <i>Field survey, August 2014</i></p>
<b>Landslide Mechanism</b>	
<p><b>Type of Movement:</b> Slide  <b>State:</b> Active, Reactivated, Suspended  <b>Distribution:</b> Advancing</p>	<p><b>Style:</b> Single  <b>Water Content:</b> Moist  <b>Material:</b> Soil/Earth</p>
<p><b>Land Cover/Use Type :</b>                      Herbaceous vegetation is the Primary land cover of Tanker pahar. Forest/ woodland type is also visible in this hill.</p>	
<p><b>Causes of Movement:</b>                      Hill cutting is the major issue that caused landslide in this area and intense rainfall acted as a triggering factor for landslide.</p>

<b>Land Slide History and Future Risk of Landslide</b>	
<p>Landslide in this site occurred in 1998 and 2010. Five houses got destroyed and 11 people died during the landslide of 1998. Utility facilities were highly damaged in this incident. Economic activities were hampered so does the social life of people. Environment has been found to be severely damaged. One house was partially collapsed during the landslide of 2010. Damage intensity of this landslide was low. Still there are many houses located at the down slope of the hill. Soil of this site has been found to be sandy. The escapement slope is found to be near vertical. The failed mass is a part of upper portion. Vertical Slope characteristics can be considered as a contributing factor to future landslide for this hill. Settlements located at the down slope of this hill are at a huge risk of massive landslide. The risk is high (Field Survey, August 2014).</p>

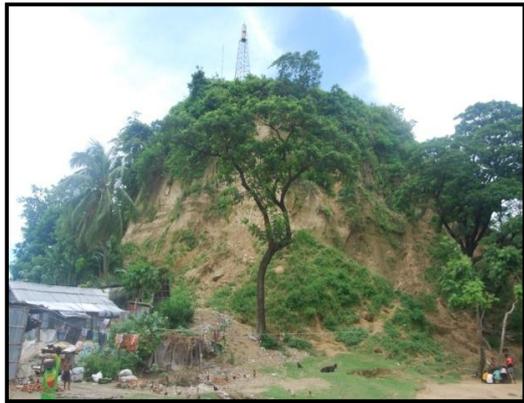
<p style="text-align: center;">Source: <i>Field survey, August 2014</i></p>
<b>Landslide Mechanism</b>	
<p><b>Type of Movement:</b> Fall, Slide</p> <p><b>State:</b> Active</p> <p><b>Distribution:</b> Advancing</p>	<p><b>Style:</b> Single</p> <p><b>Water Content:</b> Moist</p> <p><b>Material:</b> Soil/Earth</p>
<p><b>Land Cover/Use Type:</b> Herbaceous vegetation is the Primary land cover of Batali hill. Forest/ woodland type is also visible in this hill.</p>	
<p><b>Causes of Movement:</b> Intense and prolonged rainfall: (268 mm in 7 days rainfall event) inducing collapse of slope are main the causes of movement.</p>

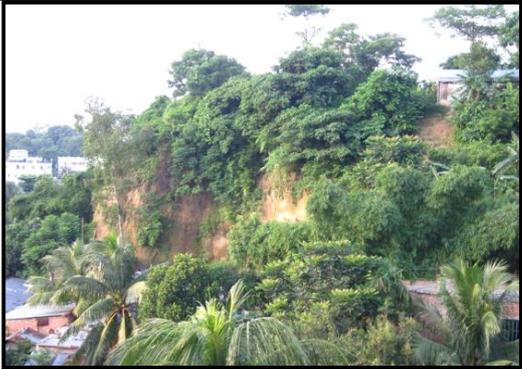
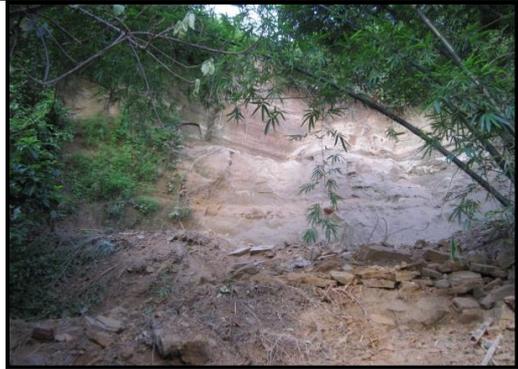
<p>Source: <i>Field survey, August 2014</i></p>	<p>Source: <i>Field survey, August 2014</i></p>
<b>Landslide Mechanism</b>	
<p><b>Type of Movement:</b> Fall, Slide</p> <p><b>State:</b> Active</p> <p><b>Distribution:</b> Advancing</p>	<p><b>Style:</b> Successive</p> <p><b>Water Content:</b> Moist</p> <p><b>Material:</b> Soil/Earth</p>
<p><b>Land Cover/Use Type :</b></p> <p>Forest/ woodland are the Primary land cover of Batali hill.</p>	
<p><b>Causes of Movement:</b></p> <p>Hill cutting is the major issue that caused landslide in this area and intense rainfall acted as a triggering factor for landslide.</p>

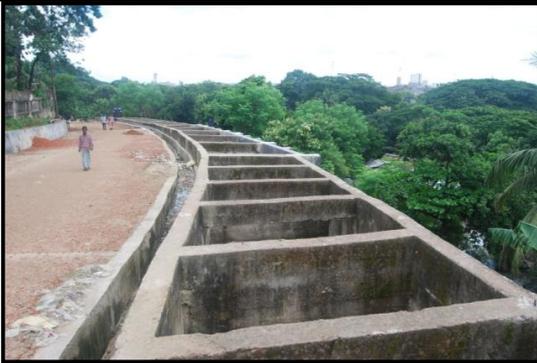
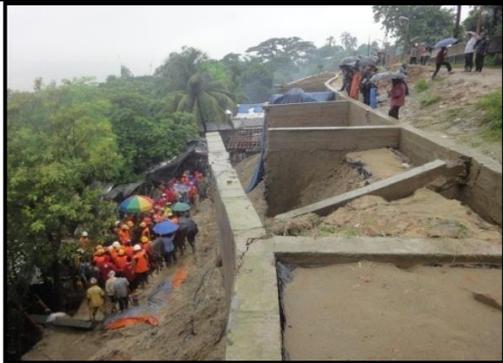
<p><i>Source: Department of Environment</i></p>
<b>Landslide Mechanism</b>	
<p><b>Type of Movement:</b> Tumble, Slide</p> <p><b>State:</b> Active</p> <p><b>Distribution:</b> Advancing</p>	<p><b>Style:</b> Single</p> <p><b>Water Content:</b> Moist</p> <p><b>Material:</b> Soil/Earth</p>
<p><b>Land Cover/Use Type :</b></p> <p>Bare soil and built over have been found as the land cover in this site.</p>	
<p><b>Causes of Movement:</b></p> <p>Weak foundation of wall as well as loose soil contributed to the movement.</p>	
<b>Land Slide History and Future Risk of Landslide</b>

<p>Retaining wall of Tiger pass collapsed on July 1 in 2011. Seventeen people died in this incident (Demo News Portal, July 28 2014). Houses located down the slope got damaged severely. Utility facilities got damaged in this incident. Economic activities were hampered so does the social life of people. Environmental damage is unquantifiable. Incessant rains in the port city have caused a retaining wall to collapse at Batali Hill, triggering a hill slide (bdnews24, 2011).</p> <p>The escapement slope is found to be near vertical. Vertical Slope characteristics and loose sandy soil can be considered as a contributing factor to future landslide for this hill. Settlements located at the down slope of this hill are at a risk of landslide. The risk is moderate.</p>

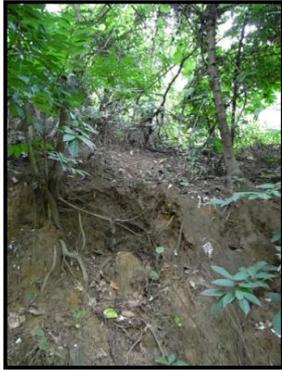
</div> <p style="text-align: center;">Source: <i>Field survey, August 2014</i></p>	
<b>Landslide Mechanism</b>	
<p><b>Type of Movement:</b> Fall, Slide</p> <p><b>State:</b> Dormant</p> <p><b>Distribution:</b> Confined</p>	<p><b>Style:</b> Single</p> <p><b>Water Content:</b> Moist</p> <p><b>Material:</b> Soil/Earth</p>
<p><b>Land Cover/Use Type (%):</b></p> <p>Forest/ woodland is the Primary land cover of Lebu bagan. Herbaceous vegetation is also visible in this hill.</p>	
<p><b>Causes of Movement:</b></p> <p>Excessive rainfall event (658 mm in 9 days rainfall event) is the main cause of movement.</p>

<b>Land Slide History and Future Risk of Landslide</b>	
<p>A massive landslide occurred in Lebu bagan in 11 June, 2007. As many as thirty people were killed and 20-30 people were injured in landslide which hit houses at Lebu Bagan of Chittagong Cantonment (Dept of Environment, Chittagong). The heavy rainfall saturated the hillsides in and around the city giving residents no chance to escape when a tide of mud and water swept down on their homes in the early hours of yesterday morning, burying whole families under mud and debris while they slept. The powerful current simply washed others away. At present there exists no settlement. People were moved from this place. Now this place has become woodland area. Future risk of landslide is low.</p>

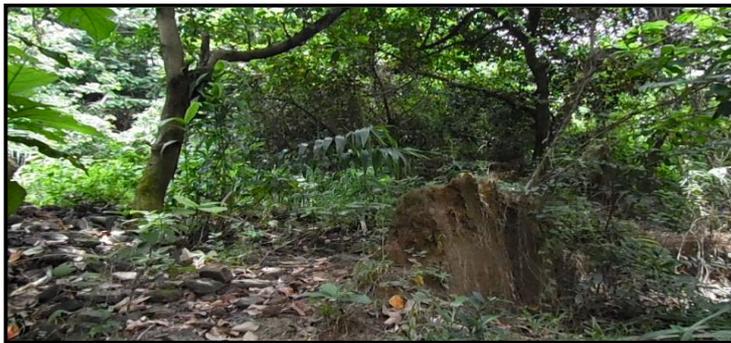
</div> <p>Source: <i>Field survey, August 2014</i></p>	
Landslide Mechanism	
<p><b>Type of Movement:</b> Slide</p> <p><b>State:</b> Dormant</p> <p><b>Distribution:</b> Confined</p>	<p><b>Style:</b> Single</p> <p><b>Water Content:</b> Moist</p> <p><b>Material:</b> Soil/Earth</p>
<p><b>Land Cover/Use Type :</b></p> <p>Forest/ woodland is the Primary land cover of Lebu bagan. Herbaceous vegetation is also visible in this hill.</p>	
<p><b>Causes of Movement:</b></p> <p>Excessive rainfall event (658 mm in 9 days rainfall event) is the main cause of movement.</p>

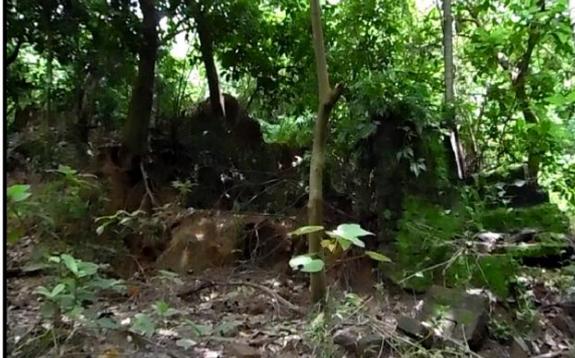
</div> <p style="text-align: center; font-size: small;"><i>Source: Field survey, August 2014</i></p>	
<b>Landslide Mechanism</b>	
<p><b>Type of Movement:</b> Fall, Slide</p> <p><b>State:</b> Dormant</p> <p><b>Distribution:</b> Confined</p>	<p><b>Style:</b> Single</p> <p><b>Water Content:</b> Moist</p> <p><b>Material:</b> Soil/Earth</p>
<p><b>Land Cover/Use Type :</b></p> <p>Forest/ woodland is the Primary land cover of Lebu bagan. Herbaceous vegetation is also visible in this hill.</p>	
<p><b>Causes of Movement:</b></p> <p>Excessive rainfall event (658 mm in 9 days rainfall event) is the main cause of movement.</p>

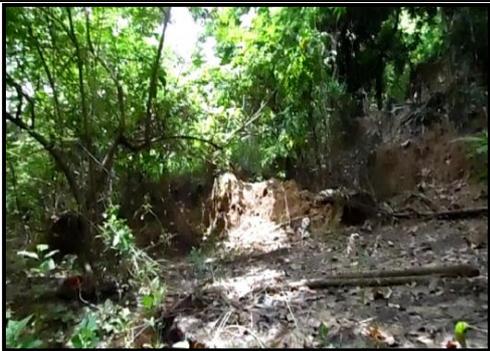
<b>Landslide Mechanism</b>	
<p><b>Type of Movement:</b> Slide</p> <p><b>State:</b> Stabilized</p> <p><b>Distribution:</b> Confined</p>	<p><b>Style:</b> Single</p> <p><b>Water Content:</b> Moist</p> <p><b>Material:</b> Soil/Earth</p>
<p><b>Land Cover/Use Type :</b></p> <p>Forest/ woodland is the Primary land cover of Kaicchaghona. Herbaceous vegetation is also visible in this hill.</p>	
<p><b>Causes of Movement:</b></p> <p>Excessive rainfall event (658 mm in 9 days rainfall event) is the main cause of movement.</p>	
<b>Land Slide History and Future Risk of Landslide</b>

<p>A massive landslide occurred in Kaicchaghona in 11 June, 2007. As many as two persons were killed and 12-15 people were injured and in landslide which hit houses at Kaicchaghona of Chittagong Cantonment (Dept. Of Environment). Many houses got destroyed in this disaster. The heavy rainfall saturated the hillsides in and around the city giving residents no chance to escape when a tide of mud and water swept down on their homes in the early hours of yesterday morning, burying whole families under mud and debris while they slept. The powerful current simply washed others away. At present there exists no settlement. People were moved from this place. Now this place has become woodland area. Future risk of landslide is low.</p>

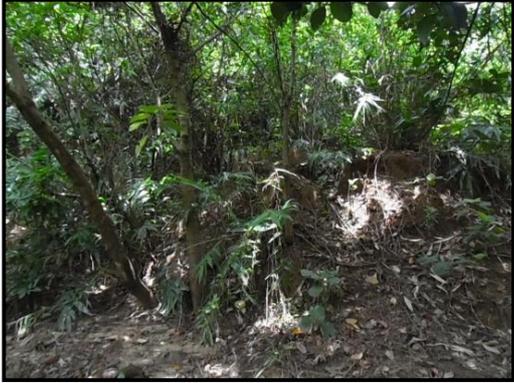
<p style="text-align: center;">Source: <i>Field survey, August 2014</i></p>
Landslide Mechanism	
<p><b>Type of Movement:</b> Fall, slide</p> <p><b>State:</b> Stabilized</p> <p><b>Distribution:</b> Confined</p>	<p><b>Style:</b> Single</p> <p><b>Water Content:</b> Moist</p> <p><b>Material:</b> Soil/Earth</p>
<p><b>Land Cover/Use Type :</b> Herbaceous vegetation is the Primary land cover of Kaicchaghona. Forest/ woodland type is also visible in this hill.</p>	
<p><b>Causes of Movement:</b> Excessive rainfall event (658 mm in 9 days rainfall event) is the main cause of movement.</p>

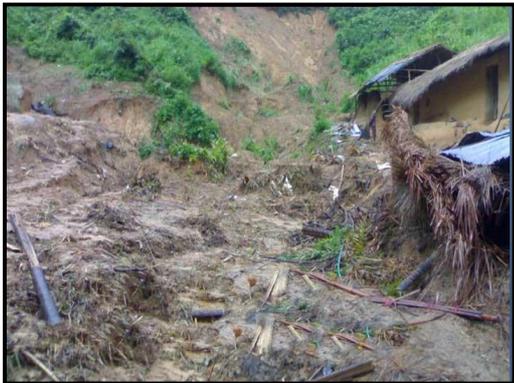
<p>Source: Dept. Of Environment, 2007</p>
Landslide Mechanism	
<p><b>Type of Movement:</b> Fall, slide</p> <p><b>State:</b> Dormant</p> <p><b>Distribution:</b> Confined</p>	<p><b>Style:</b> Single</p> <p><b>Water Content:</b> Moist</p> <p><b>Material:</b> Soil/Earth</p>
<p><b>Land Cover/Use Type :</b> Herbaceous vegetation is the Primary land cover of Lebu Bagan. Forest/ woodland type is also visible in this hill.</p>	
<p><b>Causes of Movement:</b> Excessive rainfall event (658 mm in 9 days rainfall event) is the main cause of movement.</p>	
Land Slide History and Future Risk of Landslide

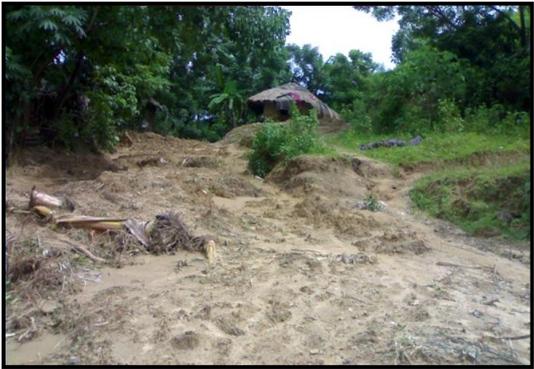
<p style="text-align: center;">Source: <i>Dept. Of Environment, 2007</i></p>
Landslide Mechanism	
<p><b>Type of Movement:</b> Slide</p> <p><b>State:</b> Stabilized</p> <p><b>Distribution:</b> Confined</p>	<p><b>Style:</b> Single</p> <p><b>Water Content:</b> Moist</p> <p><b>Material:</b> Soil/Earth</p>
<p><b>Land Cover/Use Type :</b> Forest/ woodland and Herbaceous vegetation are the Primary land cover of Sekandar Para</p>	
<p><b>Causes of Movement:</b> Excessive rainfall event (268 mm in 7 days rainfall event) is the main cause of movement.</p>	
Land Slide History and Future Risk of Landslide

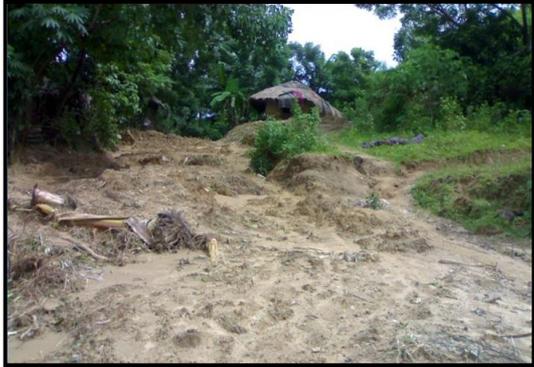
<p style="text-align: center;"><i>Source: Dept. Of Environment, 2007</i></p>
<b>Landslide Mechanism</b>	
<p><b>Type of Movement:</b> Slide</p> <p><b>State:</b> Stabilized</p> <p><b>Distribution:</b> Confined</p>	<p><b>Style:</b> Single</p> <p><b>Water Content:</b> Moist</p> <p><b>Material:</b> Soil/Earth</p>
<p><b>Land Cover/Use Type:</b> Forest/ woodland and Herbaceous vegetation are the Primary land cover of Sekandar Para</p>	
<p><b>Causes of Movement:</b> Excessive rainfall event (268 mm in 7 days rainfall event) is the main cause of movement.</p>	
<b>Land Slide History and Future Risk of Landslide</b>

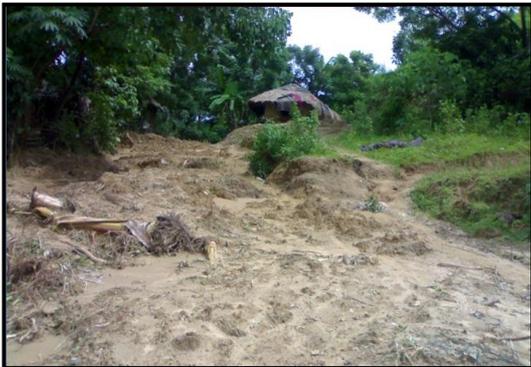
<p style="text-align: center;">Source: Dept. Of Environment, 2007</p>
Landslide Mechanism	
<p><b>Type of Movement:</b> Slide</p> <p><b>State:</b> Stabilized</p> <p><b>Distribution:</b> Confined</p>	<p><b>Style:</b> Single</p> <p><b>Water Content:</b> Moist</p> <p><b>Material:</b> Soil/Earth</p>
<p><b>Land Cover/Use Type :</b> Forest/ woodland and Herbaceous vegetation are the Primary land cover of Sekandar Para</p>	
<p><b>Causes of Movement:</b> Excessive rainfall event (658 mm in 9 days rainfall event) is the main cause of movement.</p>	
Land Slide History and Future Risk of Landslide

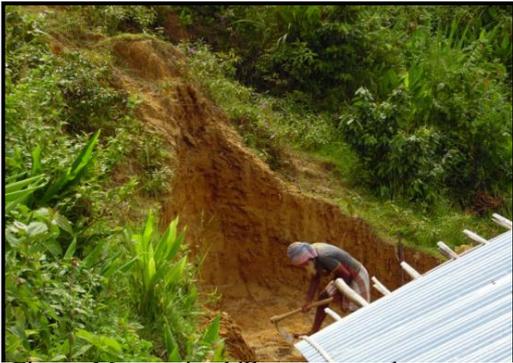
<p>Figure: Man cutting hill to construct house</p> <p>Source: Field survey, August 2014</p>
Landslide Mechanism	
<p><b>Type of Movement:</b> Fall, slide</p> <p><b>State:</b> Active</p> <p><b>Distribution:</b> Advancing</p>	<p><b>Style:</b> Successive</p> <p><b>Water Content:</b> Moist</p> <p><b>Material:</b> Soil/Earth</p>
<p><b>Land Cover/Use Type :</b> Forest/ woodland and Herbaceous vegetation are the Primary land cover of Ispahani Hill.</p>	
<p><b>Causes of Movement:</b> Excessive rainfall event and hill cutting is the main cause of movement.</p>
