# Developing Dynamic Web-GIS based Early Warning System for the Communities at Landslide Risks in Chittagong Metropolitan Area, Bangladesh

## Landslide Inventory Report August, 2014

# **Landslide Inventory Report of Chittagong Metropolitan Area, Bangladesh**

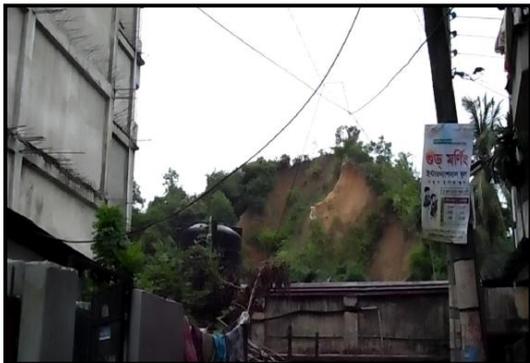
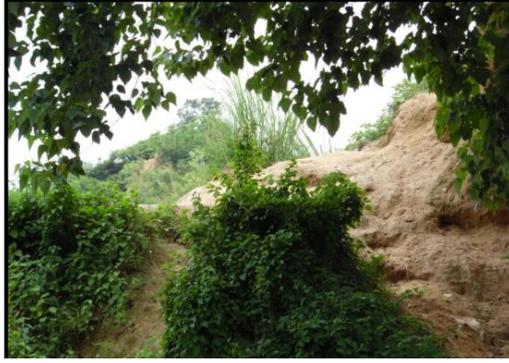
<p>Source: <i>Field survey, August 2014</i></p>
<b>Landslide Mechanism</b>	
<p><b>Type of Movement:</b> Fall, slide</p> <p><b>State:</b> Active</p> <p><b>Distribution:</b> Advancing</p>	<p><b>Style:</b> Successive</p> <p><b>Water Content:</b> Moist</p> <p><b>Material:</b> Soil/Earth</p>
<p><b>Land Cover/Use Type :</b> Herbaceous vegetation are the Primary land cover of Kushumbagh Housing hill</p>	
<p><b>Causes of Movement:</b> Excessive rainfall and hill cutting is the main cause of movement.</p>	
<b>Land Slide History and Future Risk of Landslide</b>

<p>Land slide in Kushumbagh Housing, hill occurs in every rainy season. People cut hill to construct houses at the slopes of hill. There are some tin shed houses are seen located at slopes of Kushumbagh Housing hill. Till now no big landslide has occurred in this place. Landslides that have been occurring in every rainy season have low damage intensity. Soil characteristic of this site is of sandy type. The escapement slope is found to be near vertical. Vertical Slope characteristics can be considered as a contributing factor to future landslide for this hill. Settlements located at the down slope of this hill are at a huge risk of massive landslide. The risk is high.</p>

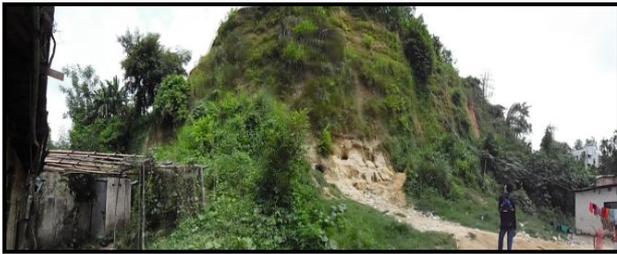
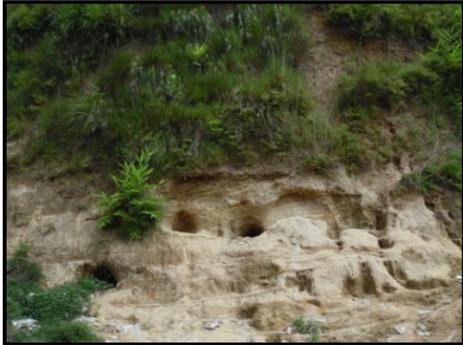
</div> <p>Source: <i>Field survey, August 2014</i></p>	
Landslide Mechanism	
<p><b>Type of Movement:</b> Topple, slide</p> <p><b>State:</b> Active</p> <p><b>Distribution:</b> Advancing</p>	<p><b>Style:</b> Successive</p> <p><b>Water Content:</b> Moist</p> <p><b>Material:</b> Soil/Earth</p>
<p><b>Land Cover/Use Type :</b> Herbaceous vegetation is the Primary land cover of Goribullah shah hill</p>	
<p><b>Causes of Movement:</b> Excessive rainfall and hill cutting is the main cause of movement.</p>	
Land Slide History and Future Risk of Landslide

<p>Land slide in Goribullah shah hill occurs in every rainy season. People cut hill to construct houses at the slopes of hill. There are some tin shed houses are seen located at slopes of Goribullah shah hill. Till now no big landslide has occurred in this place. Landslides that have been occurring in every rainy season have low damage intensity. Soil characteristic of this site is of sandy type. The escapement slope is found to be near vertical. Vertical Slope characteristics can be considered as a contributing factor to future landslide for this hill. Settlements located at the down slope of this hill are at a huge risk of massive landslide. The risk is high (Field Survey, August 2014)</p>

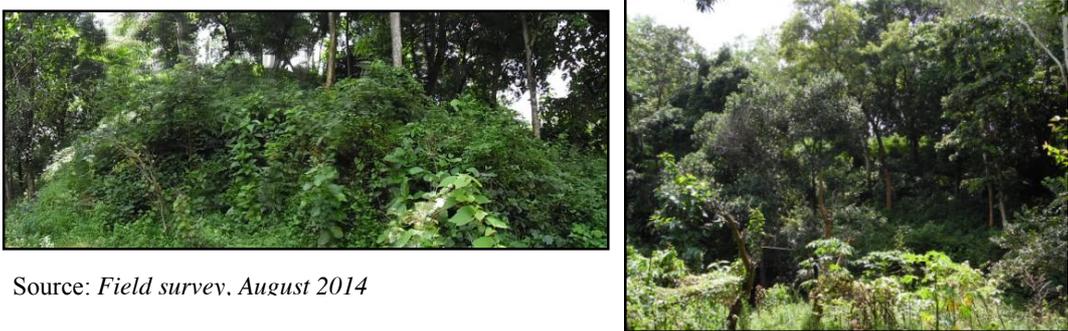
<p>Source: <i>Field survey, August 2014</i></p>	
Landslide Mechanism	
<b>Type of Movement:</b> Topple, slide <b>State:</b> Active <b>Distribution:</b> Advancing	<b>Style:</b> Single <b>Water Content:</b> Moist <b>Material:</b> Soil/Earth
<b>Land Cover/Use Type :</b> Herbaceous vegetation and forest/woodland are the Primary land cover of Chittagong University hill.	
<b>Causes of Movement:</b> Excessive rainfall event (658 mm in 9 days rainfall event) is the main cause of movement.	
Land Slide History and Future Risk of Landslide	
Land slide in Chittagong University hill occurred in 11 June, 2007. . None was found to be injured or dead. Intense and prolonged rainfall had been occurring for 5-7 days prior to landslide. Utility facilities did not get damaged in this incident. Economic and Environmental loss was not quantifiable. Soil characteristic of this site is of sandy type. The escapement slope is found to be near vertical. Vertical Slope characteristics can be considered as a contributing factor to future landslide for this hill. No Settlements are located at the down slope of this hill.

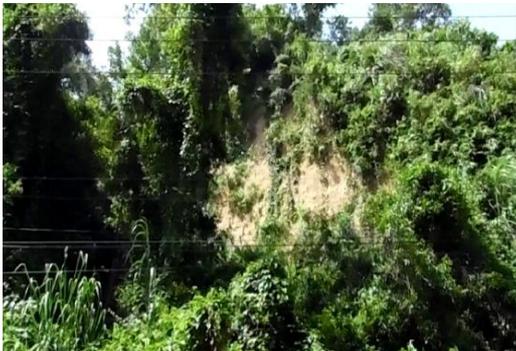
<p>Source: <i>Field survey, August 2014</i></p>
Landslide Mechanism	
<p><b>Type of Movement:</b> Fall, slide</p> <p><b>State:</b> Active</p> <p><b>Distribution:</b> Advancing</p>	<p><b>Style:</b> Single</p> <p><b>Water Content:</b> Moist</p> <p><b>Material:</b> Soil/Earth</p>
<p><b>Land Cover/Use Type :</b> Herbaceous vegetation and forest/woodland are the Primary land cover of Chittagong University hill.</p>	
<p><b>Causes of Movement:</b> Excessive rainfall is the main cause of movement.</p>	
Land Slide History and Future Risk of Landslide	
<p>Land slide in Chittagong University hill occurred in June, 2011. A huge chunk of earth fell from the top of the hill. None was found to be injured or dead. Intense and prolonged rainfall had been occurring for 5-7 days prior to landslide (Dept. Of Environment, Chittagong). Utility facilities did not get damaged in this incident. Economic and Environmental loss was not quantifiable. Soil characteristic of this site is of sandy type. The escapement slope is found to be near vertical. Vertical Slope characteristics can be considered as a contributing factor to future landslide for this hill. No Settlements are located at the down slope of this hill.</p>

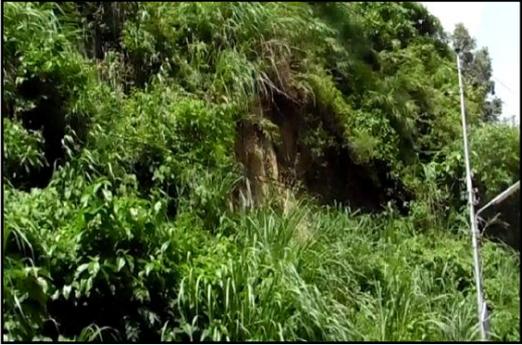
<p>Source: <i>Field survey, August 2014</i></p>
Landslide Mechanism	
<p><b>Type of Movement:</b> Topple, slide</p> <p><b>State:</b> Active</p> <p><b>Distribution:</b> Advancing</p>	<p><b>Style:</b> Single</p> <p><b>Water Content:</b> Moist</p> <p><b>Material:</b> Soil/Earth</p>
<p><b>Land Cover/Use Type :</b> Herbaceous vegetation and forest/woodland are the Primary land cover of Chittagong University hill.</p>	
<p><b>Causes of Movement:</b> Excessive rainfall event (658 mm in 9 days rainfall event) is the main cause of movement.</p>	
Land Slide History and Future Risk of Landslide

<p>Land slide in Chittagong University hill occurred in 11 June, 2007. None was found to be injured or dead. Intense and prolonged rainfall had been occurring for 5-7 days prior to landslide. Utility facilities did not get damaged in this incident. Economic and Environmental loss was not quantifiable. Soil characteristic of this site is of sandy type. The escapement slope is found to be near vertical. Vertical Slope characteristics can be considered as a contributing factor to future landslide for this hill. No Settlements are located at the down slope of this hill.</p>

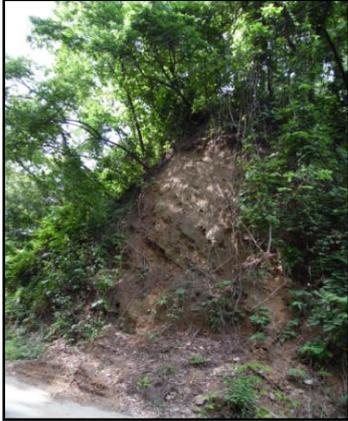
<p style="text-align: center;">Source: <i>Field survey, August 2014</i></p>
<b>Landslide Mechanism</b>	
<p><b>Type of Movement:</b> Topple, slide</p> <p><b>State:</b> Active</p> <p><b>Distribution:</b> Advancing</p>	<p><b>Style:</b> Single</p> <p><b>Water Content:</b> Moist</p> <p><b>Material:</b> Soil/Earth</p>
<p><b>Land Cover/Use Type :</b> Herbaceous vegetation and forest/woodland are the Primary land cover of Chittagong University hill.</p>	
<p><b>Causes of Movement:</b> Excessive rainfall event (667 mm in 3 days rainfall event) is the main cause of movement.</p>

<b>Land Slide History and Future Risk of Landslide</b>	
<p>A significant land slide in Chittagong University hill, Golachipa occurred in 22 June, 2014. None was found to be injured or dead. Intense and prolonged rainfall had been occurring for 5-7 days prior to landslide. Utility facilities did not get damaged in this incident. Economic and Environmental loss was not quantifiable. Landslide in this hill occurs at every rainy season. Soil characteristic of this site is of sandy type. The escapement slope is found to be near vertical. Vertical Slope characteristics can be considered as a contributing factor to future landslide for this hill. No Settlements are located at the down slope of this hill.</p>

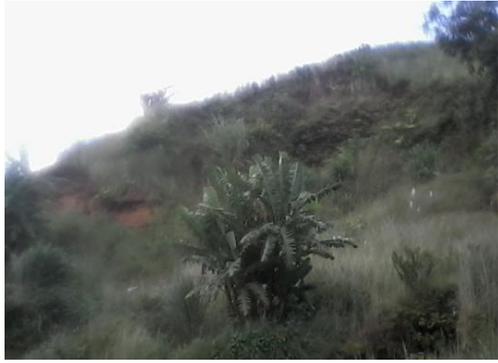
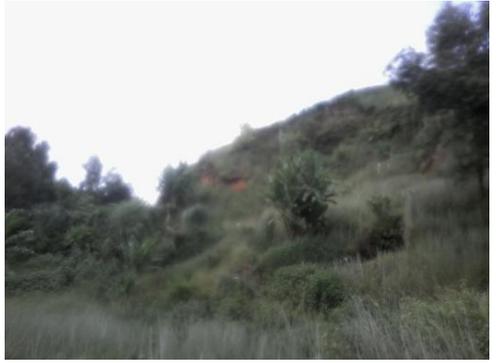
<p>Source: <i>Field survey, August 2014</i></p>
<b>Landslide Mechanism</b>	
<p><b>Type of Movement:</b> Fall, Slide  <b>State:</b> Active  <b>Distribution:</b> Advancing</p>	<p><b>Style:</b> Successive  <b>Water Content:</b> Moist  <b>Material:</b> Soil/Earth</p>
<p><b>Land Cover/Use Type:</b>                      Herbaceous vegetation and forest/woodland are the Primary land cover of Gol Pahar hill.</p>	
<p><b>Causes of Movement:</b>                      Excessive rainfall and hill cutting are the main cause of movement.</p>	
<b>Land Slide History and Future Risk of Landslide</b>

<p>A significant land slide in Gol Pahar, Foy'z lake hill occurred in 1990. None was found to be injured or dead. Landslide in this hill occurs at every rainy season. Soil characteristic of this site is of sandy type. The escapement slope is found to be near vertical. Vertical Slope characteristics can be considered as a contributing factor to future landslide for this hill. Settlements are located at the down slope of this hill. People have constructed their house through cutting hill. Sac filled with sand have been used to protect hill from land slide. Still land slide has been occurring in this site. People located near Goal Pahar hill are in great risk of massive landslide.</p>

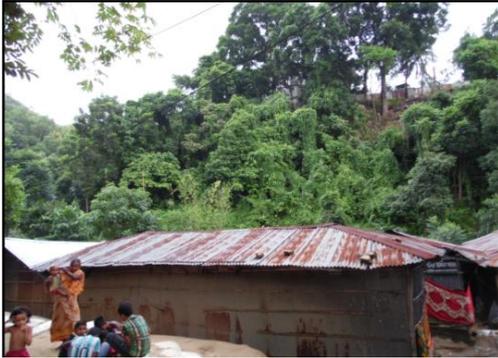
<p>Source: <i>Field survey, August 2014</i></p>
<b>Landslide Mechanism</b>	
<p><b>Type of Movement:</b> Fall, Slide</p> <p><b>State:</b> Active</p> <p><b>Distribution:</b> Advancing</p>	<p><b>Style:</b> Successive</p> <p><b>Water Content:</b> Moist</p> <p><b>Material:</b> Soil/Earth</p>
<p><b>Land Cover/Use Type:</b> Herbaceous vegetation and forest/woodland are the Primary land cover of Gol Pahar hill.</p>	
<p><b>Causes of Movement:</b> Excessive rainfall and hill cutting are the main cause of movement.</p>	
<b>Land Slide History and Future Risk of Landslide</b>

<p>A significant land slide in Gol Pahar, Foy’z lake hill occurred in 1990. None was found to be injured or dead. Landslide in this hill occurs at every rainy season. Soil characteristic of this site is of sandy type. The escapement slope is found to be near vertical. Vertical Slope characteristics can be considered as a contributing factor to future landslide for this hill. Settlements are located at the down slope of this hill. People have constructed their house through cutting hill. Sac filled with sand have been used to protect hill from land slide. Still land slide has been occurring in this site. People located near Goal Pahar hill are in great risk of massive landslide (Field Survey, August 2014).</p>

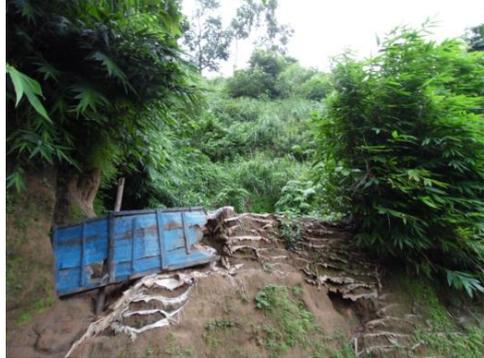
<p style="text-align: center;"><i>Source: Field survey, August 2014</i></p>
<b>Landslide Mechanism</b>	
<p><b>Type of Movement:</b> Fall, Slide</p> <p><b>State:</b> Active</p> <p><b>Distribution:</b> Advancing</p>	<p><b>Style:</b> Successive</p> <p><b>Water Content:</b> Moist</p> <p><b>Material:</b> Soil/Earth</p>
<p><b>Land Cover/Use Type:</b> Herbaceous vegetation and forest/woodland are the Primary land cover of Gol Pahar hill.</p>	
<p><b>Causes of Movement:</b> Excessive rainfall and hill cutting are the main cause of movement.</p>	
<b>Land Slide History and Future Risk of Landslide</b>

<p>A significant land slide in Gol Pahar, Foy’z lake hill occurred in 1990. None was found to be injured or dead. Landslide in this hill occurs at every rainy season. Soil characteristic of this site is of sandy type. The escapement slope is found to be near vertical. Vertical Slope characteristics can be considered as a contributing factor to future landslide for this hill. Settlements are located at the down slope of this hill. People have constructed their house through cutting hill. Sac filled with sand have been used to protect hill from land slide. Still land slide has been occurring in this site. People located near Goal Pahar hill are in great risk of massive landslide (Field Survey, August 2014)</p>

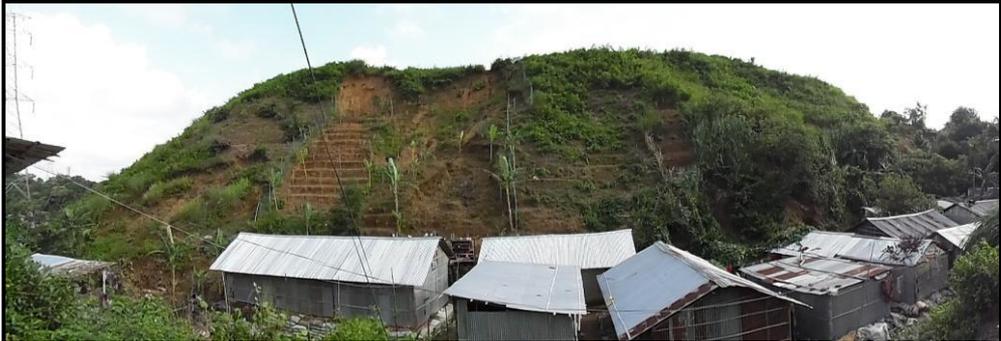
<p>Source: Field survey, August 2014</p>	
Landslide Mechanism	
<p><b>Type of Movement:</b> Fall, Flow</p> <p><b>State:</b> Active</p> <p><b>Distribution:</b> Advancing</p>	<p><b>Style:</b> Single</p> <p><b>Water Content:</b> Moist</p> <p><b>Material:</b> Soil/Earth</p>
<p><b>Land Cover/Use Type :</b> Herbaceous vegetation and is the Primary land cover of Akbar shsh mazar hill.</p>	
<p><b>Causes of Movement:</b> Excessive rainfall event (658 mm in 9 days rainfall event) and hill cutting are the main cause of movement.</p>	
Land Slide History and Future Risk of Landslide	
<p>A significant land slide in Akbar Shah Mazar hill hill occurred in 11 June 2007. Seven people were killed and 20-30 people were injured in that land slide occurrence (Feild Survey, August 2014). Twelve tin shed houses were completely destroyed. At present 200-250 families live in 30 houses located just down the slope of the hill. Characteristic of this site is of sandy type. The escapement slope is found to be near vertical. Vertical Slope characteristics can be considered as a contributing factor to future landslide for this hill. Settlements People have constructed their house through cutting hill. Sac filled with sand have been used to protect hill from land slide. People located near Goal Pahar hill are in great risk of massive landslide.</p>

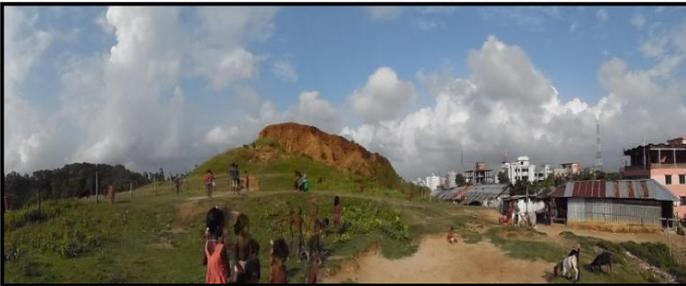
</div> <p>Source: <i>Field survey, August 2014</i></p>	
Landslide Mechanism	
<p><b>Type of Movement:</b> Topple, Slide</p> <p><b>State:</b> Active</p> <p><b>Distribution:</b> Advancing</p>	<p><b>Style:</b> Successive</p> <p><b>Water Content:</b> Moist</p> <p><b>Material:</b> Soil/Earth</p>
<p><b>Land Cover/Use Type:</b> Herbaceous vegetation and is the Primary land cover of Lal Pahar.</p>	
<p><b>Causes of Movement:</b> Excessive rainfall and hill cutting are the main cause of movement.</p>	
Land Slide History and Future Risk of Landslide

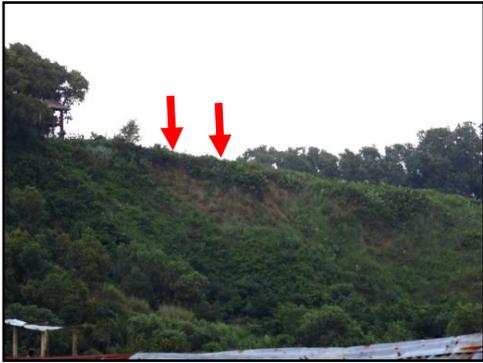
<p style="text-align: center;">Source: <i>Field survey, August 2014</i></p>
Landslide Mechanism	
<p><b>Type of Movement:</b> Slide</p> <p><b>State:</b> Active</p> <p><b>Distribution:</b> Advancing</p>	<p><b>Style:</b> Successive</p> <p><b>Water Content:</b> Moist</p> <p><b>Material:</b> Soil/Earth</p>
<p><b>Land Cover/Use Type :</b> Herbaceous vegetation and is the Primary land cover of Foy'z Lake Observation Tower hill</p>	
<p><b>Causes of Movement:</b> Excessive rainfall is the main cause of movement.</p>	
Land Slide History and Future Risk of Landslide	
<p>Land slide in Foy'z Lake Observation Tower hill occurs at every rainy season. No information about any significant land slide in this site is found. At present 150-200 families live on the down slope area of the hill. Soil characteristic of this site is of sandy type. No natural or artificial drainage path has been seen in this site. The escapement slope is found to be near vertical to incline. People have constructed their house through cutting hill at the down slope of hill. People located near Foy'z Lake Observation Tower hill are in moderate risk of massive landslide.</p>

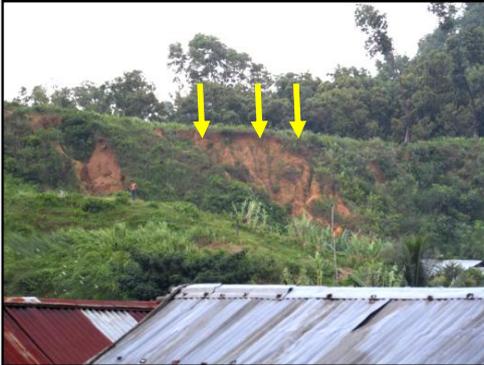
<p>Source: <i>Field survey, August 2014</i></p>
Landslide Mechanism	
<p><b>Type of Movement:</b> Topple, Slide</p> <p><b>State:</b> Active</p> <p><b>Distribution:</b> Advancing</p>	<p><b>Style:</b> Successive</p> <p><b>Water Content:</b> Moist</p> <p><b>Material:</b> Soil/Earth</p>
<p><b>Land Cover/Use Type :</b> Herbaceous vegetation and is the Primary land cover Foy’z Lake Zoo hill</p>	
<p><b>Causes of Movement:</b> Excessive rainfall is the main cause of movement.</p>	
Land Slide History and Future Risk of Landslide	
<p>Land slide in occurs in Foy’z Lake Zoo hill at every rainy season. No information about any significant land slide in this site is found. At present 150-200 families live on the down slope area of the hill. Soil characteristic of this site is of sandy type. No natural or artificial drainage path has been seen in this site. The escapement slope is found to be near vertical to incline. People have constructed their house through cutting hill at the down slope of hill. People located near Foy’z Foy’z Lake Zoo hill are in moderate risk of massive landslide.</p>

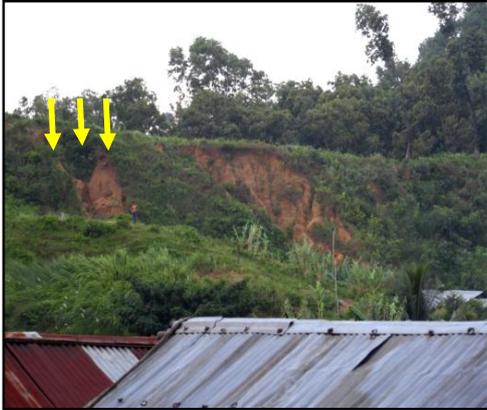
<p style="text-align: center;">Source: <i>Field survey, August 2014</i></p>
Landslide Mechanism	
<p><b>Type of Movement:</b> Slide</p> <p><b>State:</b> Active</p> <p><b>Distribution:</b> Advancing</p>	<p><b>Style:</b> Successive</p> <p><b>Water Content:</b> Moist</p> <p><b>Material:</b> Soil/Earth</p>
<p><b>Land Cover/Use Type:</b> Herbaceous vegetation and is the Primary land cover Foy’z Lake Zoo hill</p>	
<p><b>Causes of Movement:</b> Excessive rainfall is the main cause of movement.</p>	
Land Slide History and Future Risk of Landslide	
<p>Land slide in occurs in Foy’s Lake Zoo hill at every rainy season. No information about any significant land slide in this site is found. At present 150-200 families live on the down slope area of the hill. Soil characteristic of this site is of sandy type. No natural or artificial drainage path has been seen in this site. The escapement slope is found to be near vertical to incline. People have constructed their house through cutting hill at the down slope of hill. People located near Foy’s Foy’s Lake Zoo hill are in moderate risk of massive landslide (Field Survey, August 2014)</p>

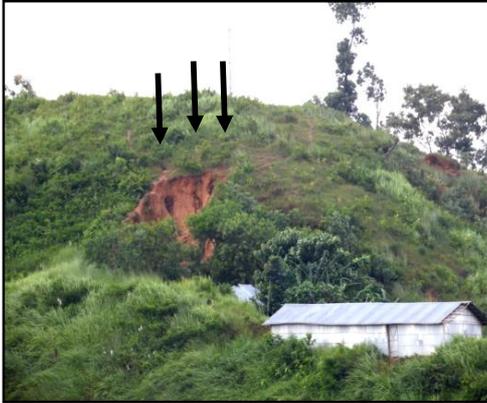
<p style="text-align: center;">Source: <i>Field survey, August 2014</i></p>
Landslide Mechanism	
<p><b>Type of Movement:</b> Slide</p> <p><b>State:</b> Active</p> <p><b>Distribution:</b> Advancing</p>	<p><b>Style:</b> Single</p> <p><b>Water Content:</b> Moist</p> <p><b>Material:</b> Soil/Earth</p>
<p><b>Land Cover/Use Type:</b> Herbaceous vegetation and is the Primary land cover Foy’z Lake Zoo hill</p>	
<p><b>Causes of Movement:</b> Excessive rainfall and hill cutting are the main cause of movement.</p>	
Land Slide History and Future Risk of Landslide	
<p>Land slide in this site occurred in 2013. Damage intensity of that land slide was low. None was found to be dead or injured. At present 100-180 families live on the down slope area of the hill (Field survey, August 2014). Soil characteristic of this site is of sandy type. No natural or artificial drainage path has been seen in this site. The escapement slope is found to be near vertical to incline. People have constructed their house through cutting hill at the down slope of hill. People located near Foy’s Lake Zoo hill are in moderate risk of massive landslide (Field Survey, August 2014)</p>

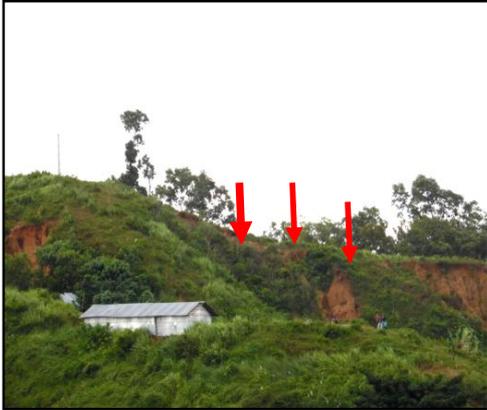
<p style="text-align: center;">Source: <i>Field survey, August 2014</i></p>
Landslide Mechanism	
<p><b>Type of Movement:</b> Slide</p> <p><b>State:</b> Active</p> <p><b>Distribution:</b> Advancing</p>	<p><b>Style:</b> Single</p> <p><b>Water Content:</b> Moist</p> <p><b>Material:</b> Soil/Earth</p>
<p><b>Land Cover/Use Type :</b> Herbaceous vegetation and is the Primary land cover Foy’z Lake Zoo hill</p>	
<p><b>Causes of Movement:</b> Excessive rainfall and hill cutting are the main cause of movement.</p>	
Land Slide History and Future Risk of Landslide	
<p>Land slide in this site occurred in 2013. Damage intensity of that land slide was low. None was found to be dead or injured. At present 100-180 families live on the down slope area of the hill (Field survey, August 2014). Soil characteristic of this site is of sandy type. No natural or artificial drainage path has been seen in this site. The escapement slope is found to be near vertical to incline. People have constructed their house through cutting hill at the down slope of hill. People located near Foy’s Lake Zoo hill are in moderate risk of massive landslide.</p>

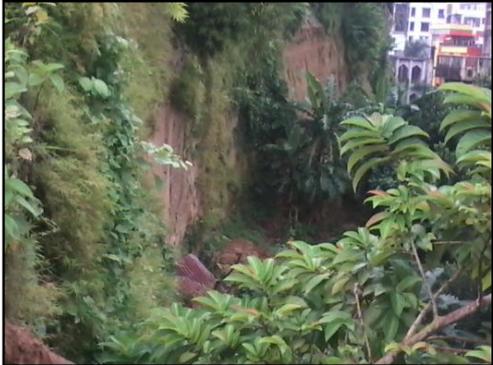
<p>Source: <i>Field survey, August 2014</i></p>
Landslide Mechanism	
<p><b>Type of Movement:</b> Slide</p> <p><b>State:</b> Active</p> <p><b>Distribution:</b> Advancing</p>	<p><b>Style:</b> Single</p> <p><b>Water Content:</b> Moist</p> <p><b>Material:</b> Soil/Earth</p>
<p><b>Land Cover/Use Type :</b> Herbaceous vegetation is the Primary land cover Nasirabad Housing Properties</p>	
<p><b>Causes of Movement:</b> Excessive rainfall and hill cutting are the main cause of movement.</p>	
Land Slide History and Future Risk of Landslide	
<p>No exact date of the occurrence of land slide in this site has been found. At present many multi storied buildings have been developed in this site through hill cutting. Soil characteristic of this site is of sandy type. No natural or artificial drainage path has been seen in this site. The escapement slope is found to be near vertical to incline. People have constructed their house through cutting hill at the down slope of hill. People located near Nasirabad Housing Properties <b>are</b> in low risk of landslide.</p>

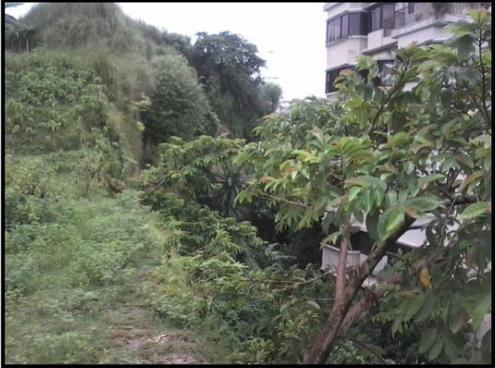
<p>Source: <i>Field survey, August 2014</i></p>
Landslide Mechanism	
<p><b>Type of Movement:</b> Slide</p> <p><b>State:</b> Active</p> <p><b>Distribution:</b> Advancing</p>	<p><b>Style:</b> Single</p> <p><b>Water Content:</b> Moist</p> <p><b>Material:</b> Soil/Earth</p>
<p><b>Land Cover/Use Type:</b> Herbaceous vegetation is the Primary land cover Nasirabad Housing Properties</p>	
<p><b>Causes of Movement:</b> Excessive rainfall and hill cutting are the main cause of movement.</p>	
Land Slide History and Future Risk of Landslide	
<p>No exact date of land slide occurrence in this site has been found. At present many multi storied buildings have been developed in this site through hill cutting. Soil characteristic of this site is of sandy type. No natural or artificial drainage path has been seen in this site. The escapement slope is found to be near vertical to incline. People have constructed their house through cutting hill at the down slope of hill. People located near Nasirabad Housing Properties are in low risk of landslide.</p>

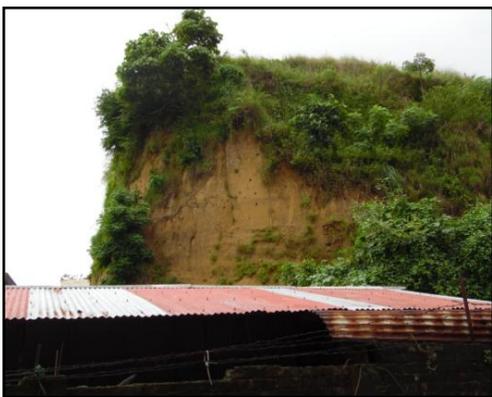
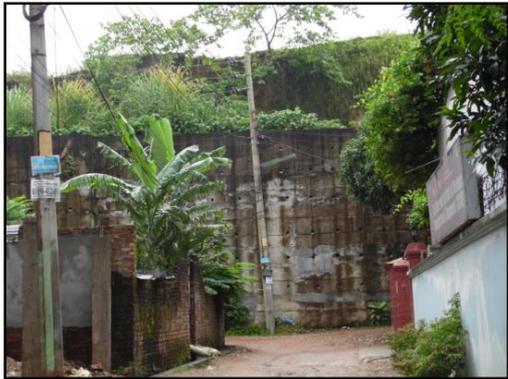
<p>Source: <i>Field survey, August 2014</i></p>
<b>Landslide Mechanism</b>	
<b>Type of Movement:</b> Fall, Topple <b>State:</b> Active <b>Distribution:</b> Advancing	<b>Style:</b> Single <b>Water Content:</b> Moist <b>Material:</b> Soil/Earth
<b>Land Cover/Use Type :</b> Herbaceous vegetation is the Primary land cover of Jakir Hossain Road, South Khulshi .	
<b>Causes of Movement:</b> Excessive rainfall and hill cutting are the main cause of movement.	
<b>Land Slide History and Future Risk of Landslide</b>	
<p>Land slide in this site occurred in 2013. None was found to be dead or injured. Damage of the property for this event was insignificant. Zakr hossain road area is a well developed residential area. This area has been developed through hill cutting. A big retention wall has been constructed to protect the area from being damaged from land slide. Many multi storied buildings are located in this area. Soil characteristic of this hill is of sandy type. No natural or artificial drainage path has been seen in this site. The escapement slope is found to be near vertical. There is a huge risk of land slide in this hill. But there is less chance of property damage as the area is protected by retention wall. Some semi built shops and houses are located near this hill which may suffer from being landslide (Field Survey, August 2014).</p>

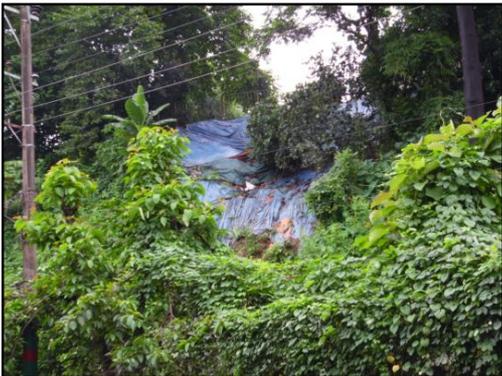
Source: Field survey, August 2014	
Landslide Mechanism	
<p><b>Type of Movement:</b> Topple, Slide</p> <p><b>State:</b> Active</p> <p><b>Distribution:</b> Advancing</p>	<p><b>Style:</b> Single</p> <p><b>Water Content:</b> Moist</p> <p><b>Material:</b> Soil/Earth</p>
<p><b>Land Cover/Use Type (%):</b> Herbaceous vegetation and Forest/ Woodland are the Primary land cover of Holy Crescent, Khulshi.</p>	
<p><b>Causes of Movement:</b> Excessive rainfall and hill cutting are the main cause of movement.</p>	
Land Slide History and Future Risk of Landslide	
<p>Land slide in this site occurred in 2013. None was found to be dead or injured. Damage of the property for this event was insignificant. Many multi storied buildings are being constructed in this site. Soil characteristic of this hill is of sandy type. No natural or artificial drainage path has been seen in this site. The escapement slope is found to be near vertical. There is a huge risk of land slide in this hill.</p>

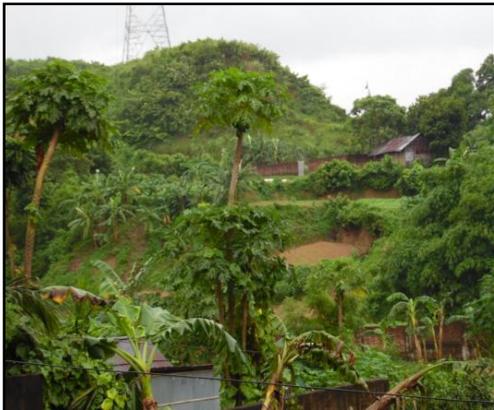
<p>Source: <i>Field survey, August 2014</i></p>
<b>Landslide Mechanism</b>	
<p><b>Type of Movement:</b> Topple, Slide</p> <p><b>State:</b> Active</p> <p><b>Distribution:</b> Advancing</p>	<p><b>Style:</b> Single</p> <p><b>Water Content:</b> Moist</p> <p><b>Material:</b> Soil/Earth</p>
<p><b>Land Cover/Use Type :</b> Herbaceous vegetation is the Primary land cover of Krishnochura Housing</p>	
<p><b>Causes of Movement:</b> Excessive rainfall is the main cause of movement.</p>	
<b>Land Slide History and Future Risk of Landslide</b>	
<p>No exact date of the occurrence of land slide has been found. A few houses made of tin have been seen in the site. These houses are constructed through hill cutting. People have prepared land for agricultural purpose through hill cutting. Soil characteristic of this site is of sandy type. No natural or artificial drainage path has been seen in this site. The escapement slope is found to be near vertical to incline. There is risk of landslide in this hill.</p>

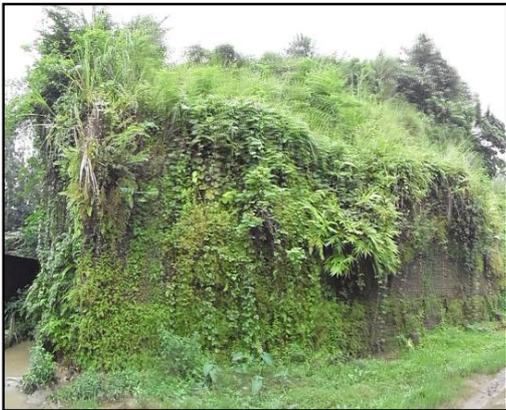
<p>Source: <i>Field survey, August 2014</i></p>
Landslide Mechanism	
<p><b>Type of Movement:</b> Topple, Slide</p> <p><b>State:</b> Active</p> <p><b>Distribution:</b> Advancing</p>	<p><b>Style:</b> Single</p> <p><b>Water Content:</b> Moist</p> <p><b>Material:</b> Soil/Earth</p>
<p><b>Land Cover/Use Type :</b> Herbaceous vegetation is the Primary land cover of Krishnochura Housing .</p>	
<p><b>Causes of Movement:</b> Excessive rainfall is the main cause of movement.</p>	
Land Slide History and Future Risk of Landslide	
<p>No exact date of the occurrence land slide has been found. A few houses made of tin have been seen in the site. These houses are constructed through hill cutting. People have prepared land for agricultural purpose through hill cutting. Soil characteristic of this site is of sandy type. No natural or artificial drainage path has been seen in this site. The escapement slope is found to be near vertical to incline. There is risk of landslide in this hill.</p>

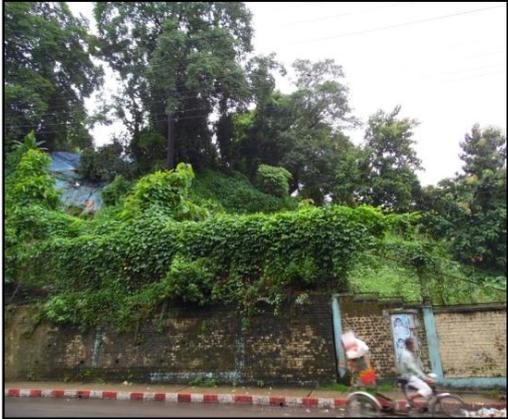
<p>Source: <i>Field survey, August 2014</i></p>
Landslide Mechanism	
<p><b>Type of Movement:</b> Topple, Slide</p> <p><b>State:</b> Stabilized</p> <p><b>Distribution:</b> Confined</p>	<p><b>Style:</b> Single</p> <p><b>Water Content:</b> Moist</p> <p><b>Material:</b> Soil/Earth</p>
<p><b>Land Cover/Use Type :</b> Herbaceous vegetation is the Primary land cover of Krishnochura Housing</p>	
<p><b>Causes of Movement:</b> Excessive rainfall is the main cause of movement.</p>	
Land Slide History and Future Risk of Landslide	
<p>Land slide in this site occurred in 2013. None was found to be dead or injured. Damage of the property for this event was insignificant. Many multi storied buildings are being constructed in this site. Soil characteristic of this hill is of sandy type. No natural or artificial drainage path has been seen in this site. The escapement slope is found to be near vertical. There is a huge risk of land slide in this hill.</p>

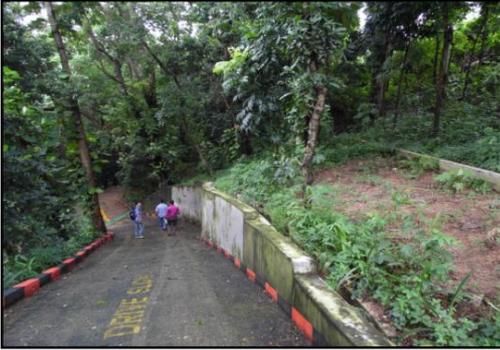
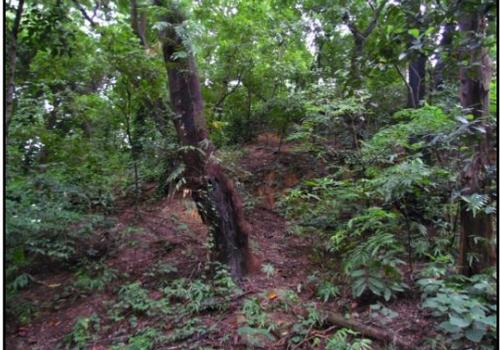
<p>Source: <i>Field survey, August 2014</i></p>	
<b>Landslide Mechanism</b>	
<p><b>Type of Movement:</b> Slide</p> <p><b>State:</b> Stabilized</p> <p><b>Distribution:</b> Confined</p>	<p><b>Style:</b> Successive</p> <p><b>Water Content:</b> Moist</p> <p><b>Material:</b> Soil/Earth</p>
<p><b>Land Cover/Use Type:</b> Herbaceous vegetation and forest/ woodland are the Primary land cover of Finley hill.</p>	
<p><b>Causes of Movement:</b> Excessive rainfall is the main cause of movement.</p>	
<b>Land Slide History and Future Risk of Landslide</b>	
<p>No exact date of occurrence of the Land slide in this site has been found. Damage of the property for this event was insignificant. None was found to be dead or injured. Banglows of the officials of Finley company have been constructed on the slope of hill through hill cutting. This hill has been managed in a good way. There exists artificial drainage system so that rain water can easily be drained off. Soil characteristic of this hill is of sandy type. The escapement slope is found to be near vertical to incline. There is low risk of land slide in this hill.</p>

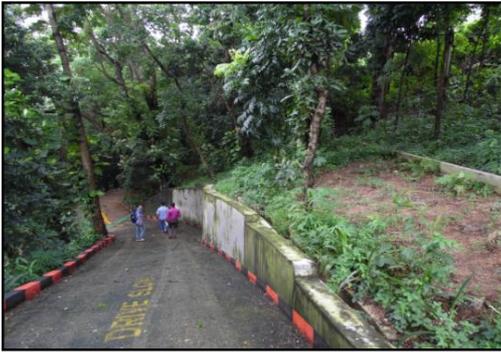
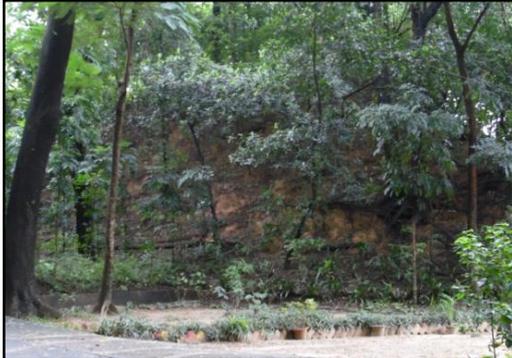
<p>Source: <i>Field survey, August 2014</i></p>	
<b>Landslide Mechanism</b>	
<p><b>Type of Movement:</b> Slide</p> <p><b>State:</b> Stabilized</p> <p><b>Distribution:</b> Confined</p>	<p><b>Style:</b> Single</p> <p><b>Water Content:</b> Moist</p> <p><b>Material:</b> Soil/Earth</p>
<p><b>Land Cover/Use Type:</b> Herbaceous vegetation and forest/ woodland are the Primary land cover of Finley hill.</p>	
<p><b>Causes of Movement:</b> Excessive rainfall is the main cause of movement.</p>	
<b>Land Slide History and Future Risk of Landslide</b>	
<p>No exact date of occurrence of the Land slide in this site has been found. Damage of the property for this event was insignificant. None was found to be dead or injured. Banglows of the officials of Finley company have been constructed on the slope of hill through hill cutting. This hill has been managed in a good way. There exists artificial drainage system so that rain water can easily be drained off. Soil characteristic of this hill is of sandy type. The escapement slope is found to be near vertical to incline. There is low risk of land slide in this hill.</p>

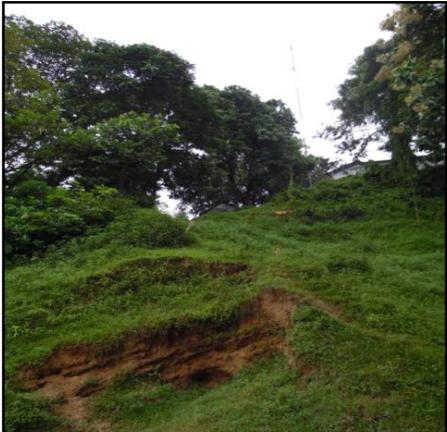
<p style="text-align: center;"><i>Source: Field survey, August 2014</i></p>
<b>Landslide Mechanism</b>	
<p><b>Type of Movement:</b> Slide</p> <p><b>State:</b> Active</p> <p><b>Distribution:</b> Advancing</p>	<p><b>Style:</b> Single</p> <p><b>Water Content:</b> Moist</p> <p><b>Material:</b> Soil/Earth</p>
<p><b>Land Cover/Use Type:</b> Herbaceous vegetation and forest/ woodland are the Primary land cover of Finley hill.</p>	
<p><b>Causes of Movement:</b> Excessive rainfall is the main cause of movement.</p>	
<b>Land Slide History and Future Risk of Landslide</b>	
<p>No exact date of occurrence of the Land slide in this site has been found. Damage of the property for this event was insignificant. None was found to be dead or injured. Banglows of the officials have been constructed on the slope of hill through hill cutting. There exists artificial drainage system so that rain water can easily be drained off. Soil characteristic of this hill is of sandy type. The escapement slope is found to be near vertical to incline. There is low risk of land slide in this hill.</p>

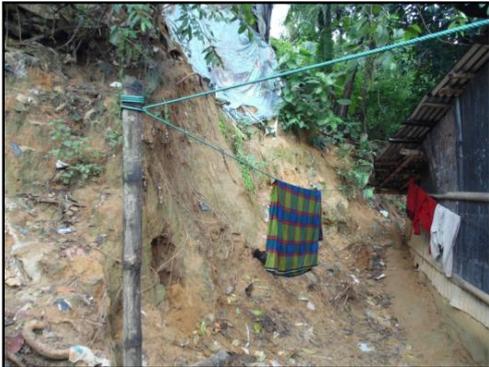
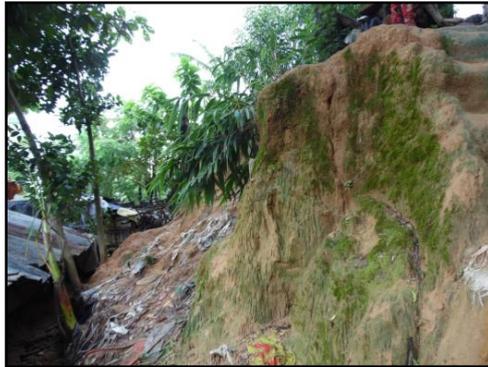
<p>Source: <i>Field survey, August 2014</i></p>	
<b>Landslide Mechanism</b>	
<p><b>Type of Movement:</b> Fall, Slide</p> <p><b>State:</b> Active</p> <p><b>Distribution:</b> Advancing</p>	<p><b>Style:</b> Single</p> <p><b>Water Content:</b> Moist</p> <p><b>Material:</b> Soil/Earth</p>
<p><b>Land Cover/Use Type :</b> Bare soil and Herbaceous vegetation are the Primary land cover of Medical hill.</p>	
<p><b>Causes of Movement:</b> Excessive rainfall and hill cutting are the main causes of movement.</p>	
<b>Land Slide History and Future Risk of Landslide</b>

<p>Land slide in this site occurred on May 2014. No houses got damaged due to this event. None was found to be dead or injured. There are many settlements located surrounding this hill. People have constructed their houses through hill cutting. Natural drainage system is seriously hampered by the human activities. There exists no artificial drainage system to drain off rain water. Soil characteristic of this hill is of sandy type. The escapement slope is found to be near vertical to incline. There is a high risk of land slide in this hill and people living in this site may get severely affected by the future landslide.</p>

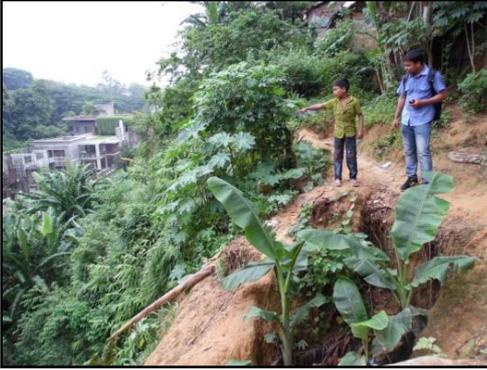
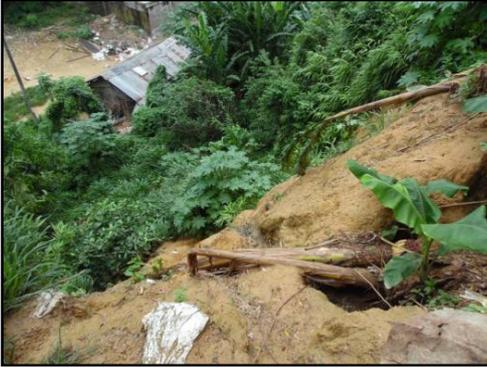
<p>Source: <i>Field survey, August 2014</i></p>	
<b>Landslide Mechanism</b>	
<p><b>Type of Movement:</b> Fall, Slide</p> <p><b>State:</b> Active</p> <p><b>Distribution:</b> Advancing</p>	<p><b>Style:</b> Single</p> <p><b>Water Content:</b> Moist</p> <p><b>Material:</b> Soil/Earth</p>
<p><b>Land Cover/Use Type:</b> Bare soil and Herbaceous vegetation are the Primary land cover of Medical hill.</p>	
<p><b>Causes of Movement:</b> Excessive rainfall and hill cutting are the main causes of movement.</p>	
<b>Land Slide History and Future Risk of Landslide</b>

<p>Land slide in this site occurred on May 2014. No houses got damaged due to this event. None was found to be dead or injured. There are many settlements located on slope of this hill. People have constructed their houses through hill cutting. Natural drainage system is seriously hampered by the human activities. There exists no artificial drainage system to drain off rain water. Soil characteristic of this hill is of sandy type. The escapement slope is found to be near vertical to incline. There is a high risk of land slide in this hill and people living in this site may get severely affected by the future landslide.</p>

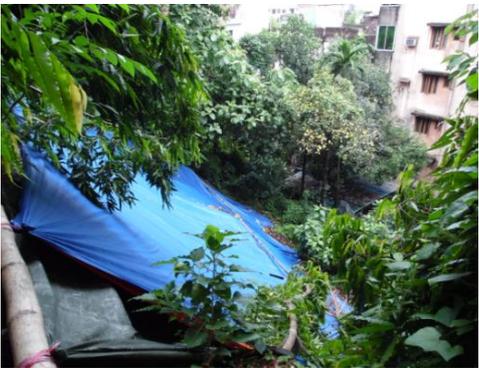
<b>Landslide Mechanism</b>	
<p><b>Type of Movement:</b> Fall, Slide</p> <p><b>State:</b> Active</p> <p><b>Distribution:</b> Advancing</p>	<p><b>Style:</b> Single</p> <p><b>Water Content:</b> Moist</p> <p><b>Material:</b> Soil/Earth</p>
<p><b>Land Cover/Use Type (%):</b> Bare soil and Herbaceous vegetation are the Primary land cover of King of Chittagong hill.</p>	
<p><b>Causes of Movement:</b> Excessive rainfall and hill cutting are the main causes of movement.</p>	
<b>Land Slide History and Future Risk of Landslide</b>	
<p>Land slide in this site occurred on July 2013. No houses got damaged due to this event. None was found to be dead or injured. A community centre named the king of Chittagong has been constructed at the top the hill through hill cutting. There exists artificial drainage system to drain off rain water. Soil characteristic of this hill is of sandy type. The escapement slope is found to be near vertical to incline. There is low risk of land slide in this hill. No significant numbers of settlements are located near this site.</p>

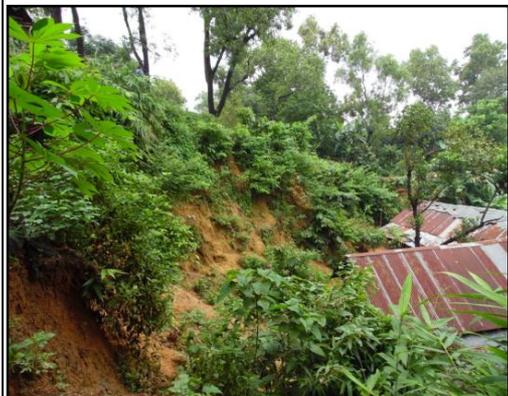
<p>Source: <i>Field survey, August 2014</i></p>
Landslide Mechanism	
<p><b>Type of Movement:</b> Fall, Slide</p> <p><b>State:</b> Active</p> <p><b>Distribution:</b> Advancing</p>	<p><b>Style:</b> Single</p> <p><b>Water Content:</b> Moist</p> <p><b>Material:</b> Soil/Earth</p>
<p><b>Land Cover/Use Type:</b> Bare soil and Herbaceous vegetation are the Primary land cover of King of Chittagong hill.</p>	
<p><b>Causes of Movement:</b> Excessive rainfall and hill cutting are the main causes of movement.</p>	
Land Slide History and Future Risk of Landslide	
<p>Land slide in this site occurred on July 2011. One three storied building got damaged. None was found to be dead or injured. People shifted from that house and the building got demolished by the authority. At present many semi built houses have been constructed on this spot. Soil characteristic of this hill is of sandy type. The escapement slope is found to be near vertical. No natural or artificial drainage system has been found in the site. Human activities have destroyed the natural drainage system. There is a huge risk of future land slide in this hill.</p>

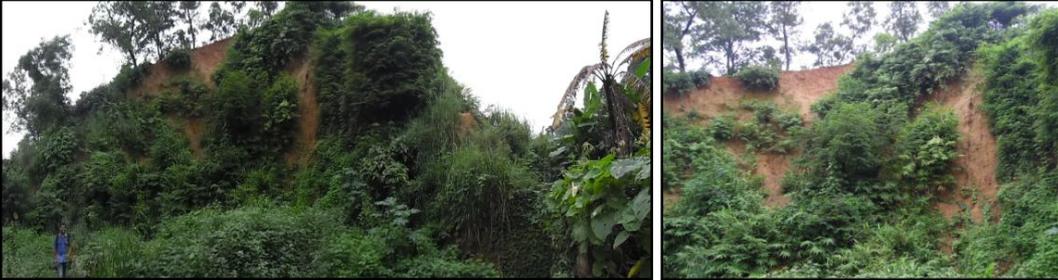
<p>Source: <i>Field survey, August 2014</i></p>	
Landslide Mechanism	
<p><b>Type of Movement:</b> Fall, Slide</p> <p><b>State:</b> Active</p> <p><b>Distribution:</b> Advancing</p>	<p><b>Style:</b> Single</p> <p><b>Water Content:</b> Moist</p> <p><b>Material:</b> Soil/Earth</p>
<p><b>Land Cover/Use Type :</b> Bare soil and Herbaceous vegetation are the Primary land cover of King of Chittagong hill.</p>	
<p><b>Causes of Movement:</b> Excessive rainfall and hill cutting are the main causes of movement.</p>	
Land Slide History and Future Risk of Landslide	
<p>Land slide in this site occurred on July 2011. One three storied building got damaged. None was found to be dead or injured. People shifted from that house and the building got demolished by the authority. At present many semi built houses have been constructed on this spot. Soil characteristic of this hill is of sandy type. The escapement slope is found to be near vertical. No natural or artificial drainage system has been found in the site. Human activities have destroyed the natural drainage system. There is a huge risk of future land slide in this hill.</p>

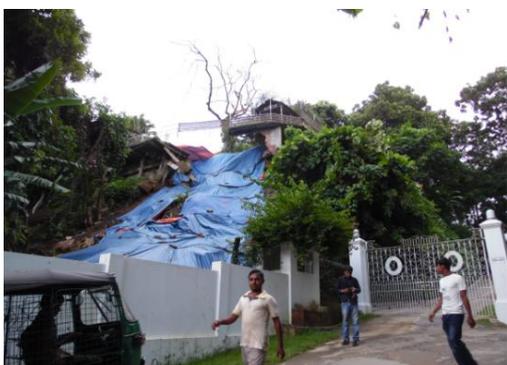
<p style="text-align: center;"><i>Source: Field survey, August 2014</i></p>
<b>Landslide Mechanism</b>	
<p><b>Type of Movement:</b> Fall, Slide</p> <p><b>State:</b> Active</p> <p><b>Distribution:</b> Advancing</p>	<p><b>Style:</b> Single</p> <p><b>Water Content:</b> Moist</p> <p><b>Material:</b> Soil/Earth</p>
<p><b>Land Cover/Use Type:</b> Bare soil and Herbaceous vegetation and built cover are the Primary land cover of AK Khan hill.</p>	
<p><b>Causes of Movement:</b> Excessive rainfall event (658 mm in 9 days rainfall event) and hill cutting are the main causes of movement.</p>

<b>Land Slide History and Future Risk of Landslide</b>	
<p>A massive landslide occurred in this site on 2013. House of AK Khan is located at the top of the hill. This house was constructed through hill cutting. Loose soil and heavy rainfall acted as the major triggering factor of landslide. House was collapsed and severely damaged. None was found to be injured. Still people live in this house. Protection measure has been taken. Future risk of landslide is low.</p>

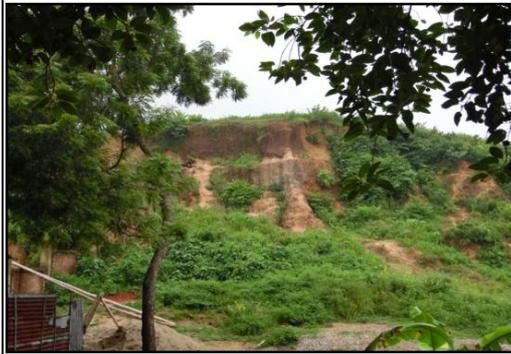
<p>Source: <i>Field survey, August 2014</i></p>
Landslide Mechanism	
<p><b>Type of Movement:</b> Topple, Slide</p> <p><b>State:</b> Active</p> <p><b>Distribution:</b> Advancing</p>	<p><b>Style:</b> Single</p> <p><b>Water Content:</b> Moist</p> <p><b>Material:</b> Soil/Earth</p>
<p><b>Land Cover/Use Type:</b> Herbaceous vegetation are the Primary land cover of King of Chittagong hill.</p>	
<p><b>Causes of Movement:</b> Excessive rainfall is the main causes of movement.</p>	
Land Slide History and Future Risk of Landslide	
<p>No exact date of occurrence of the Land slide in this site has been found. Damage of the property for this event was insignificant. None was found to be dead or injured. At present many semi built houses have been constructed on the surrounding areas of this hill. Soil characteristic of this hill is of sandy type. The escapement slope is found to be near vertical. No natural or artificial drainage system has been found in the site. Human activities have destroyed the natural drainage system. There is a huge risk of future land slide in this hill.</p>

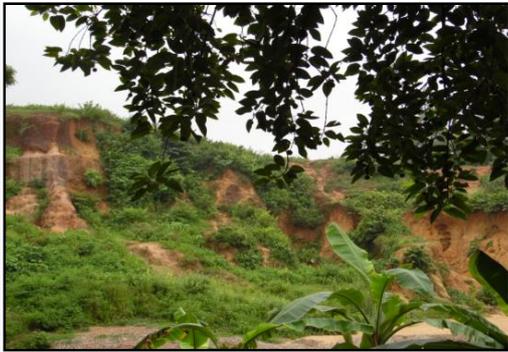
<p>Source: <i>Field survey, August 2014</i></p>
Landslide Mechanism	
<p><b>Type of Movement:</b> Topple, Slide</p> <p><b>State:</b> Active</p> <p><b>Distribution:</b> Advancing</p>	<p><b>Style:</b> Single</p> <p><b>Water Content:</b> Moist</p> <p><b>Material:</b> Soil/Earth</p>
<p><b>Land Cover/Use Type:</b> Herbaceous vegetation are the Primary land cover of Amin Textile hill.</p>	
<p><b>Causes of Movement:</b> Excessive rainfall is the main causes of movement.</p>	
Land Slide History and Future Risk of Landslide	
<p>No exact date of occurrence of the Land slide in this site has been found. From the field investigation it has been known from local people that damage of the property in that event was insignificant. None was found to be dead or injured. At present many semi built houses have been constructed on the surrounding areas of this hill. Soil characteristic of this hill is of sandy type. The escapement slope is found to be near vertical. No natural or artificial drainage system has been found in the site. Human activities have destroyed the natural drainage system. There is a huge risk of future land slide in this hill.</p>

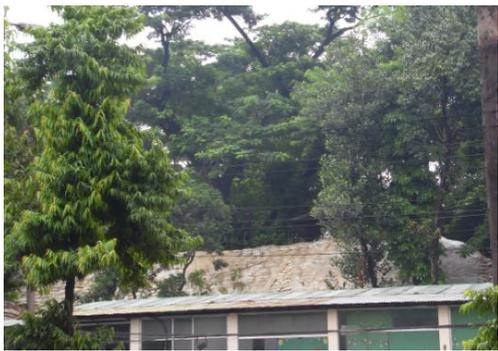
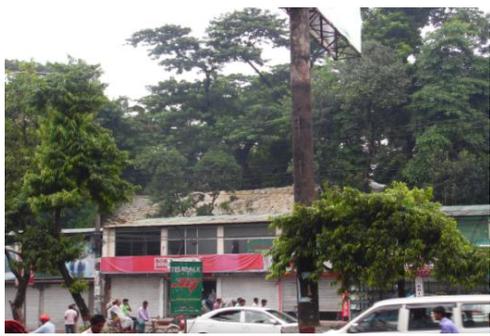
<p>Source: <i>Field survey, August 2014</i></p>
<b>Landslide Mechanism</b>	
<p><b>Type of Movement:</b> Slide</p> <p><b>State:</b> Stabilized</p> <p><b>Distribution:</b> Confined</p>	<p><b>Style:</b> Single</p> <p><b>Water Content:</b> Moist</p> <p><b>Material:</b> Soil/Earth</p>
<p><b>Land Cover/Use Type :</b> Forest/ Woodland is the Primary land cover of Amin Textile</p>	
<p><b>Causes of Movement:</b> Excessive rainfall and hill cutting are the main causes of movement.</p>	
<b>Land Slide History and Future Risk of Landslide</b>	
<p>No exact date of occurrence of the Land slide in this site has been found. Damage of the property for this event was insignificant. None was found to be dead or injured. At present construction work of housing is going on in this site. Natural slope characteristics of this hill have been destroyed through hill cutting. The escapement slope is found to be near vertical. Protection measure on this hiss has been taken. Sacks filled with sand are used for protection material. There is low risk of future landslide in this hill.</p>

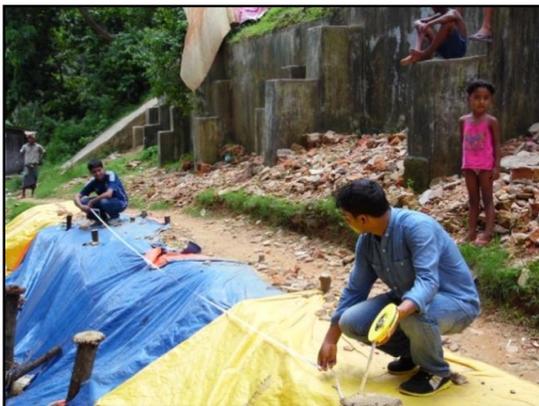
Figure 1. : Measuring displacement of mass.

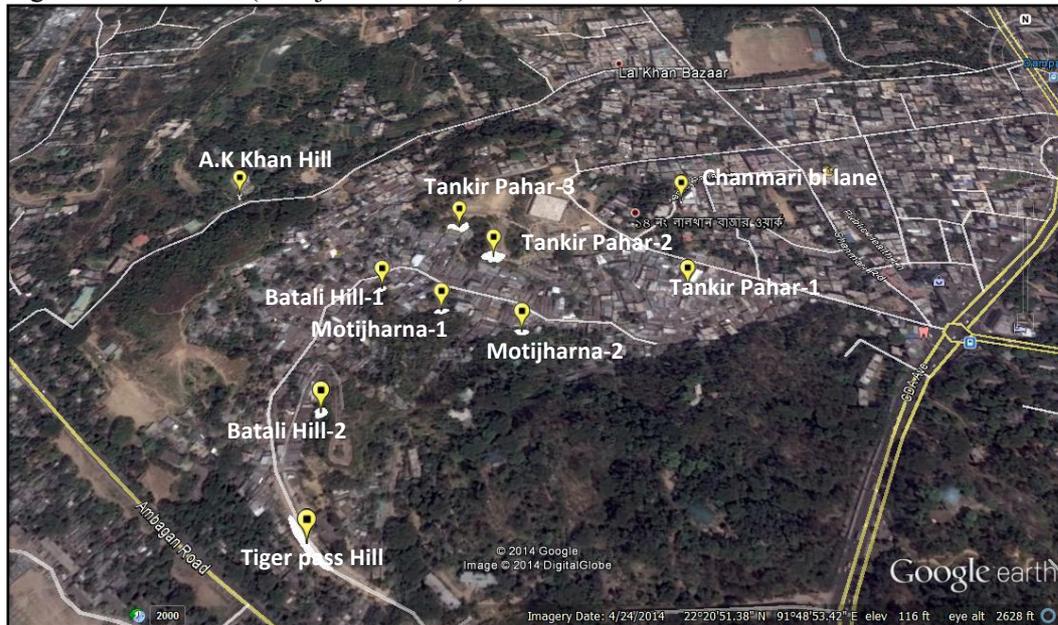
Figure 1: Cluster- 1 (Motijharna Area)

A Branch of Chanmari Road is at the North side of this cluster. At the South, East and West side there are Tiger pass railway colony, CDA Avenue and Ambagan Road respectively (Figure-1, Appendix-C).

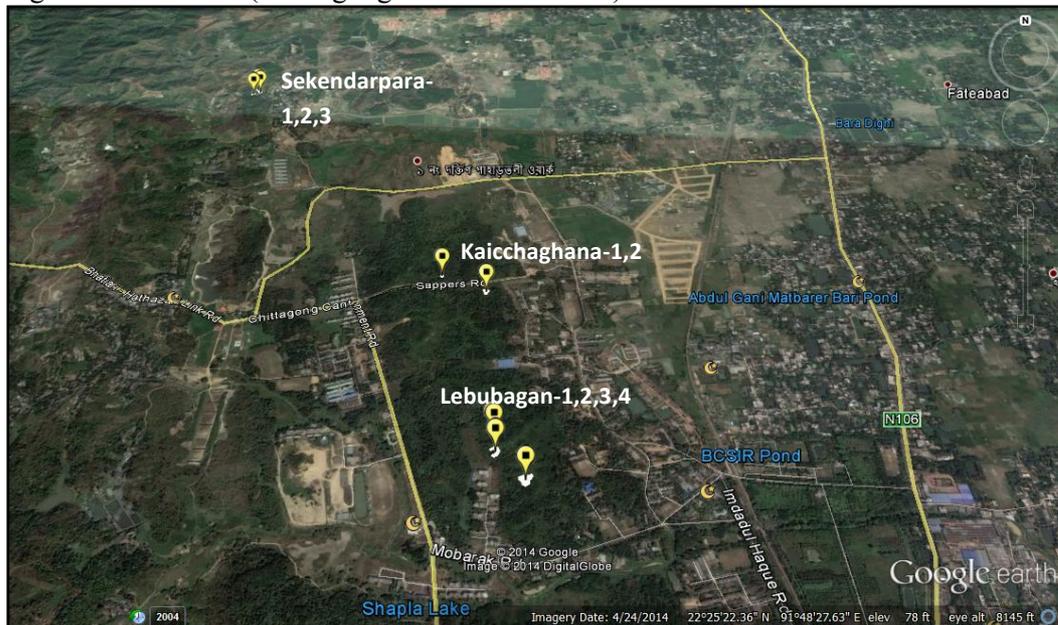
Figure 2: Cluster- 2 (Chittagong Cantonment Area)

This cluster is inside the Chittagong Cantonment Area. The Cantonment Area is located at the North side of the major road Bayejid Bostami Road. Chittagong cantonment road is at the west side of Lebugan and Kaccharghona area. The Bhatiari Hathazari Link Road and Mobarok Road are at North and South side respectively. Chittagong cantonment Railway station is at the East. Besides, Sekandarpara is at North side of Bhatiari Hathazari Link Road. (Figure-2, Appendix-C).
