# Developing Dynamic Web-GIS based Early Warning System for the Communities at Landslide Risks in Chittagong Metropolitan Area, Bangladesh

## Landslide Inventory Report August, 2014

# **Landslide Inventory Report of Chittagong Metropolitan Area, Bangladesh**

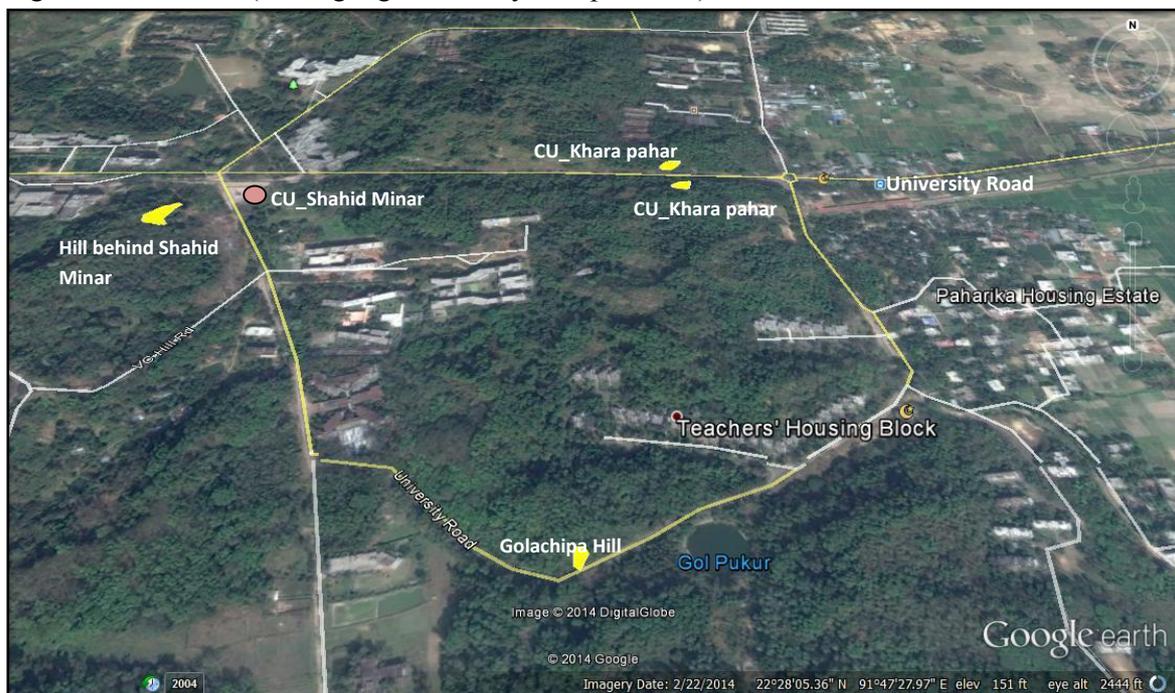
Figure 4: Cluster- 4 (Chittagong University Campus Area)

The locations in this cluster are in the Chittagong University Campus. At the North there are Tsunami Garden and Shahjalal Hall. The University Jame Mosque and Mosque of Faculty of Science are at North and West side of this area. The Golpukur is at the South of the cluster. (Figure-4, Appendix-C).

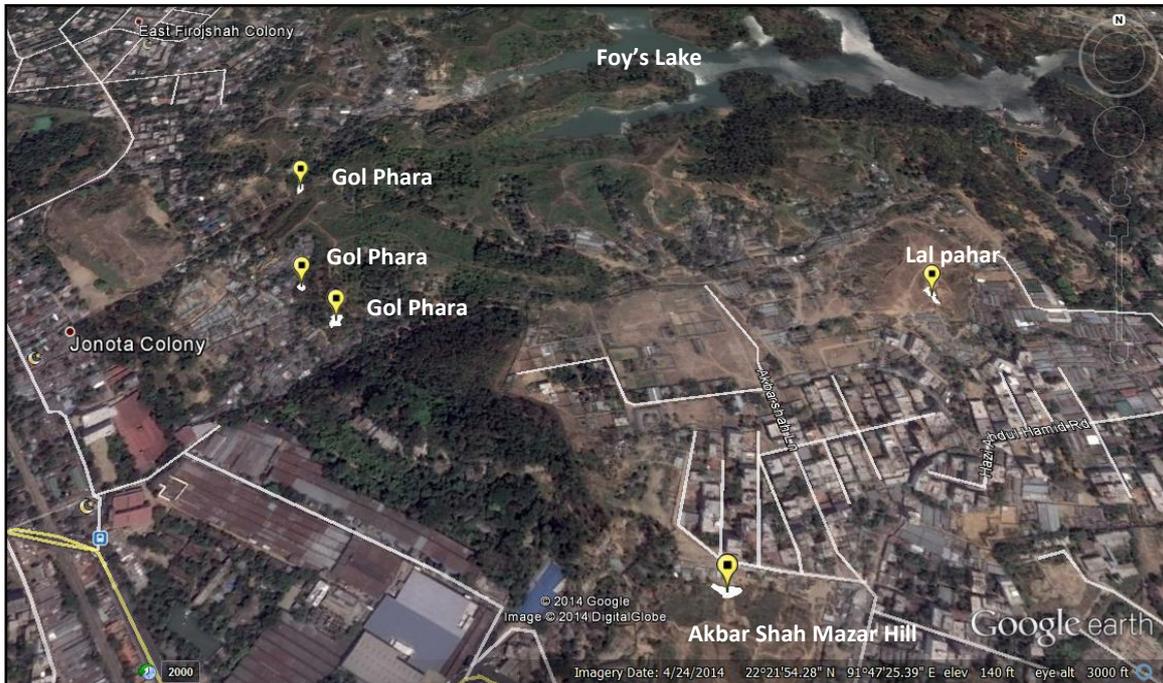
Figure 5: Cluster-5 (Akbar Shah Mazar Area)

This cluster is surrounded by North side Foy's Lake, Foy's Lake Road, Zakir Hossain Road and Bara Peer Hazrat Abdul Kader Zilani (R) Masjid at the North, East, South and West side. (Figure-5, Appendix-C).

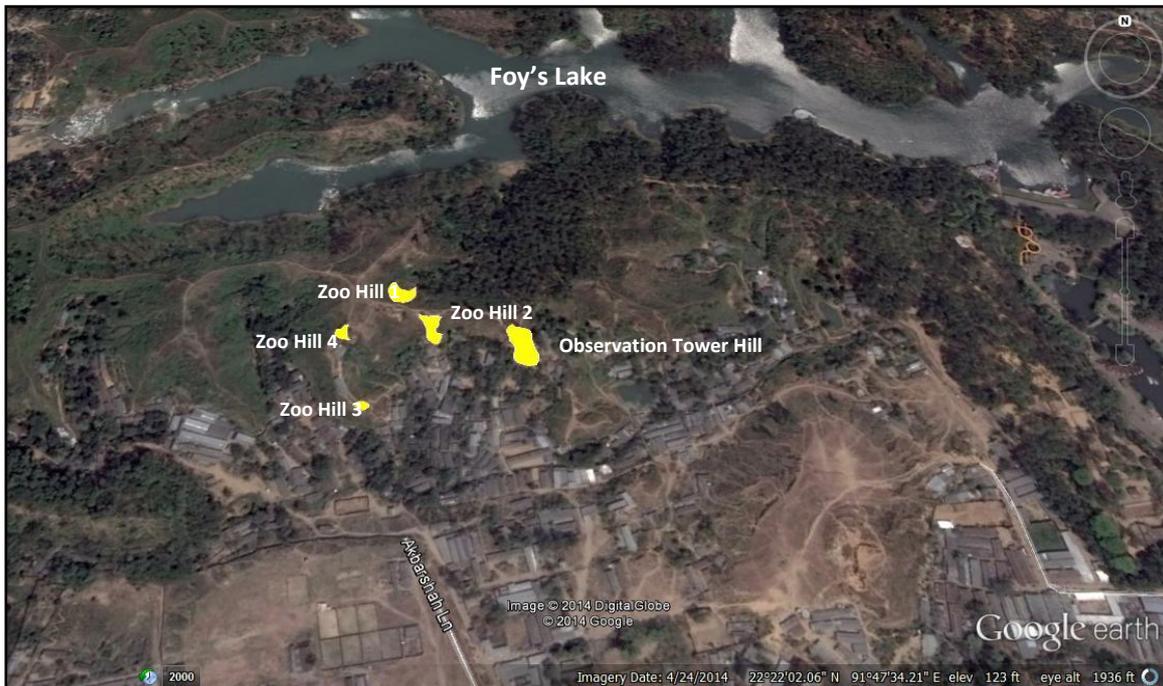
Figure 6: Cluster- 6 (Foy's Lake Area)

The Foy's lake is at North side of this cluster. The Cluster 5 is at the West side of this area. (Figure-6, Appendix-C).

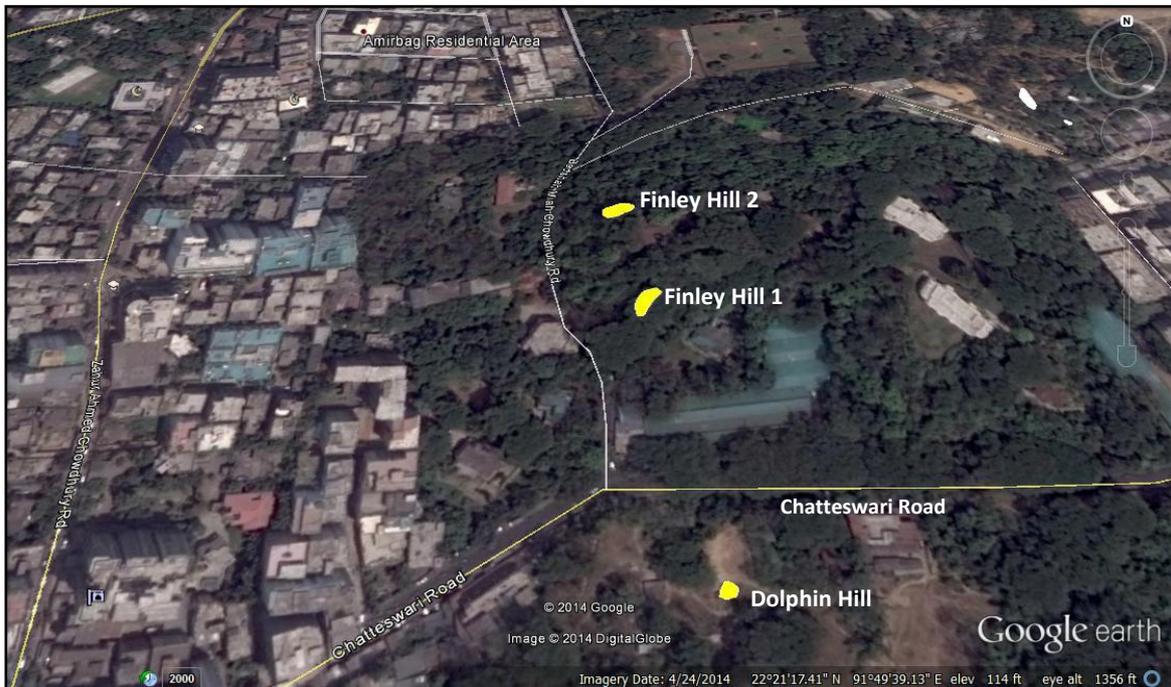
Figure 8: Cluster- 8 (Chatteswari Area)

Amirbagh Residential Area is at the North side of this cluster. Badshah Mia Chowdhury Road at the West and the Beverly Hill Residential Area is at the East side. The Chatteswari Road is in between the Finley Hill and Dolphin Hill to the East-West direction. (Figure-8, Appendix-C).

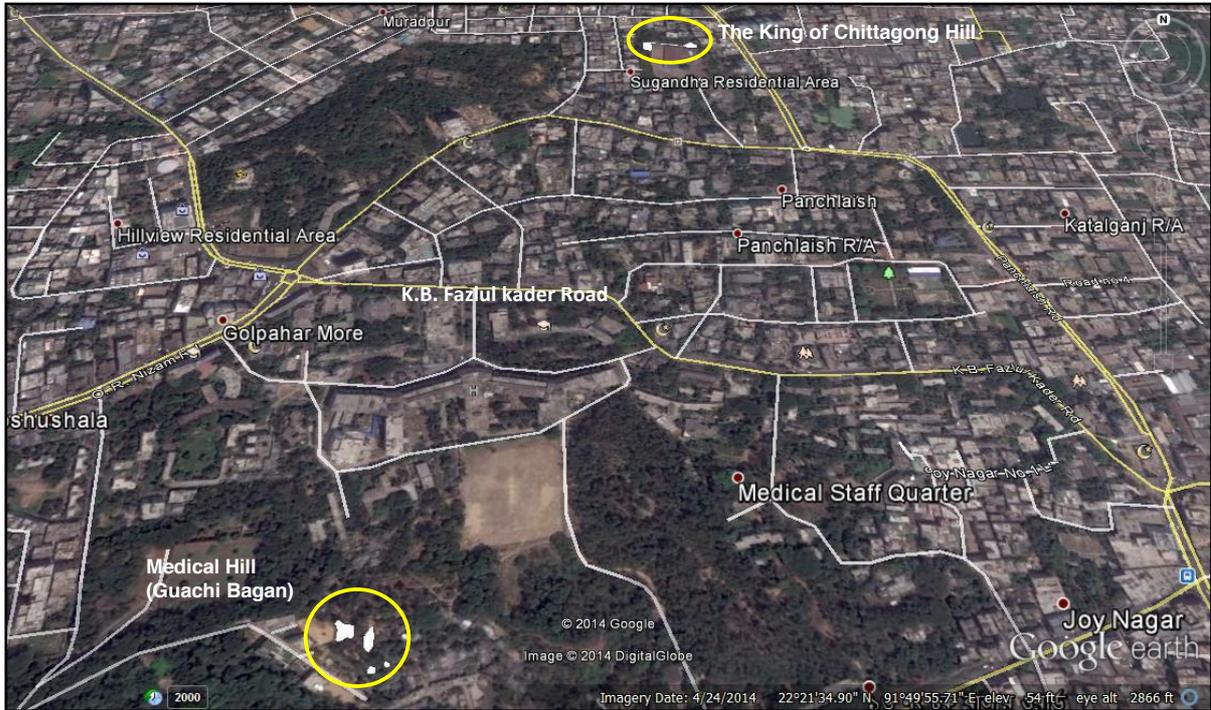
Figure 9: Cluster- 9 (Pachlaish Area)

The Beverly Hill Residential Area and Chittagong Medical College Staff Quarter are at South and East side respectively. O R Nizam Road is in between the king of Chittagong and Medical Hill. (Figure-9, Appendix-C).
