# LANDSLIDE INVENTORY AND LAND-USE MAPPING, DEM PREPARATION, PRECIPITATION THRESHOLD VALUE AND ESTABLISHMENT OF EARLY WARNING DEVICES

March 2012

### **Rainfall Triggered Landslide Hazard Zonation in Cox's Bazar & Teknaf Municipalities as well as Introducing Community-based Early Warning System for Landslide Hazard Management**

#### **Revised Report on Landslide Inventory and Land-use Mapping, DEM Preparation, Precipitation Threshold Value & Establishment of Early Warning Devices**

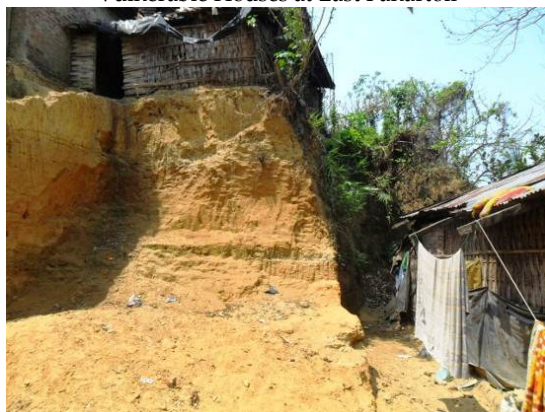
Vulnerable houses at Mohajer para

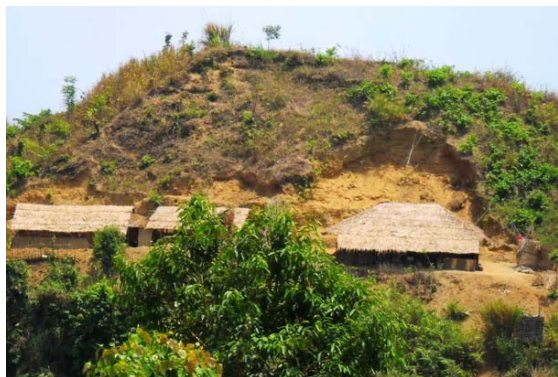
Houses at Hillside of Kolatolii

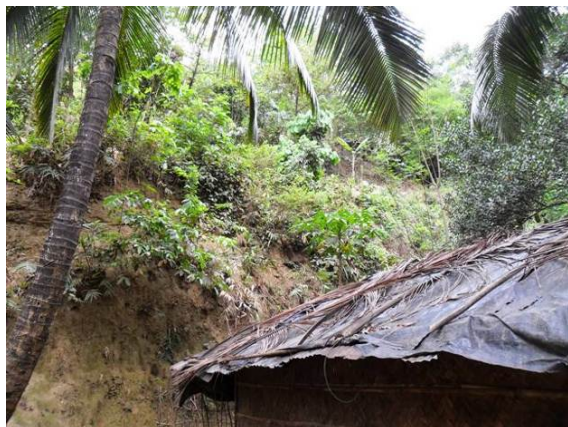
Houses near landslide site at Urumer Chara

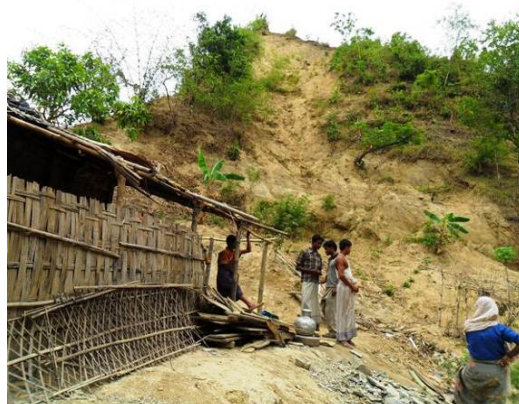
Houses Located near the Landslide site at Puran Pallan Para

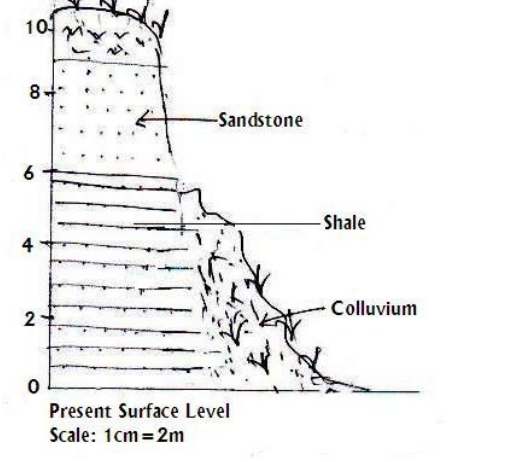
| <p><b>Landslide ID:</b> 09<br/><b>Location:</b> South Ganar Ghona, Cox's Bazar district</p> | <p><b>Coordinates:</b><br/>N-21°25'00.5", E-92°01'04.6"</p> |

| <p><b>Date of Occurrence:</b> 15 June 2010, 3 July 2008 and 11 June 2007.<br/>(The Landslide Occurred around 6:00am due to heavy rain.</p> | <p><b>Landslide History:</b> Initiated movement in June 2007, Subsequently activated in July 2008 and June 2010.</p> |
| <p><b>Rainfall:</b> June 11, 2007: 101 mm during 24 hours and 240mm during 7 days (continuous rain from 4 to 11 June).<br/>July 3, 2008: 134 mm during 24 hours and 729mm during 7 days (continuous rain from 27 June to 3 July).<br/>June 15, 2010:</p> | |

| <b>Future Risks</b> | <p>In future this sliding can get repeated as there is a possibility of destabilization of the mass above the slope. The impact would be further destruction to the hill and garden.</p> <p>In the down slope around 50m away several human settlements are located and down slope movement of debris flow can create impact to houses and also people living there. The risk is moderate to high.</p> |

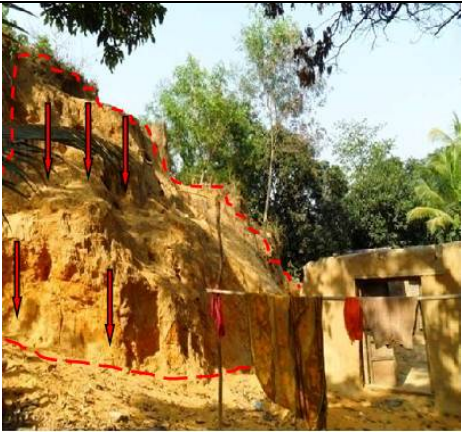
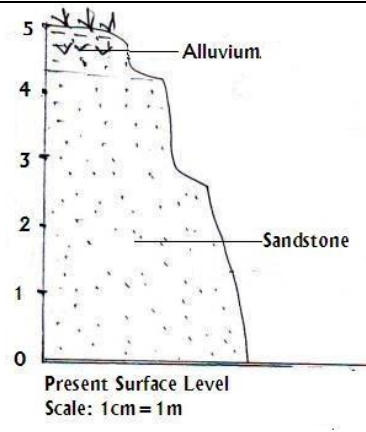
| <p><b>Landslide ID:</b> 21</p> <p><b>Location:</b> South Ganar Ghona, Cox's Bazar district</p> | <p><b>Coordinates:</b><br/>N-21°25'02.2", E-92°00'54.9"</p> |

| <b>Date of Occurrence:</b> 15 June 2010.<br>The Landslide Occurred around 5:00am due to heavy rain. | | <b>Landslide History:</b> Landslide occurred here in June 2010. | |

| <b>Future Risks</b> | In future this sliding can get repeated as there is a possibility of destabilization of the mass above the slope. The impact would be further destruction to the hill and human settlements and gardens. The risk is moderate to high. |

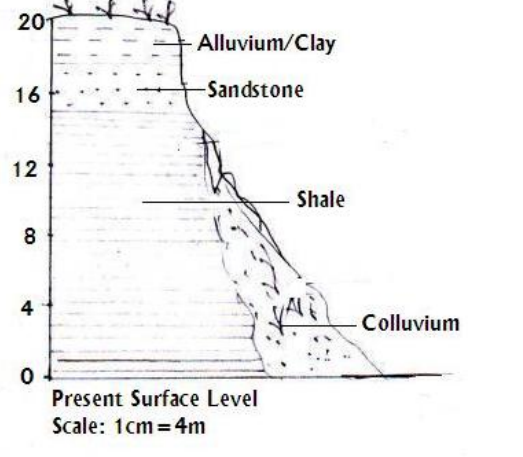
| <p><b>Landslide ID:</b> 70<br/><b>Location:</b> West Lar Para, Kolatoli Bypass., Cox's Bazar district</p> | <p><b>Coordinates:</b><br/>N-21°25'35.8"<br/>E-91°59'47.0"</p> |

| <p><b>Date of Occurrence:</b> 15 June, 2010 and 15 June, 2003.</p> | <p><b>Landslide History:</b> Initiated movement in June 2003, Subsequently activated in June 2010 (Repetitive).</p> |
| <p><b>Rainfall:</b> June 15, 2003: 77 mm during 24 hours and 771mm during 13 days (continuous rain from 3 to 15 June) June 15, 2010:</p> | |

| <b>Future Risks</b> | <p>In future this sliding can get repeated as there is a possibility of destabilization of the mass above the slope. The impact would be further destruction to the hill.</p> <p>In the down slope around 20m away several human settlements are located and down slope movement of debris flow can create impact to houses and also people living there. The impact would be further destruction to the hill. The risk is moderate to high.</p> |

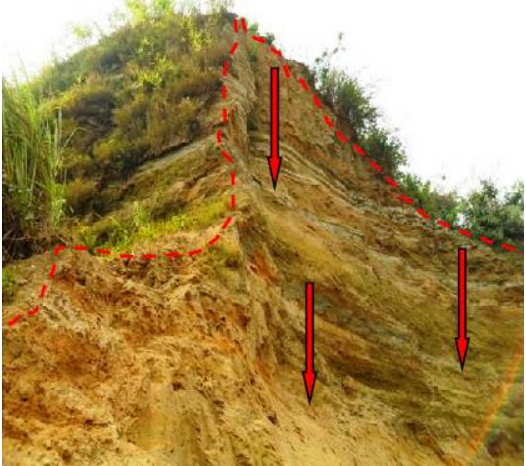
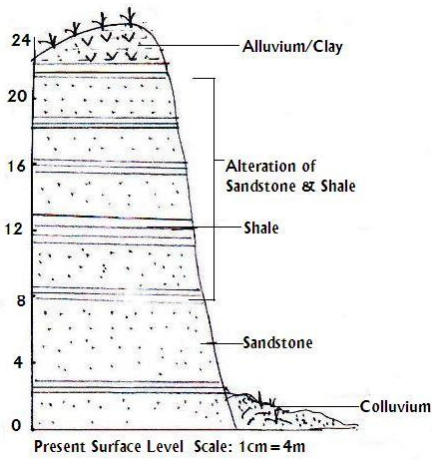
| <p><b>Landslide ID:</b> 80<br/><b>Location:</b> Lar Para, Kolatoli Bypass., Cox's Bazar district</p> | <p><b>Coordinates:</b><br/>N-21°25'30.2",<br/>E-92°00'10.2"</p> |

| <p><b>Date of Occurrence:</b> 15 June, 2010 and 3 July 2008.</p> | <p><b>Landslide History:</b> Initiated movement in July 2008, Subsequently activated in June 2010.</p> |
| <p><b>Rainfall:</b> July 3, 2008: 134 mm during 24 hours and 729mm during 7 days (continuous rain from 27 June to 3 July)</p> | |

| <b>Future Risks</b> | <p>In future this sliding can get repeated as there is a possibility of destabilization of the mass above the slope. The impact would be further destruction to the hill.</p> <p>In the down slope around 10m away the local people residence is located and down slope movement of larger debris flow can create impact to houses and also people living there. The risk is moderate to high.</p> |

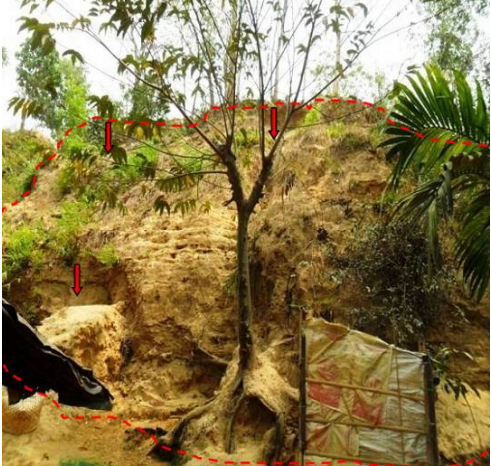
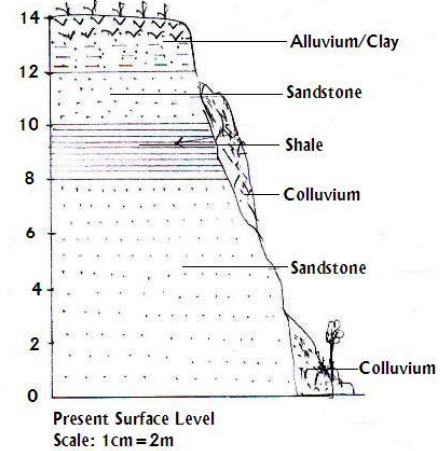
| <p><b>Landslide ID:</b> 86<br/><b>Location:</b> South Dikkul, Lar Para, Kolatoli Bypass., Cox's Bazar district</p> | <p><b>Coordinates:</b><br/>N-21°25'17.5",<br/>E-92°00'29.1"</p> |

| <p><b>Date of Occurrence:</b> July 6, 2008.</p> | <p><b>Landslide History:</b> Landslide occurred here in July 2008.</p> |
| <p><b>Rainfall:</b> 64 mm during 24 hours and 927mm during 10 days (continuous rain from 27 June to 6 July)</p> | |

| <b>Future Risks</b> | <p>In future this sliding can get repeated as there is a possibility of destabilization of the mass above the slope. The impact would be further destruction to the hill.</p> <p>In the down slope around 10m away the local human residence is located and down slope movement of larger debris flow can create impact to houses and also people living there. The risk is moderate to high.</p> |

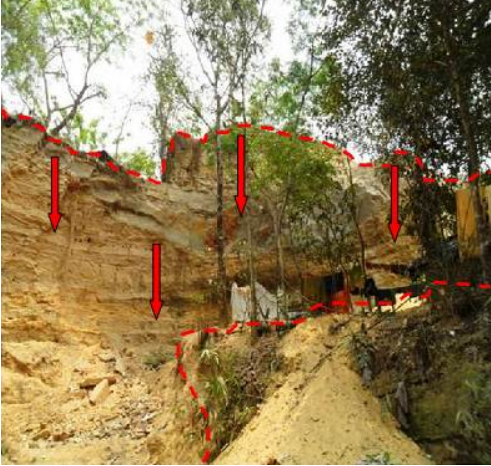
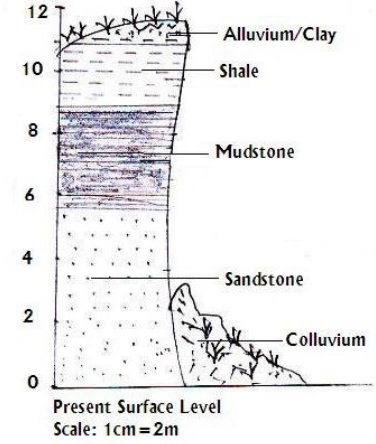
| <p><b>Landslide ID:</b> 90<br/><b>Location:</b> South Dikkul, Lar Para, Cox's Bazar district.</p> | <p><b>Coordinates:</b><br/>N-21°25'31.8"<br/>E-92°00'25.7"</p> |

| <p><b>Date of Occurrence:</b> July 3, 2008.</p> | <p><b>Landslide History:</b> Subsequently activated in July 2008.</p> |
| <p><b>Rainfall:</b> 134 mm during 24 hours and 729mm during 7 days (continuous rain from 27 June to 3 July)</p> | |

| <b>Future Risks</b> | In future this sliding can get repeated as there is a possibility of destabilization of the mass above the slope. The impact would be further destruction to the hill.<br>In the down slope around 15m away the local human residence is located and down slope movement of larger debris flow can create impact to houses and also people living there. The risk is moderate to high. |

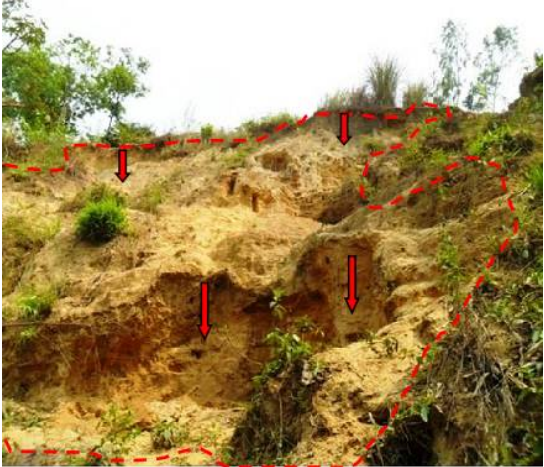
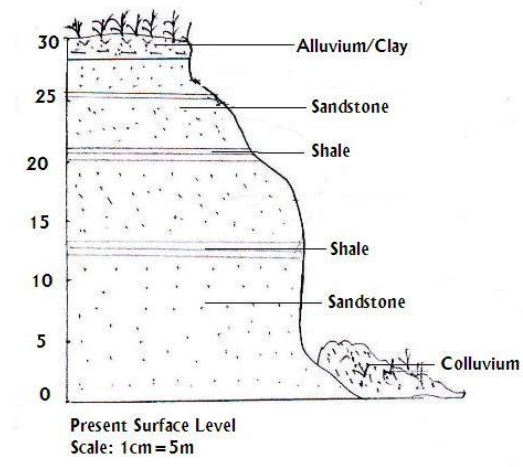
| <b>Landslide ID:</b> 93<br><b>Location:</b> South Dikkul, Lar Para, Cox's Bazar district | <b>Coordinates:</b><br>N-21°25'26.2",<br>E-92°00'33.2" |

| <b>Date of Occurrence:</b> 15 June 2010 and 3 July 2008. | <b>Landslide History:</b> Initiated movement in July 2008, Subsequently activated in June 2010. |
| <b>Rainfall:</b> July 6, 2008: 64 mm during 24 hours and 927mm during 10 days (continuous rain from 27 June to 6 July) | |

| <b>Future Risks</b> | In future this sliding can get repeated as there is a possibility of destabilization of the mass above the slope. The impact would be further destruction to the hill.<br>In the down slope around 10m away the local human residence is located and down slope movement of larger debris flow can create impact to houses and also people living there. The risk is moderate to high. |

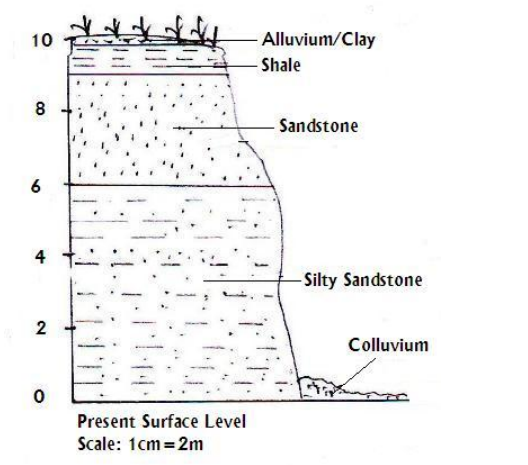
| <b>Landslide ID:</b> 97<br><b>Location:</b> South Haji Para, Cox's Bazar district | <b>Coordinates:</b><br>N-21°25'26.6"<br>E-92°00'40.0" |

| <b>Date of Occurrence:</b> 15 June 2010 and 10 June 2006. | <b>Landslide History:</b> Initiated movement in June 2006, Subsequently activated in June 2010. |
| <b>Rainfall:</b> June 10, 2006: 113 mm during 24 hours and 477mm during 7 days (continuous rain from 4 to 10 June). | |

| <b>Future Risks</b> | <p>In future this sliding can get repeated as there is a possibility of destabilization of the mass above the slope. The impact would be further destruction to the hill.</p> <p>In the down slope around 10m away the local human residence is located and down slope movement of larger debris flow can create impact to houses and also people living there. The risk is moderate to high.</p> |

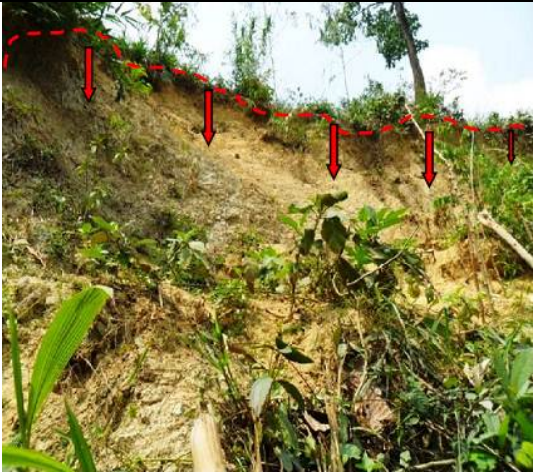
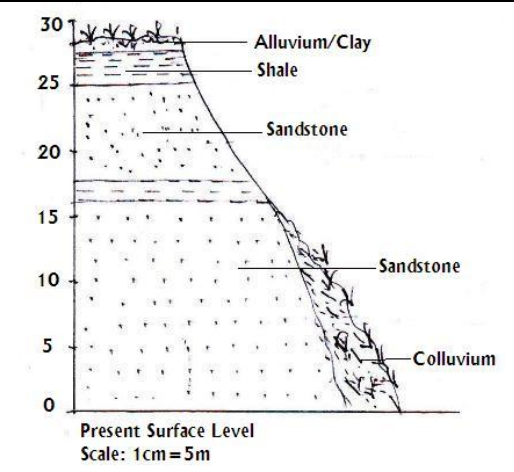
| <b>Landslide ID:</b> 98<br><b>Location:</b> South Haji Para, Cox's Bazar district | | <b>Coordinates:</b><br>N-21°25'21.3"<br>E-92°00'38.7" | |

| <b>Date of Occurrence:</b> 15 June 2010 and June 19, 2004. | | <b>Landslide History:</b> Initiated movement in June 2004, Subsequently activated in June 2010. | |
| <b>Rainfall:</b> June 19, 2004: 142 mm during 24 hours and 447mm during 4 days (continuous rain from 15 to 19 June) | | | |

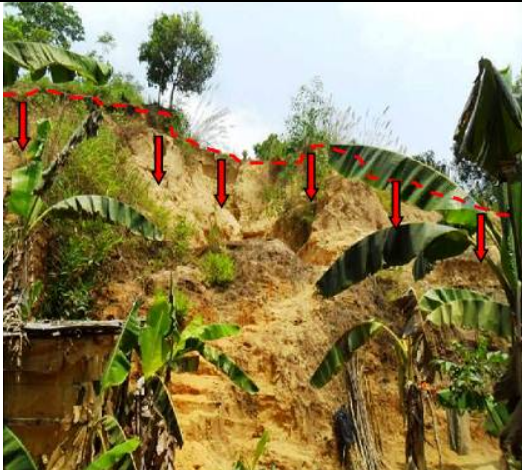
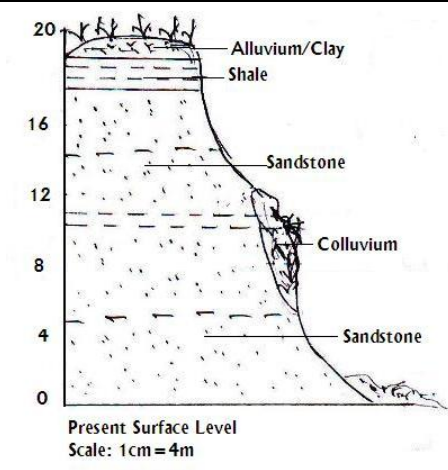
| <p><b>Landslide ID:</b> 99<br/><b>Location:</b> South Haji Para, Cox's Bazar district</p> | <p><b>Coordinates:</b><br/>N-21°25'18.4"<br/>E-92°00'39.9"</p> |

| <p><b>Date of Occurrence:</b> 15 June 2010 and July 3, 2008.</p> | <p><b>Landslide History:</b> Initiated movement in July 2008, Subsequently activated in June 2010.</p> |
| <p><b>Rainfall:</b> July 3, 2008: 134 mm during 24 hours and 729mm during 7 days (continuous rain from 27 June to 3 July)</p> | |
| <p><b>Geology:</b> The failed slope is southern scarp of a large escarpment with a height of around 25m. The height of the failed part of the slope is around 21m and width is around 30m. The mountain forming bed rock of the escarpment is formed of mainly two lithological units- bluish gray thinly laminated shale unit and yellowish brown cross-bedded to massive medium- to fine-grained sandstone. Top part of this section about 2.5 m is highly weathered. The failed mass comprised of highly weathered rock and moderately weathered rock. After the slide at places a</p> | |

| <p>moderately weathered rock is exposed. The exposed rock units are mostly composed of light brown fine to medium grained sand, silt and clay. The height of the failure surface is around 21 m.</p> <p><b>Fracturing:</b> Three sets of joints are observed on failure surface of the bed rock and one is parallel to the bedding plane (350/10) and other two are almost vertical and perpendicular to each other (350/80 and 185/85). The joints are filled with weathered clay, silt and fine sand.</p> <p><b>Overburden Deposits:</b> Total overburden comprised of clay, silt and sand material. The material contains the relic structure of the bed rock which suggests it to be residual soil. The soil thickness of the residual soil layer which overlays the bed rock mass is around 1 m thick and the residual soil thickness is around 6m.</p> | |
| <b>Slope Characteristics</b> | <p>The escarpment slope is near vertical to incline and the upper part consists of highly weathered bed rock (clay type rock). Lower part consists of fine to medium grained sand. Original slope 34°. The failed mass is a part of the near vertical escarpment and the debris moved from the slope is underlain by the talus material, which seems to be the remnants of previous landslides. The failed mass is a part of the upper portion. Thickness is around 6 meters.</p> |

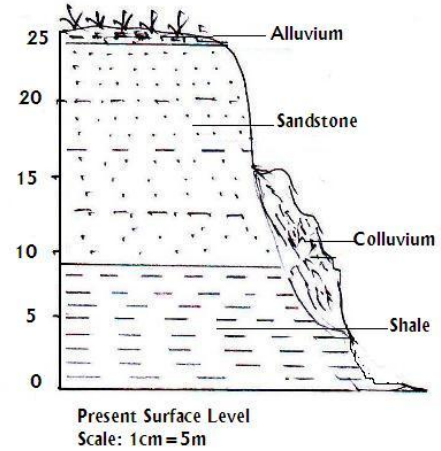
| <p><b>Landslide ID:</b> 107<br/><b>Location:</b> Badshar Ghuna, Cox's Bazar district</p> | <p><b>Coordinates:</b><br/>N-21°26'4.4"<br/>E-91°58'50.7"</p> |

| <p><b>Date of Occurrence:</b> 15 June 2010 and June 11, 2007.</p> | <p><b>Landslide History:</b> Initiated movement in June 2007, Subsequently activated in June 2010.</p> |
| <p><b>Rainfall:</b> June 11, 2007: 101 mm during 24 hours and 240mm during 7 days (continuous rain from 4 to 11 June)</p> | |
| <p><b>Geology:</b> The failed slope is eastern scarp of a large escarpment with a height of around 30m. The height of the failed part of the slope is around 25m and width is around 40m. The mountain forming bed rock of the escarpment is formed of mainly two lithological units- lower bluish gray thinly laminated moderately weathered shale unit and upper moderately weathered yellowish brown cross-bedded to massive medium- to fine-grained sandstone. Top part of this section about 3 m is highly weathered. The failed mass comprised of highly weathered rock and moderately weathered rock. After the slide at places a moderately weathered rock is exposed. The exposed rock units are mostly composed of light brown fine to medium grained sand, silt and clay. Sandstones comparatively loose and less compact. The height of the failure surface is around 25 m.</p> | |

| <p><b>Fracturing:</b> Three sets of joints are observed on failure surface of the bed rock and one is parallel to the bedding plane (340/5) and other two are almost vertical and perpendicular to each other (250/89 and 70/89). The joints are filled with weathered clay, silt and fine sand.</p> <p><b>Overburden Deposits:</b> Total overburden comprised of clay, silt and sand material. The material contains the relic structure of the bed rock which suggests it to be residual soil. The soil thickness of the residual soil layer which overlays the bed rock mass is around 1 m thick. The alluvial soil thickness is around 8m.</p> | |
| <b>Slope Characteristics</b> | <p>The escarpment slope is near vertical to incline and the upper part consists of highly weathered rock. Lower part consists of thinly laminated shale. Light brown color fine to medium grained sand which is about 15m in thickness present above the shale layer.</p> <p>The failed mass is a part of the near vertical escarpment and the debris moved from the slope is underlain by the talus material, which seems to be the remnants of previous landslides</p> <p>Original slope 32°. The failed mass is a part of the upper portion. Thickness is around 8 meters.</p> |

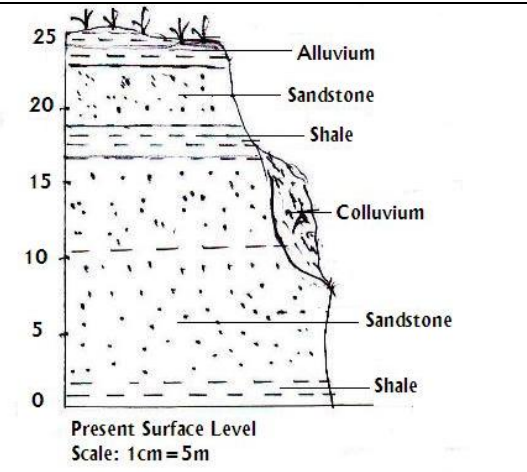
| <b>Landslide ID:</b> 109<br><b>Location:</b> East Light House para, Cox's Bazar district | <b>Coordinates:</b><br>N-21°25'40.2"<br>E-91°58'49.3" |

| <b>Date of Occurrence:</b> 15 June 2010 and July 3, 2008. | <b>Landslide History:</b> Initiated movement in July 2008, Subsequently activated in June 2010. |
| <b>Rainfall:</b> July 3, 2008: 134 mm during 24 hours and 729mm during 7 days (continuous rain from 27 June to 3 July) | |
| <b>Geology:</b> The failed slope is northern scarp of a large escarpment with a height of around 30m. The height of the failed part of the slope is around 25m and width is around 40m. The mountain forming bed rock of the escarpment is formed of mainly two lithological units- bluish gray thinly laminated moderately weathered shale unit and upper moderately weathered yellowish brown cross-bedded to massive medium- to fine-grained sandstone and the top part of this unit about 3.5 m is highly weathered. The failed mass comprised of highly weathered rock and moderately weathered rock. After the slide at places a moderately weathered rock is exposed. The exposed rock units are mostly composed of light brown fine to medium grained sand, silt and clay. Sandstones comparatively loose and less compact. The height of the failure surface is around 25 m. | |
| <b>Fracturing:</b> Three sets of joints are observed on failure surface of the bed rock and one is parallel to the bedding plane (340/15) and other two are almost vertical and perpendicular to each other (160/89 | |

| <p><b>Slope Characteristics</b></p> | <p>The escarpment slope is near vertical and the upper part consists of highly weathered bed rock. Lower part consists of thinly laminated shale. Light brown color fine to medium grained sand which is about 15m in thickness present above the shale layer.</p> <p>Original slope 32°. The failed mass is a part of the near vertical escarpment and the debris moved from the slope is underlain by the talus material, which seems to be the remnants of previous landslides. The failed mass is a part of the upper portion. Thickness is around 7 meters.</p> |

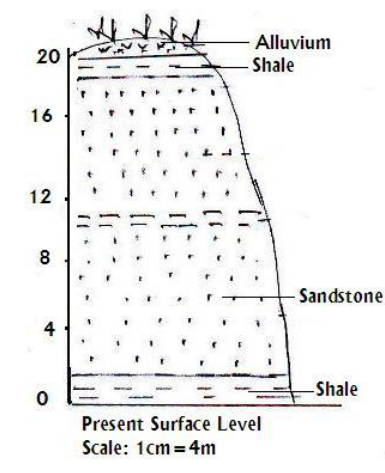
| <b>Landslide ID:</b> 143<br><b>Location:</b> Baidder Ghuna, Cox's Bazar district | <b>Coordinates:</b><br>N-21°26'16.9"<br>E-91°58'54.6" |

| <b>Date of Occurrence:</b> 15 June 2010 and July 3, 2008. | <b>Landslide History:</b> Initiated movement in July 2008, Subsequently activated in June 2010. |
| <b>Rainfall:</b> July 3, 2008: 134 mm during 24 hours and 729mm during 7 days (continuous rain from 27 June to 3 July) | |

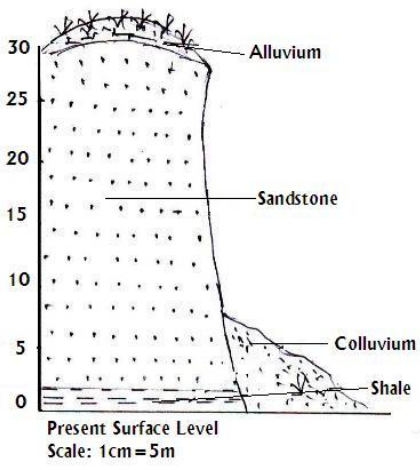
| <p><b>Landslide ID:</b> 03<br/><b>Location:</b> Fakirer Mura, Puran Pallan Para, Teknaf Municipal Area</p> | <p><b>Coordinates:</b><br/>N-20°52'21.4"<br/>E-92°17'34.2"</p> |

| <p><b>Date of Occurrence:</b> June 15, 2010 and July 6, 2008</p> | <p><b>Landslide History:</b> Initiated movement in July 2008, Subsequently activated in June 2010 .</p> |
| <p><b>Rainfall:</b> July 6, 2008: 209 mm during 24 hours and 1332mm during 12 days (continuous rain from 25 June to 6 July)</p> | |

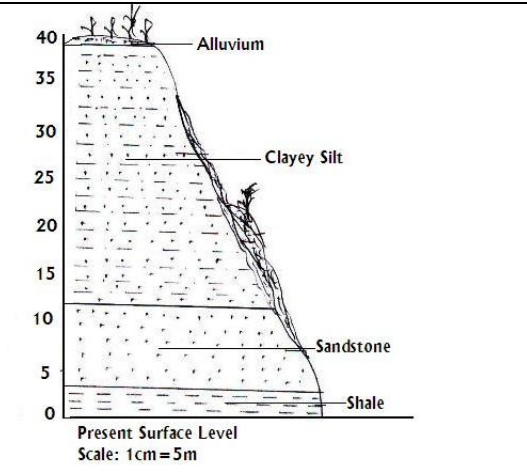
| <b>Landslide ID:</b> 06 | <b>Coordinates:</b> |

| <b>Date of Occurrence:</b> June 15, 2010 | <b>Landslide History:</b> Subsequently activated in June 2010. |

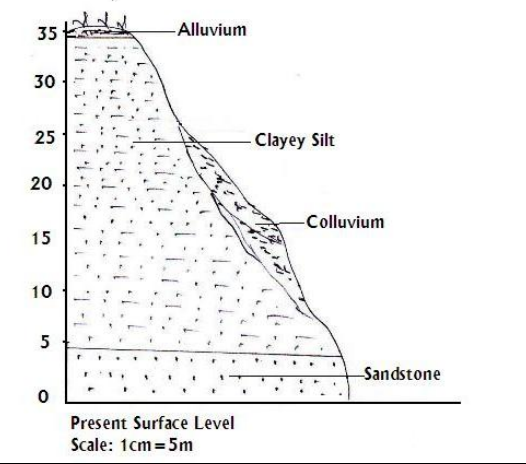
| <p><b>Landslide ID:</b> 08<br/><b>Location:</b> Puran Pallan Para, Teknaf Municipal Area</p> | <p><b>Coordinates:</b><br/>N-20°52'22.2"<br/>E-92°17'28.6"</p> |

| <p><b>Date of Occurrence:</b> July 6, 2008.</p> | <p><b>Landslide History:</b> Subsequently activated in July 2008.</p> |
| <p><b>Rainfall:</b> 209 mm during 24 hours and 1332mm during 12 days (continuous rain from 25 June to 6 July)</p> | |

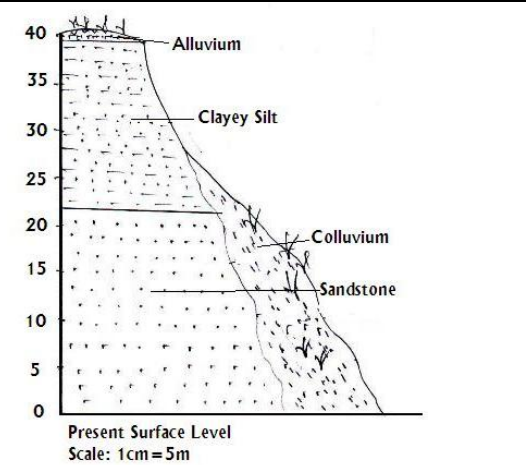
| <p><b>Landslide ID:</b> 11</p> <p><b>Location:</b> Puran Pallan Para, Teknaf Municipal Area</p> | <p><b>Coordinates:</b></p> <p>N-20°52'33.7"</p> <p>E-92°17'31.3"</p> |

| <p><b>Date of Occurrence:</b> July 6, 2008.</p> | <p><b>Landslide History:</b> Subsequently activated in July 2008.</p> |
| <p><b>Rainfall:</b> 209 mm during 24 hours and 1332mm during 12 days (continuous rain from 25 June to 6 July)</p> | |
